POST OPENING STAGE ROAD SAFETY AUDIT REPORT
Traffic Signals Installation and Access Road Connection
GEELONG-PORTARLINGTON ROAD / TIVOLI DRIVE - Curlewis

31 July 2020

AUDITOR:
Michael Stirrat – SRSA

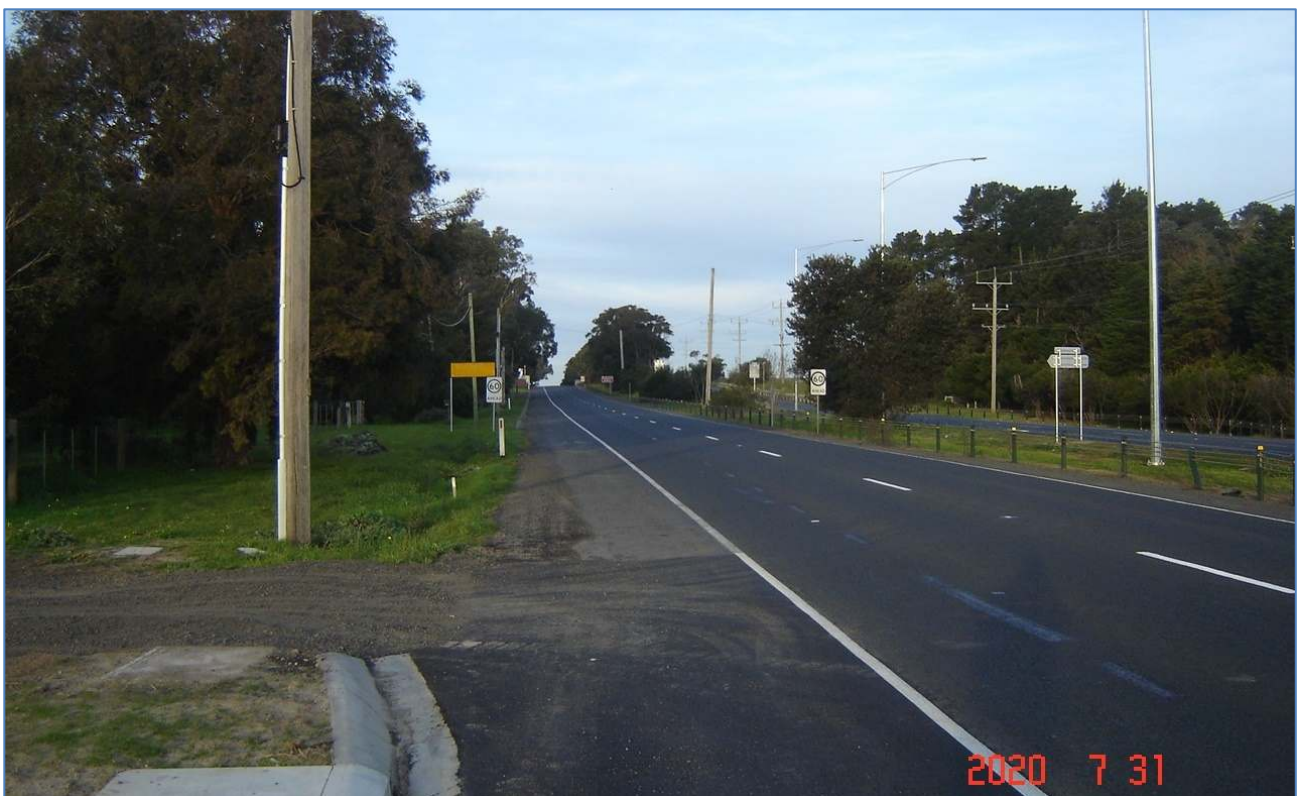
3.4 For traffic heading east, after the intersection, there are a few power poles along the north side at approx. min 4.5m offset from the edge line. These poles are providing service to individual properties. These hazards should be reviewed and either removed, relocated, or shielded.

Geelong-Portarlington Rd - Line of power service poles along edge of east side departure

5. For traffic heading east, after the intersection, there are a few power poles along the north side at approx. 4.5m min offset from the edge line.	These poles are providing service to individual properties. Either remove, relocate, or shield these hazardous poles.	Note	
TIVOLI DRIVE

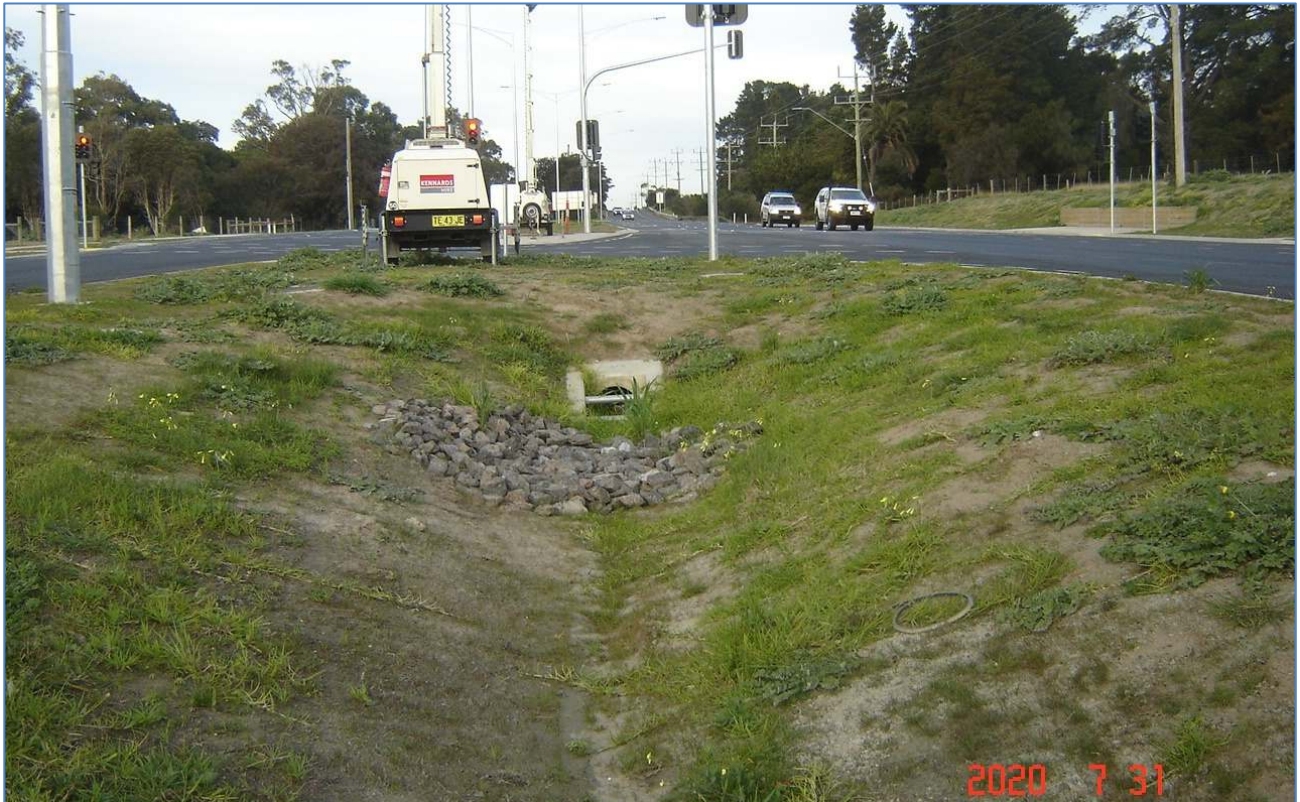
3.3 There is a culvert outlet in the central median, west side, that has batters sloping up to 1to1 (45 deg.) close to the intersection without barrier shielding. The culvert could be extended to a point where the outlet is in a flatter and more driveable location.

Steep batters to culvert endwall -worst case is south side for west bound traffic.

3. There is a culvert outlet in the central median, west side, that has batters sloping up to 1to1 (45 deg.) close to the intersection without barrier shielding.	Extend the culvert to a point where the outlet is in a flatter and more driveable location	Note

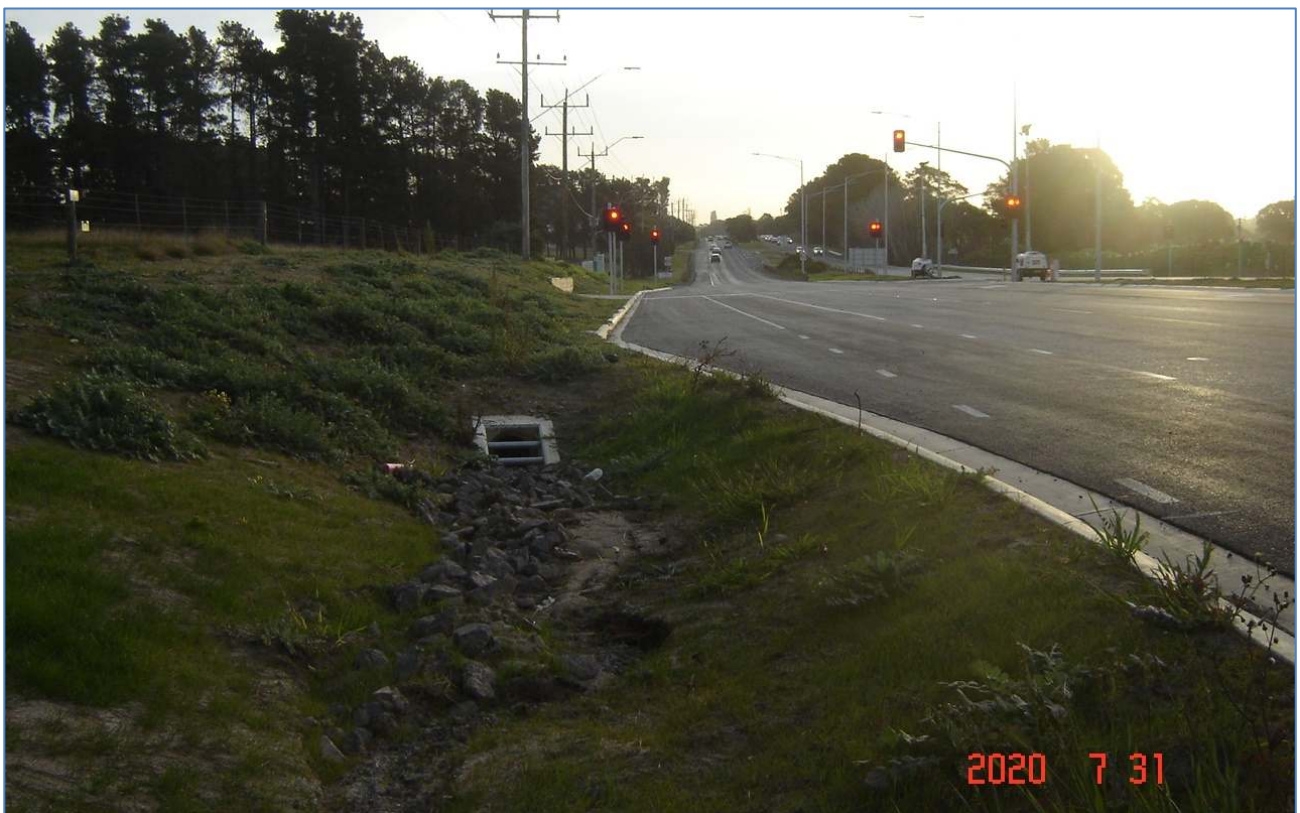
On the south side, east approach, there is a culvert inlet that is close to the back of the kerb. It has a driveable endwall, however, it has a steep batter dropping to the invert (up to 60 deg.). It is difficult to shield this hazard with a barrier due to a driveway immediately east of it. The culvert inlet should have been set back further from the kerb and the depth of the inlet minimised.

Culvert on east approach with steep batter from back of kerb?

4. On the south side, east approach, there is a culvert inlet that is close to the back of the kerb. It has a driveable endwall, however, it has a steep batter dropping to the invert (up to 60 deg.).	Either set back the culvert inlet further from the kerb and/or provide a type of drop inlet to minimise the batter slopes.	Note

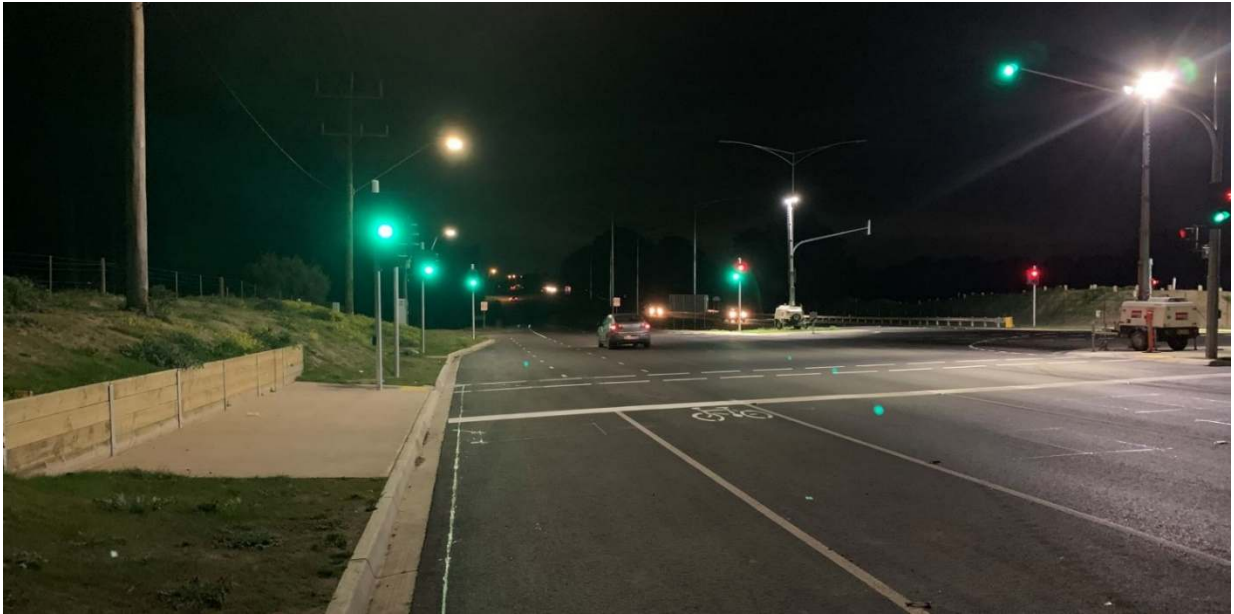
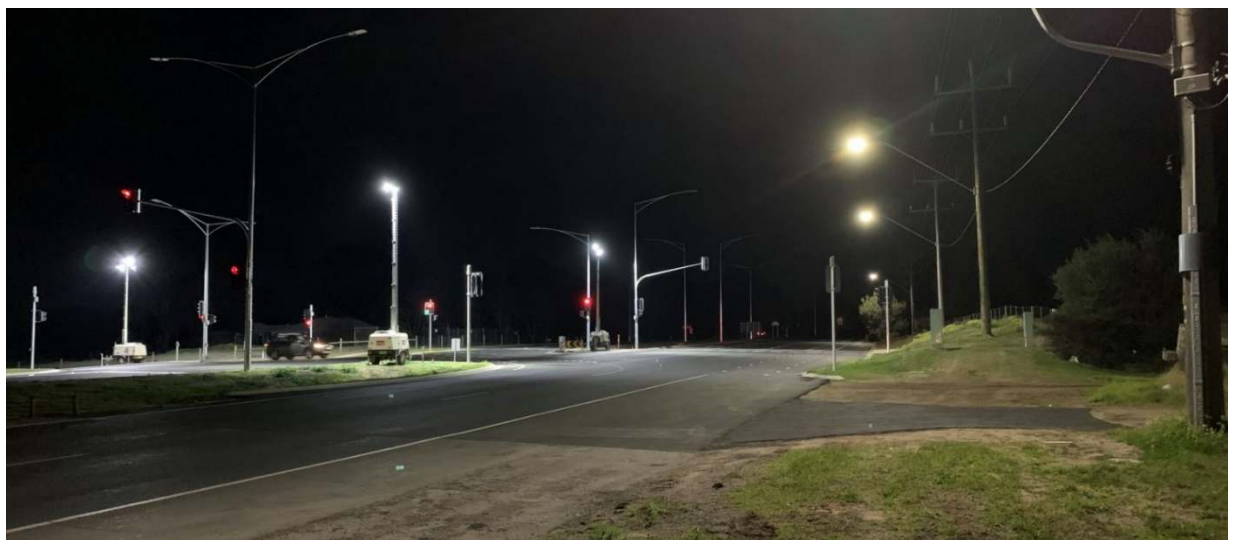
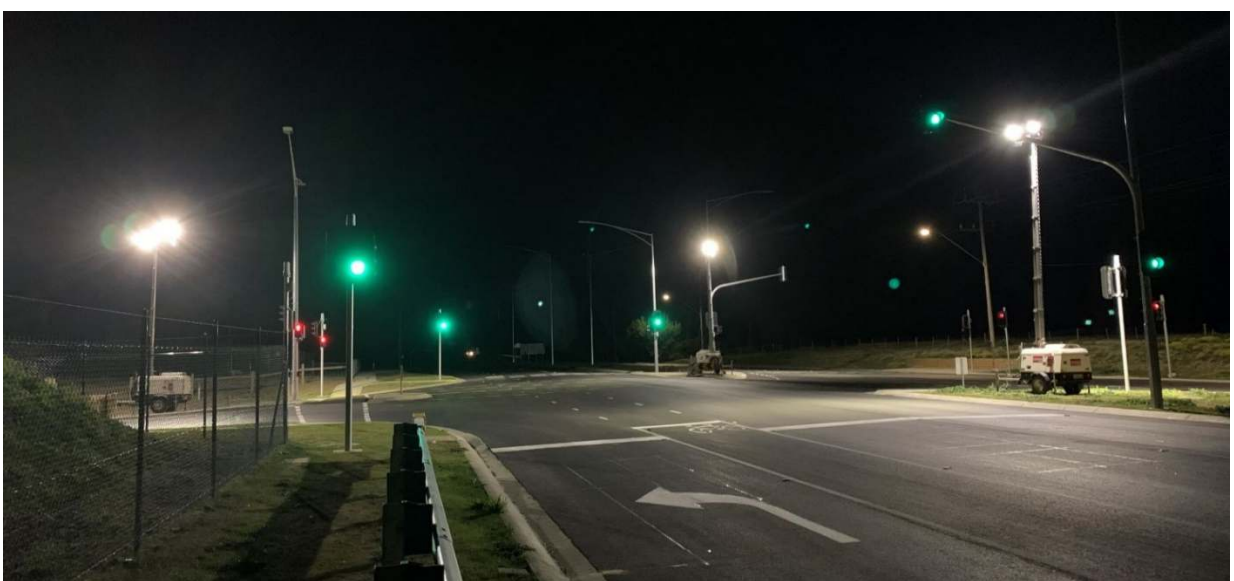
Note: The traffic signals were switched on earlier on the day of the initial site inspection. Some cosmetic works were still in progress. Lighting at the intersection is by portable generators and flood lights as permanent lighting is not yet available. The temporary lighting was providing a fair to good level of illumination where needed.

Temporary lighting around the intersection

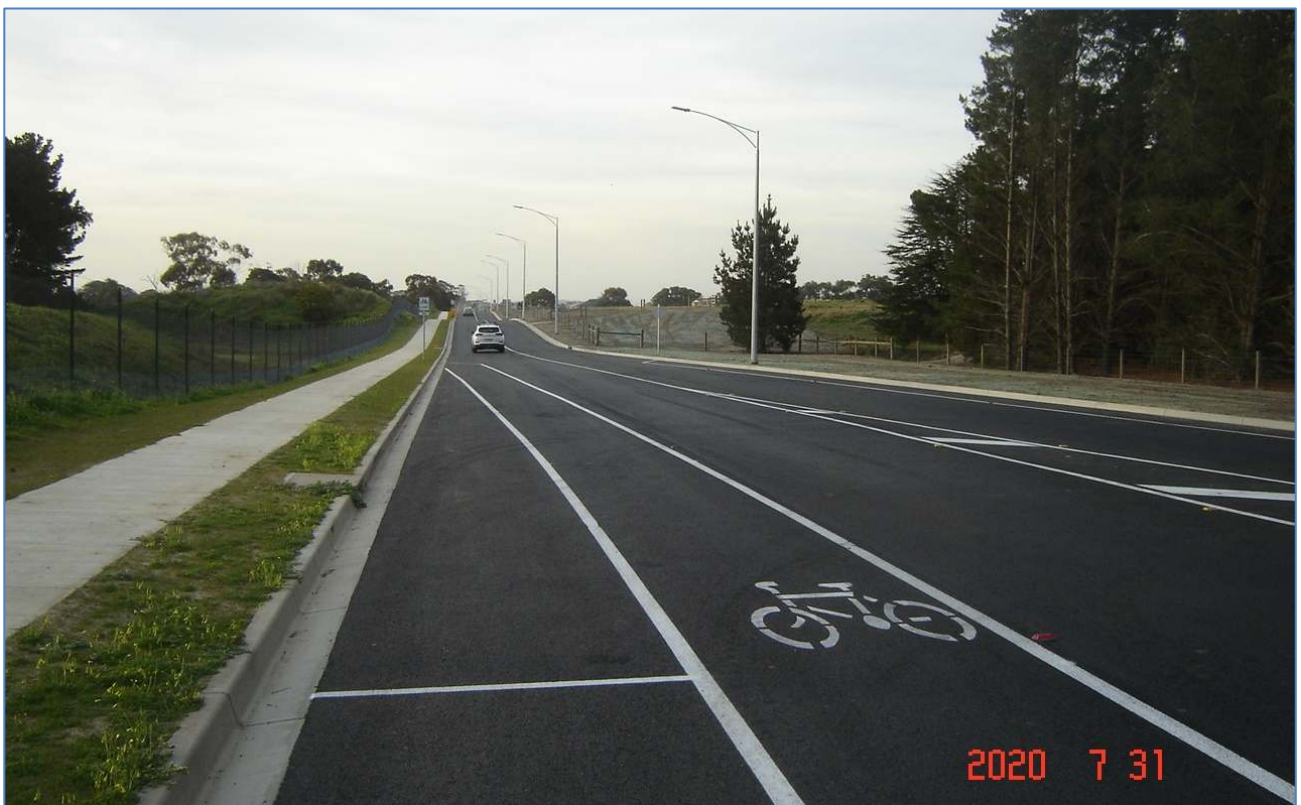
There is a bike lane provided at the exit from the Geelong-Portarlington Road, but this ends as the road narrows, and cyclists would then share a 3.75m wide lane with other traffic. The Cycling Aspects of Austroads Guides 2014 nominates a desirable minimum shared kerb side lane width of 4.2m in a 60km/h speed zone, with an acceptable minimum of 3.7m. If cyclists are to be given some on-road access and protection, then parking should be banned along the entire length of Tivoli Drive, where there is no off-road cycling facility.

Tivoli Drive looking northward where it narrows and bike lane disappears.

7. Between the Geelong-Portarlington Road and the Rail Trail crossing (600m length) the formal bike lanes at the south end are terminated. There is no formal facility for cyclists to connect to and they will need to share with all traffic in a 3.75m wide kerb side lane.	3.75m is at the lower end of an acceptable width for a shared lane (desirable 4.2m). Consider providing an off road cycling facility.	Note

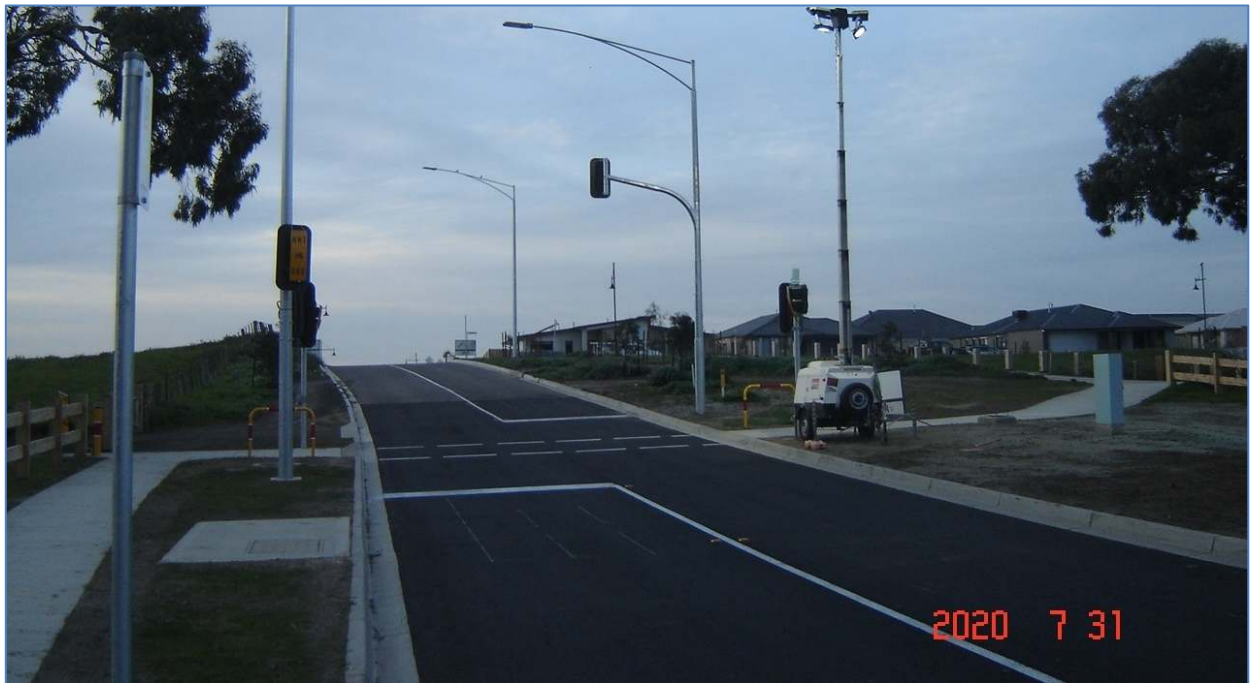
North of the Rail Trail, Tivoli Drive has a vertical curve cresting at approx. 60m north of the crossing point. Sight distance over the crest is poor. Queuing at the Rail Trail Traffic Signals will be partially hidden to south bound traffic coming over the crest, with a risk of tail end accidents. The high Mast Arm signal Outreach lantern, along with the 50km/h speed limit will help to reduce the crash risk (if the posted speed limit is obeyed).

Rail Trail crossing – looking north to crest.

8. North of the Rail Trail, Tivoli Drive has a vertical curve cresting at approx. 60m north of the crossing point. Sight distance over the crest is average to poor. Queuing at the Rail Trail Traffic Signals will be partially hidden over the crest with a risk of tail end accidents.	The high Mast Arm signal Outreach lantern, along with the 50km/h speed limit will help to reduce the crash risk. Consider adding a 'Prepare to Stop' panel to the existing Signals warning sign.	Note

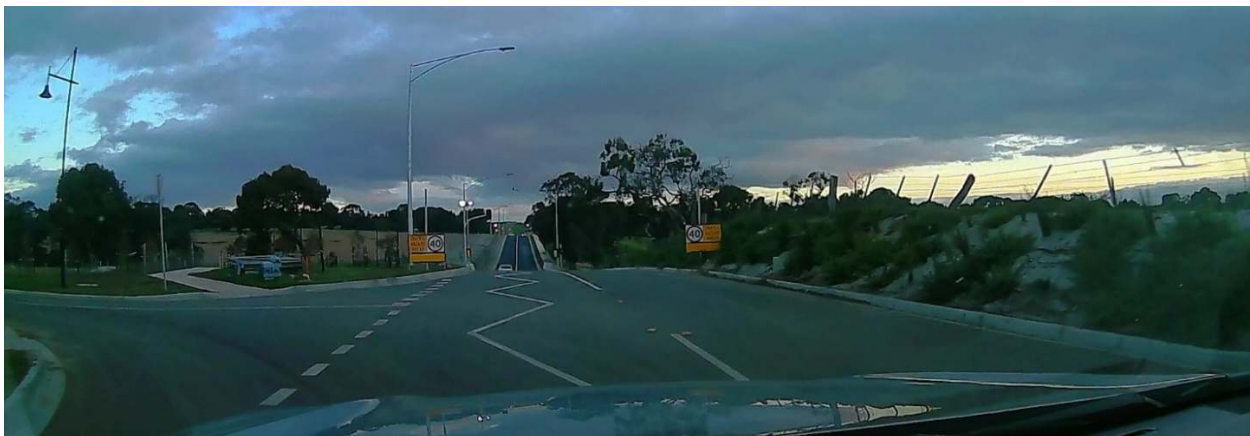
Stanley Avenue intersects Tivoli Drive from the east at the crest of the hill (T-intersection). This intersection is partly hidden due to the crest and with the parking in Tivoli Drive north. Parking, if allowed, should be kept well clear of the intersection. The installation of intersection warning signs (W2-4) would help to identify the presence of this intersection.

Looking south to Rail Trail Crossing from Stanley Avenue

9. Stanley Avenue intersects Tivoli Drive at the crest of the hill (T-intersection to east) and is partly hidden due to the crest and with the parking in Tivoli Drive	Ban parking from close to the intersection. Install intersection warning signs (W2-4).	Note

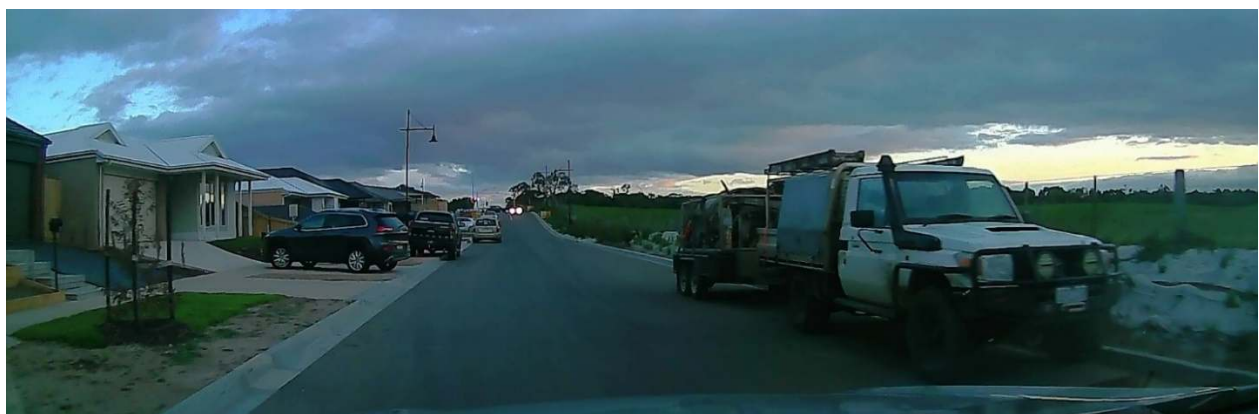
3.7 North of Stanley Avenue there were significant numbers of parked vehicles on the 7.5m wide Tivoli Drive carriageway. This leaves a driveable width of approx. 5.2m for two way traffic. This is very restrictive for this collector street. The concern is further compromised with some parking being done on the west side of the carriageway. During the inspections a number of drivers refrained from squeezing past parked vehicles and they preferred to wait for oncoming traffic to clear.

North of Stanley Ave. – example of parking both sides.

10. North of Stanley Avenue significant numbers of parked vehicles clutter the roadway and restrict the free flow of the increasing volume of collecting traffic.	Ideally ban parking along Tivoli Drive. At least restrict parking to the east side of Tivoli Drive. Provide an off-road cyclist option if parking is to remain. Proposed future widening /duplication of Tivoli Drive should be constructed as soon as possible.	Important
