THE CITY OF
GREATER GEELONG

SOUTH GEELONG URBAN DESIGN FRAMEWORK

PROPOSED REVISION TO HO1641
CITY SOUTH HERITAGE AREA

FEBRUARY 2022

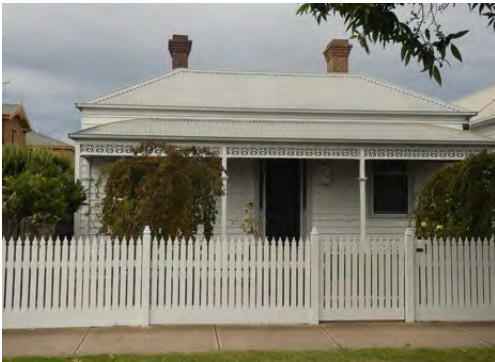
229 Yarra Street (D)

Description: a single storey detached dwelling in a Victorian architectural style, setback 2-5m from the street. Wall construction of weatherboard with a hipped roof form.

Integrity: the primary building is substantially unchanged from its early or significant character/form.

Assessed heritage value: overall the primary building and landscaping make a major contribution to the significant character of the area.

Significant character attributes include: complementary setback of the primary building from the street, scale/height, its roof form and presence of verandah/porch, its architectural style, its wall & roof cladding, window and door layout & materials, chimney stacks, aspects of its exterior detailing including the iron & timber fretwork on the verandah/porch, front fence, street tree.

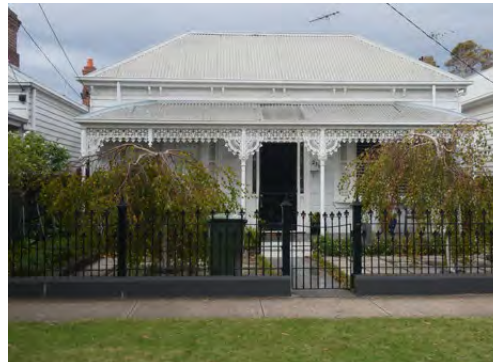
231 Yarra Street (D)

Description: a single storey detached dwelling in a Victorian architectural style, setback 2-5m from the street. Wall construction of weatherboard with a hipped roof form.

Integrity: the primary building is substantially unchanged from its early or significant character/form, with a possibly latter but complementary front fence.

Assessed heritage value: overall the primary building and landscaping make a major contribution to the significant character of the area.

Significant character attributes include: complementary setback of the primary building from the street, scale/height, its roof form and presence of verandah/porch, its architectural style, its wall & roof cladding, window and door layout & materials, aspects of its exterior detailing including the iron lacework on the verandah/porch, front eave brackets and associated panelling, timber sills & brackets on front windows, front fence.

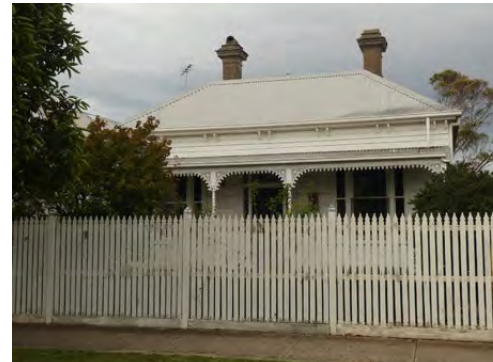
233 Yarra Street (D)

Description: a single storey detached dwelling in a Victorian architectural style, setback 2-5m from the street. Wall construction of weatherboard with a hipped roof form.

Integrity: the primary building is substantially unchanged from its early or significant character/form.

Assessed heritage value: overall the primary building and landscaping make a major contribution to the significant character of the area.

Significant character attributes include: complementary setback of the primary building from the street, scale/height, its roof form and presence of verandah/porch, its architectural style, its wall & roof cladding, window and door layout & materials, chimney stacks, aspects of its exterior detailing including the iron & lacework on the verandah/porch, front eave brackets and associated panelling, timber sills & brackets on front windows, front fence.

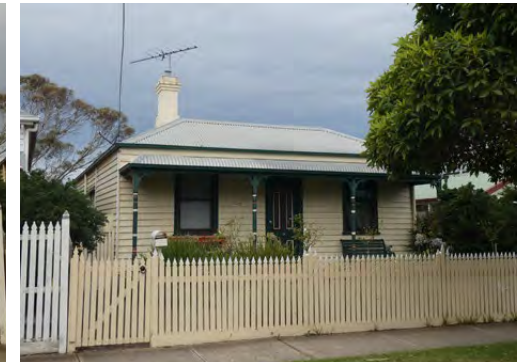
235 Yarra Street (D)

Description: a single storey detached dwelling in a Federation/Edwardian architectural style, setback 2-5m from the street. Wall construction of weatherboard with a hipped roof form.

Integrity: the primary building is substantially unchanged from its early or significant character/form.

Assessed heritage value: overall the primary building and landscaping make a major contribution to the significant character of the area.

Significant character attributes include: complementary setback of the primary building from the street, scale/height, its roof form and presence of verandah/porch, its architectural style, its wall & roof cladding, window and door layout & materials, chimney stacks, aspects of its exterior detailing including the iron & lacework on the verandah/porch, front eave brackets and associated panelling, timber sills & brackets on front windows, front fence.

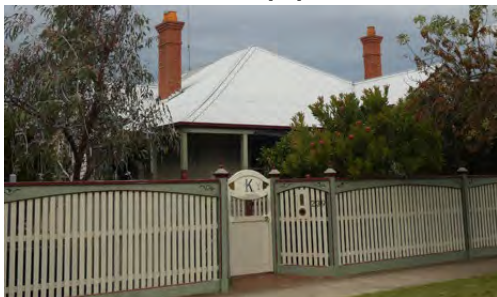
239 Yarra Street (D)

Description: a single storey detached dwelling in a Federation/Edwardian architectural style, setback 2-5m from the street. Wall construction of weatherboard with a hipped roof form.

Integrity: the primary building is substantially unchanged from its early or significant character/form, the use of native trees & shrubs is not historically consistent but complements the house and style.

Significant character attributes include: complementary setback of the primary building from the street, scale/height, its roof form including the integration of the verandah roof into the main with a slight change of pitch, presence of verandah/porch, its architectural style, its wall & roof cladding, window and door layout & materials, chimney stacks, front fence, garden trees (albeit native spp).

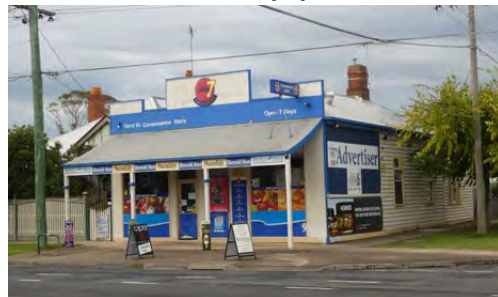
241 Yarra Street (D)

Description: a single storey corner shop with attached residence in a Federation/Edwardian architectural style, situated with 0m setback. Wall construction of weatherboard to the rear residence, panelling and shop windows with a parapet roof form.

Integrity: the primary building has been subject to minor alterations that either do not diminish its character or can be easily reversed – mid C20th (?) changes to shop windows which complement the character, modern signage which is less sympathetic but not inappropriate to the original use.

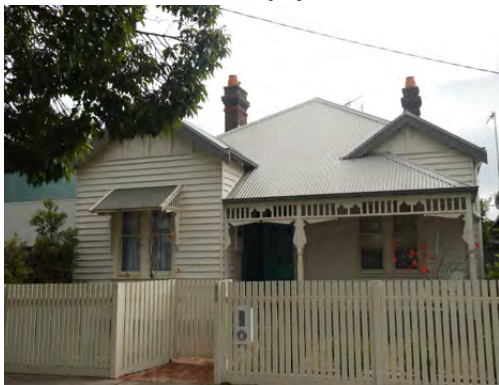
256 Yarra Street (D)

Description: a single storey detached dwelling in a Federation architectural style, setback 2-5m from the street. Wall construction of weatherboard with a hip and gable roof form.

Integrity: the primary building is substantially unchanged from its early or significant character/form.

include: complementary setback of the primary building from the street, scale/height, its roof form and presence of verandah/porch, its architectural style, its wall & roof cladding, window and door layout & materials, chimney stacks, aspects of its exterior joinery including timber panelling on the gables, fretwork along the verandah, eave brackets, timber brackets on the window hoods, front fence, street tree.

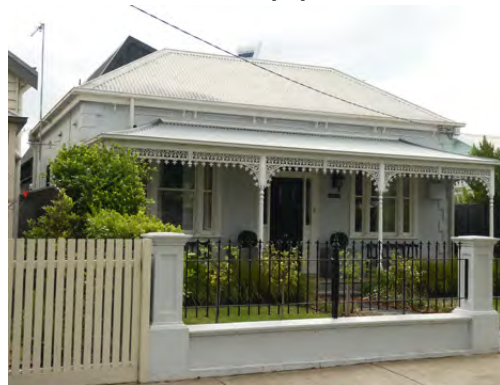
254 Yarra Street (D)

Description: a single storey detached dwelling in a Victorian architectural style, setback 2-5m from the street. Wall construction of painted brick masonry with a hipped roof form.

Integrity: the primary building is substantially unchanged from its early or significant character/form, with a latter but complementary front fence.

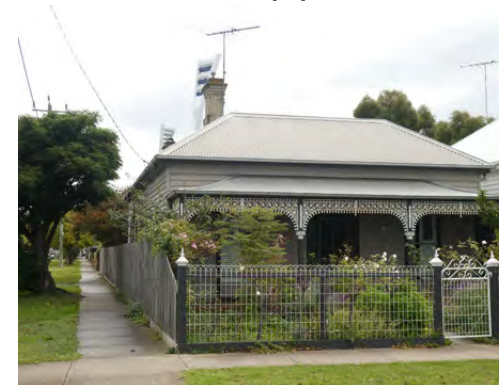
248 Yarra Street(D)

Description: a single storey detached dwelling in a Victorian architectural style, setback 2-5m from the street. Wall construction of weatherboard with a hipped roof form.

Integrity: the primary building is substantially unchanged from its early or significant character/form, with a latter but complementary front fence.

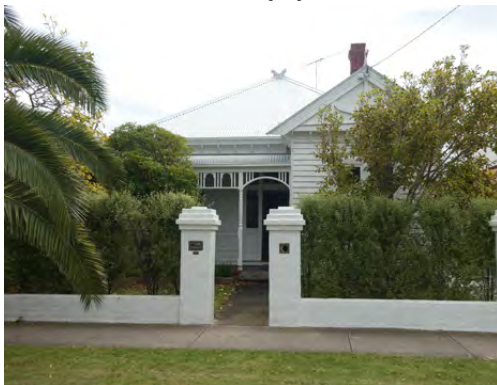
246 Yarra Street (D)

Description: a single storey detached dwelling in a Federation architectural style, setback 2-5m from the street. Wall construction of weatherboard with a hip and gable roof form.

Integrity: the primary building is substantially unchanged from its early or significant character/form.

include: complementary setback of the primary building from the street, scale/height, its roof form and presence of verandah/porch, its architectural style, its wall & roof cladding, window and door layout & materials, chimney stacks, aspects of its exterior joinery including timber panelling on the gables, fretwork along the verandah, eave brackets and associated panelling, front fence, garden trees.

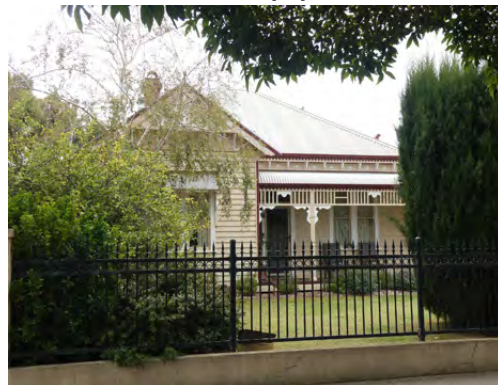
242 Yarra Street (D)

Description: a single storey detached dwelling in a Federation architectural style, setback 2-5m from the street. Wall construction of weatherboard with a hip and gable roof form.

Integrity: the primary building is substantially unchanged from its early or significant character/form with a latter but complementary front fence..

include: complementary setback of the primary building from the street, scale/height, its roof form and presence of verandah/porch, its architectural style, its wall & roof cladding, window and door layout & materials, chimney stacks, aspects of its exterior joinery including timber panelling on the gables, fretwork along the verandah, eave brackets and associated panelling, transparent front fence, garden trees, street tree.

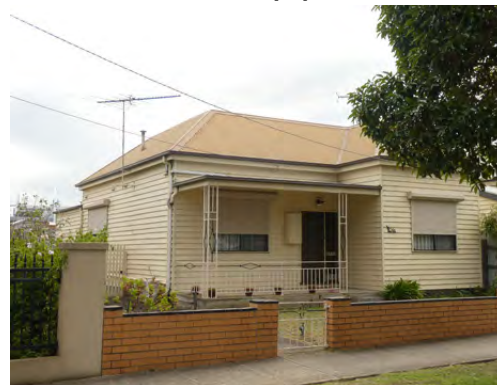
240 Yarra Street (D)

Description: a single storey detached dwelling in a Victorian architectural style with postwar alterations, setback 2-5m from the street. Wall construction of weatherboard with a hipped roof form.

Integrity: the primary building has been subject to minor alterations that either do not diminish its significant character or can be easily reversed. – mid C20th porch and front fence, aluminium windows with roller shutters, removal of chimneys.

include: complementary setback of the primary building from the street, scale/height, its roof form and presence of verandah/porch, its wall & roof cladding, low front fence.

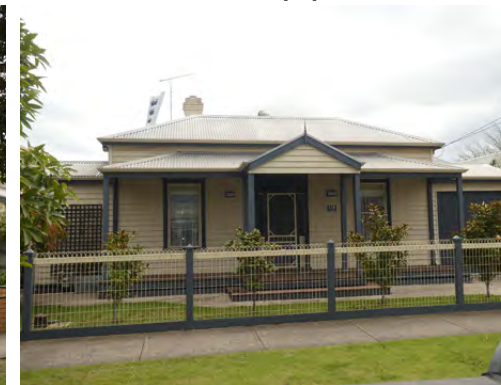
238 Yarra Street (D)

Description: a single storey detached dwelling in a Federation/Edwardian architectural style, setback 2-5m from the street. Wall construction of weatherboard with a hipped roof form.

Integrity: the primary building is substantially unchanged from its early or significant character/form, with a large addition to sides & rear and complementary changes to the verandah floor and roof including a central gable form and a latter but complementary front fence.

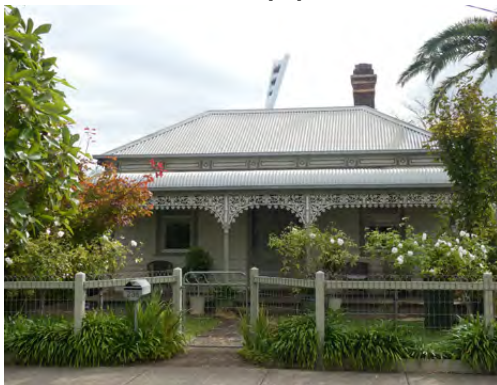
236 Yarra Street (D)

Description: a single storey detached dwelling in a Victorian architectural style, setback 2-5m from the street. Wall construction of weatherboard with a hipped roof form.

Integrity: the primary building is substantially unchanged from its early or significant character/form, with a large/unseen rear addition and latter but complementary front fence.

Significant character attributes include: complementary setback of the primary building from the street, scale/height, its roof form and presence of verandah/porch, its architectural style, its wall & roof cladding, window and door layout & materials, chimney stacks, aspects of its exterior detailing including the iron lacework on the verandah/porch, eave brackets and associated panelling, transparent front fence, garden trees/shrubs.

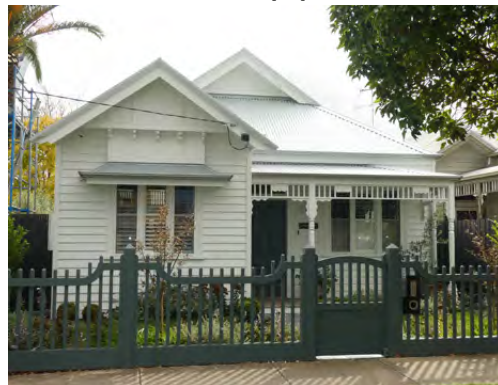
234 Yarra Street (D)

Description: a single storey detached dwelling in a Federation architectural style, setback 2-5m from the street. Wall construction of weatherboard with a hip and gable roof form.

Integrity: the primary building is substantially unchanged from its early or significant character/form, with a large/unseen rear addition and latter but complementary front fence.

Significant character attributes include: complementary setback of the primary building from the street, scale/height, its roof form and presence of verandah/porch, its architectural style, its wall & roof cladding, window and door layout & materials, aspects of its exterior joinery including timber panelling on the gables, window hood on main gable, fretwork along the verandah, front fence, street tree.

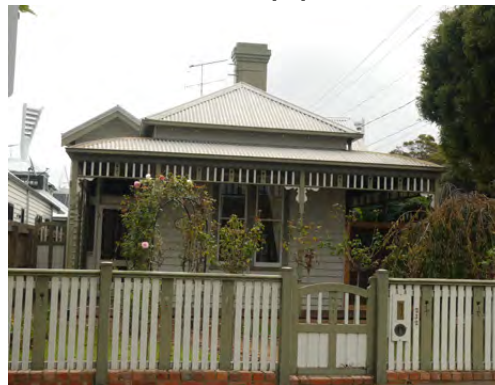
232 Yarra Street (D)

Description: a single storey detached dwelling in a Federation architectural style, setback 2-5m from the street. Wall construction of weatherboard with a hip and gable roof form.

Integrity: the primary building is substantially unchanged from its early or significant character/form.

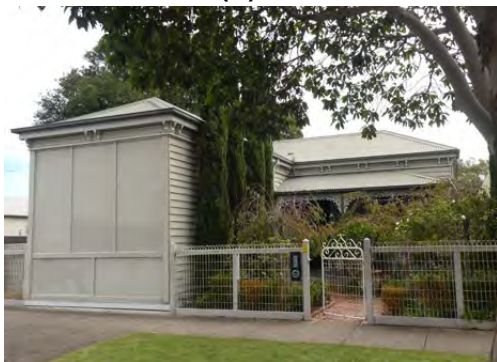
230 Yarra Street (D)

Description: a single storey corner shop or office with attached residence in a Victorian architectural style, situated with 0m setback. Wall construction of weatherboard with a hip roof form.

Integrity: the primary building has been subject to minor alterations that either do not diminish its character or can be easily reversed – the shop/business frontage has been infilled with panelling in a frame, later windows and modest rear addition added to Verner St side.

Significant character attributes include: corner shop frontage, scale/height, roof form and presence of verandah/porch, its architectural style, its wall & roof cladding, window and door layout & materials, exterior detailing including the iron lacework on the verandah/porch, eave brackets and associated panelling, window hoods & brackets, front fence, street trees.

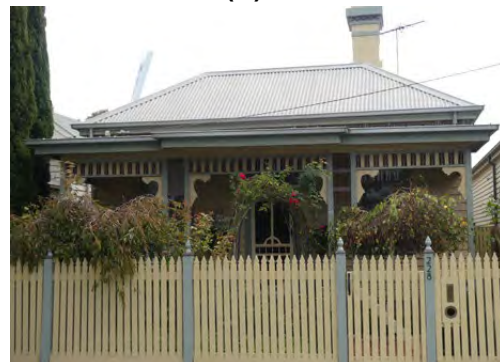
228 Yarra Street (D)

Description: a single storey detached dwelling in a Federation architectural style, setback 2-5m from the street. Wall construction of weatherboard with a hip and gable roof form.

Integrity: the primary building is substantially unchanged from its early or significant character/form, with a large/unseen rear addition and latter but complementary front fence.

Significant character attributes include: complementary setback of the primary building from the street, scale/height, its roof form and presence of verandah/porch, its architectural style, its wall & roof cladding, window and door layout & materials, chimney stacks, aspects of its exterior joinery including fretwork along the verandah, eave brackets and associated panelling, front fence.

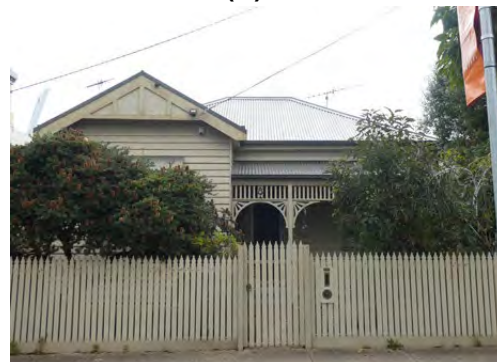
226 Yarra Street (D)

Description: a single storey detached dwelling in a Federation architectural style, setback 2-5m from the street. Wall construction of weatherboard with a hip and gable roof form.

Integrity: the primary building is substantially unchanged from its early or significant character/form, with a large/unseen rear addition and latter but complementary front fence.

Significant character attributes include: complementary setback of the primary building from the street, scale/height, its roof form and presence of verandah/porch, its architectural style, its wall & roof cladding, window and door layout & materials, aspects of its exterior joinery including timber panelling on the gables, window hood on main gable, fretwork along the verandah, front fence.

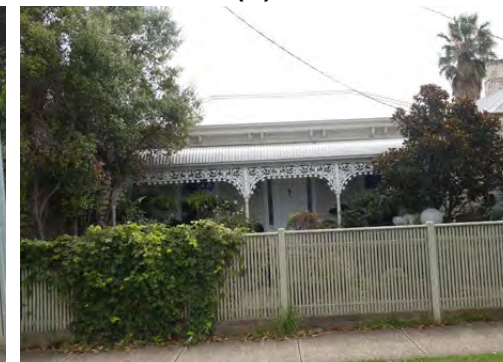
224 Yarra Street (D)

Description: a single storey detached dwelling in a Victorian architectural style, setback 2-5m from the street. Wall construction of weatherboard with a hipped roof form.

Integrity: the primary building is substantially unchanged from its early or significant character/form, with a large/unseen rear addition and latter but complementary front fence.

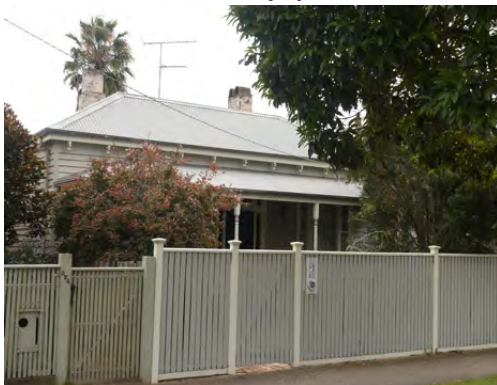
222 Yarra Street (D)

Description: a single storey detached dwelling in a Victorian architectural style, setback 2-5m from the street. Wall construction of weatherboard with a hipped roof form.

Integrity: the primary building is substantially unchanged from its early or significant character/form, with a large/unseen rear addition and latter, probable removal of verandah lace or fretwork, and a latter but complementary front fence.

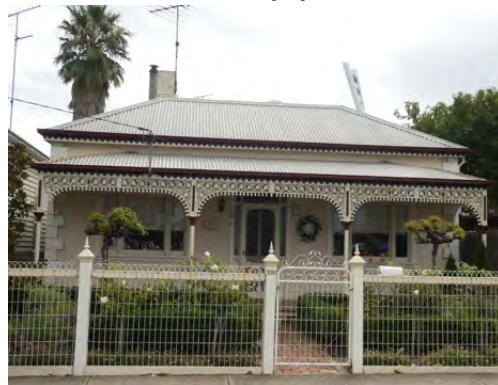
220 Yarra Street (D)

Description: a single storey detached dwelling in a Victorian architectural style, setback 2-5m from the street. Wall construction of rendered masonry with a hipped roof form.

Integrity: the primary building is substantially unchanged from its early or significant character/form, with a discrete two-storey addition at rear and latter but complementary front fence.

Assessed heritage value: overall the primary building and landscaping make a major contribution to the significant character of the area.

Significant character attributes include: complementary setback of the primary building from the street, scale/height, its roof form and presence of verandah/porch, its architectural style, its wall & roof cladding, window and door layout & materials, chimney stacks, aspects of its exterior detailing including the iron lacework on the verandah/porch, the 'www' timber fretwork on the verandah and front eave, transparent front fence.

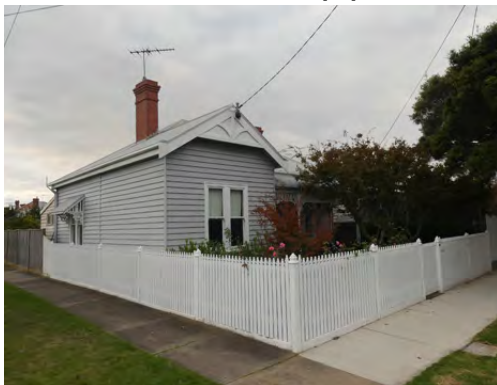
264 Bellerine Street (D)

Description: a single storey detached dwelling in a Federation architectural style, setback 2-5m from the street. Wall construction of weatherboard with a hip and gable roof form.

Integrity: the primary building is substantially unchanged from its early or significant character/form, with a discrete rear addition and latter but complementary front fence.

Assessed heritage value: overall the primary building and landscaping make a major contribution to the significant character of the area.

include: complementary setback of the primary building from the street, scale/height, its roof form and presence of verandah/porch, its architectural style, its wall & roof cladding, chimney stack, window and door layout & materials, aspects of its exterior joinery including fretwork & post along the verandah, window hood, gable panelling, exposed rafters, front fence.

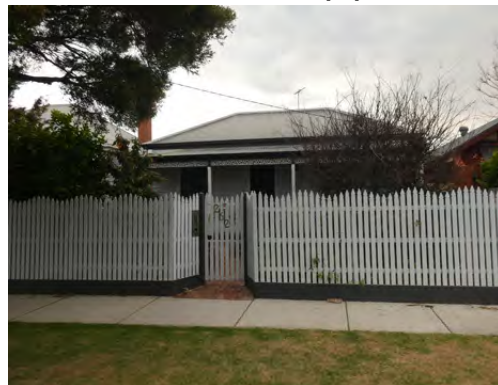
262 Bellerine Street (D)

Description: a single storey detached dwelling in a late Victorian architectural style, setback 2-5m from the street. Wall construction of weatherboard with a hipped roof form.

Integrity: the primary building is substantially unchanged from its early or significant character/form, with a discrete large addition to the rear and latter but complementary front fence.

Assessed heritage value: overall the primary building and landscaping make a major contribution to the significant character of the area.

include: complementary setback of the primary building from the street, scale/height, its roof form and presence of verandah/porch, its architectural style, its wall & roof cladding, window and door layout & materials, aspects of its exterior joinery including lacework along the verandah, front fence, street tree.

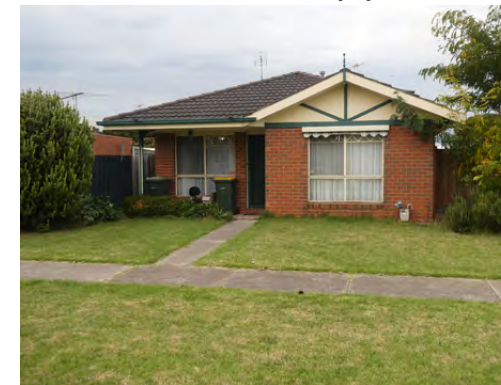
271 Bellerine Street (N)

Description: a single storey detached dwelling in a Postwar architectural style, setback 5-10m from the street. Wall construction of weatherboard with a hip and gable roof form.

Integrity: this block was redeveloped c1980s, when a previous early residence was likely demolished.

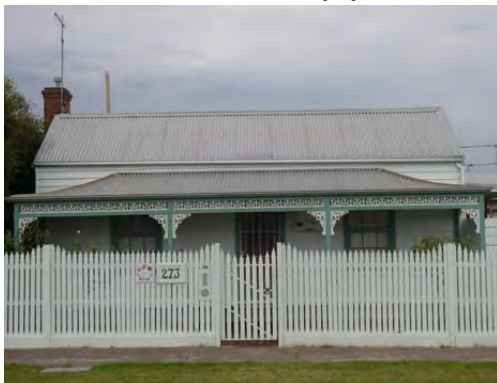
273 Bellerine Street (D)

Description: a single storey detached dwelling in a late Victorian architectural style, setback 2-5m from the street. Wall construction of weatherboard with a gabled roof form.

Integrity: the primary building is substantially unchanged from its early or significant character/form, with a discrete large addition to the rear and latter but complementary front fence.

include: complementary setback of the primary building from the street, scale/height, its roof form and presence of verandah/porch, its architectural style, its wall & roof cladding, chimney, window and door layout & materials, aspects of its exterior joinery including lacework along the verandah, front fence.

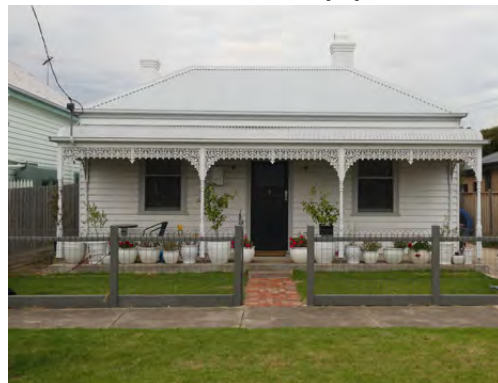
275 Bellerine Street (D)

Description: a single storey detached dwelling in a late Victorian architectural style, setback 2-5m from the street. Wall construction of weatherboard with a hipped roof form.

Integrity: the primary building is substantially unchanged from its early or significant character/form, with a discrete rear addition and latter but complementary front fence.

include: complementary setback of the primary building from the street, scale/height, its roof form and presence of verandah/porch, its architectural style, its wall & roof cladding, chimneys, window and door layout & materials, aspects of its exterior joinery including lacework along the verandah, front fence.

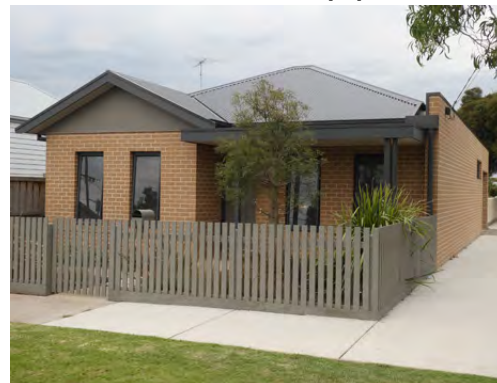
277 Bellerine Street (N)

Description: a single storey detached dwelling in a Postwar architectural style, setback 2-5m from the street. Wall construction of weatherboard with a hip and gable roof form.

Integrity: this block was redeveloped c1980s, when a previous early residence was likely demolished.

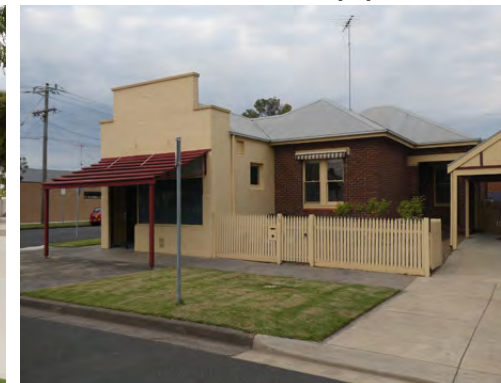
Description: a single storey corner shop with attached residence in an Interwar architectural style, situated with 0m setback. Wall construction of face brick, painted around shop, shop window & side door; parapet roof form to shop, hip to residence.

Integrity: the primary building has been subject to minor alterations that either do not diminish its character or can be easily reversed – late C20th carport, replacement of shop window & awning.

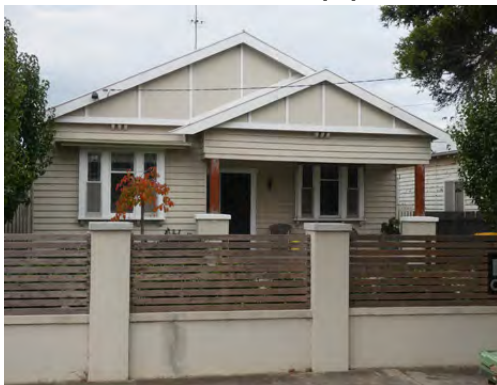
291 Bellerine Street (D)

Description: a single storey detached dwelling in an Interwar architectural style, setback 5-10m from the street. Wall construction of weatherboard with a gable roof form.

Integrity: the primary building is substantially unchanged from its early or significant character/form, with a latter but complementary front wall & fence.

include: complementary setback of the primary building from the street, scale/height, its roof form with double-gabled façade and presence of verandah/porch, its architectural style, its wall & roof cladding, window and door layout & materials, aspects of its exterior joinery including panelling & brackets on the gables, window hood, masonry & timber verandah posts, semi-transparent front fence.

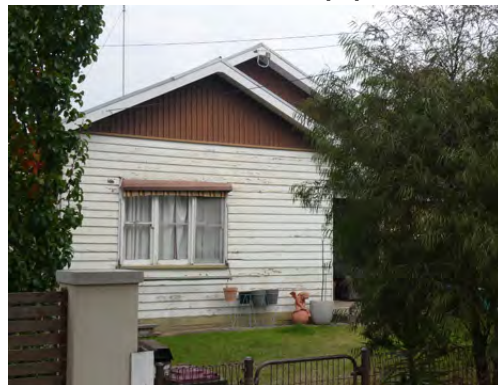
293 Bellerine Street (D)

Description: a single storey detached dwelling in an Interwar architectural style, setback 5-10m from the street. Wall construction of weatherboard with a gable roof form.

Integrity: the primary building is substantially unchanged from its early or significant character/form, with latter window awnings and wire fence.

include: complementary setback of the primary building from the street, scale/height, its roof form with double-gabled façade and presence of verandah/porch, its architectural style, its wall & roof cladding, window and door layout & materials, aspects of its exterior joinery including panelling on the gables, masonry & timber verandah posts, semi-transparent front fence.

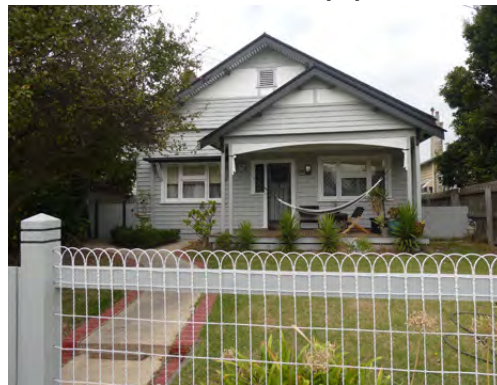
295 Bellerine Street (D)

Description: a single storey detached dwelling in an Interwar architectural style, setback 5-10m from the street. Wall construction of weatherboard with a gable roof form.

Integrity: the primary building is substantially unchanged from its early or significant character/form, with a discrete large addition to the rear and latter but complementary front fence.

include: complementary setback of the primary building from the street, scale/height, its roof form with double-gabled façade and presence of verandah/porch, its architectural style, its wall & roof cladding, window and door layout & materials, aspects of its exterior joinery including panelling & brackets on the gables, window hood, paired timber verandah posts, semi-transparent rigid wire front fence.

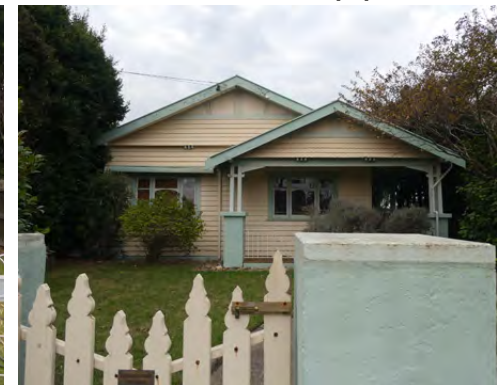
297 Bellerine Street (D)

Description: a single storey detached dwelling in an Interwar architectural style, setback 5-10m from the street. Wall construction of weatherboard with a gable roof form.

Integrity: the primary building is substantially unchanged from its early or significant character/form, with a discrete large addition to the rear and latter but complementary front fence.

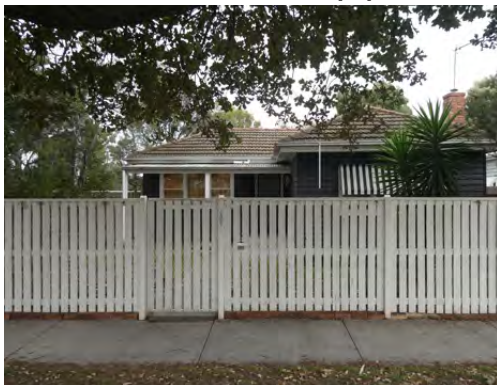
161 Swanston Street (N)

Description: a single storey detached dwelling in a Postwar architectural style, setback 2-5m from the street. Wall construction of weatherboard with a hipped roof form.

Integrity: either this block was undeveloped until c1950s or the original residence has been demolished and replaced by new development that broadly complements the character attributes of the area.

Significant character attributes include: complementary setback of the primary building from the street, scale/height, its roof form, low transparent front fence.

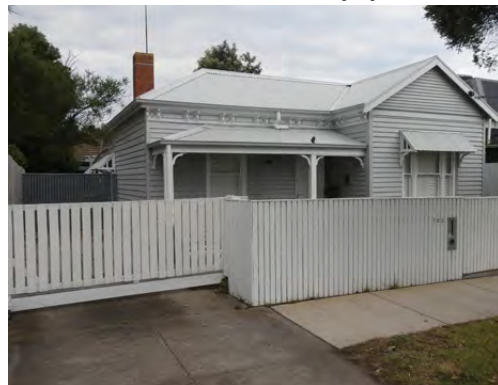
163 Swanston Street (D)

Description: a single storey detached dwelling in a Federation architectural style, setback 2-5m from the street. Wall construction of weatherboard with a hip and gable roof form.

Integrity: the primary building is substantially unchanged from its early or significant character/form, with a discrete rear addition and latter but complementary front fence.

Significant character attributes include: complementary setback of the primary building from the street, scale/height, its roof form and presence of verandah/porch, its architectural style, its wall & roof cladding, chimney stack, window and door layout & materials, aspects of its exterior joinery including verandah brackets, eaves brackets and panelling, window hood and brackets, front fence, street tree.

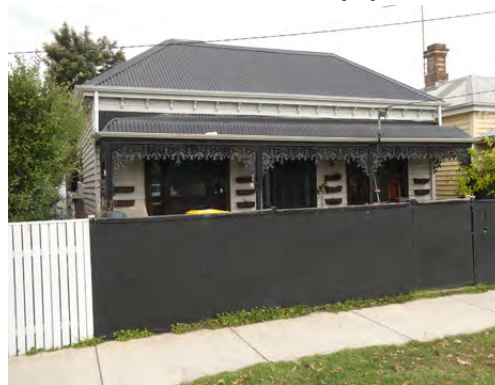
165 Swanston Street (D)

Description: a single storey detached dwelling in a Victorian architectural style, setback 2-5m from the street. Wall construction of weatherboard with a hipped roof form.

Integrity: the primary building is substantially unchanged from its early or significant character/form, with a discrete addition to the rear and a recent solid front fence.

Significant character attributes include: complementary setback of the primary building from the street, scale/height, its roof form and presence of verandah/porch, its architectural style, its wall & roof cladding, window and door layout & materials, aspects of its exterior joinery including lacework along the verandah, eave brackets and panelling.

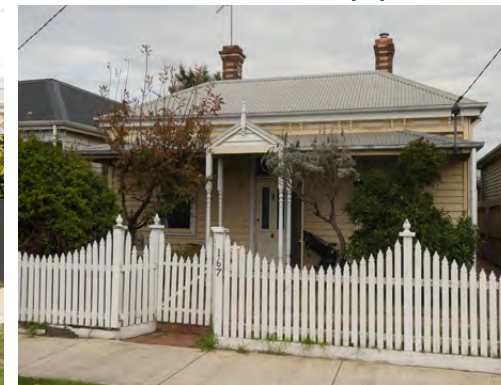
167 Swanston Street (D)

Description: a single storey detached dwelling in a Victorian architectural style, setback 2-5m from the street. Wall construction of weatherboard with a hipped roof form.

Integrity: the primary building is substantially unchanged from its early or significant character/form, although the verandah appears to have been rebuilt late C20th with new posts and the gable added, and a latter but complementary front fence.

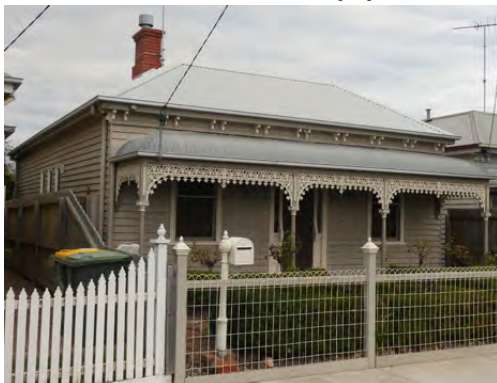
169 Swanston Street (D)

Description: a single storey detached dwelling in a Victorian architectural style, setback 2-5m from the street. Wall construction of weatherboard with a hipped roof form.

Integrity: the primary building is substantially unchanged from its early or significant character/form, with a latter but complementary front fence.

include: complementary setback of the primary building from the street, scale/height, its roof form and presence of verandah/porch, its architectural style, its wall & roof cladding, chimney stacks, window and door layout & materials, aspects of its exterior joinery including lacework along verandah, eave brackets and panelling, front fence.

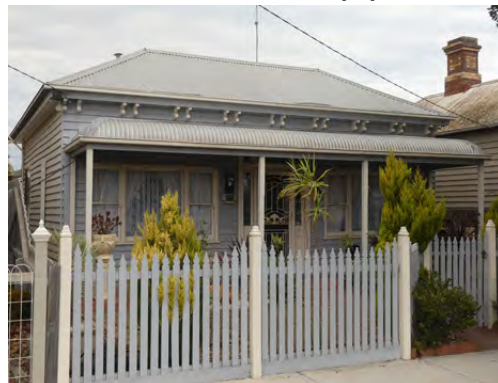
171 Swanston Street (D)

Description: a single storey detached dwelling in a Victorian architectural style, setback 2-5m from the street. Wall construction of weatherboard with a hipped roof form.

Integrity: the primary building has been subject to minor alterations that either do not diminish its significant character or can be easily reversed – larger front windows c1950s, with a latter but complementary front fence.

include: complementary setback of the primary building from the street, scale/height, its roof form and presence of verandah/porch, its architectural style, its wall & roof cladding, window and door materials, aspects of its exterior joinery including eave brackets and panelling, front fence.

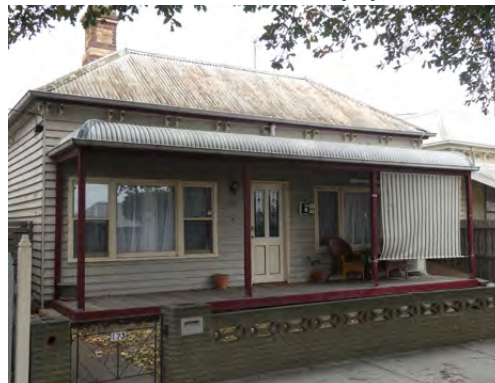
173 Swanston Street (D)

Description: a single storey detached dwelling in a Victorian architectural style, setback 2-5m from the street. Wall construction of weatherboard with a hipped roof form.

Integrity: the primary building has been subject to minor alterations that either do not diminish its significant character or can be easily reversed – larger front windows and front block boundary wall c1950s.

include: complementary setback of the primary building from the street, scale/height, its roof form and presence of verandah/porch, its architectural style, its wall & roof cladding, chimney stacks, window and door materials, aspects of its exterior joinery including eave brackets and panelling, street tree.

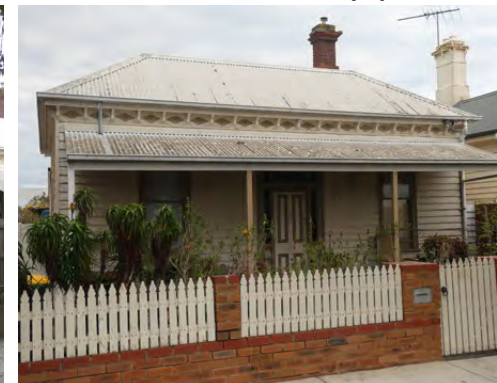
175 Swanston Street (D)

Description: a single storey detached dwelling in a Victorian architectural style, setback 2-5m from the street. Wall construction of weatherboard with a hipped roof form.

Integrity: the primary building has been subject to minor alterations that either do not diminish its significant character or can be easily reversed – verandah simplification to skillion and front brick and timber wall c1950s.

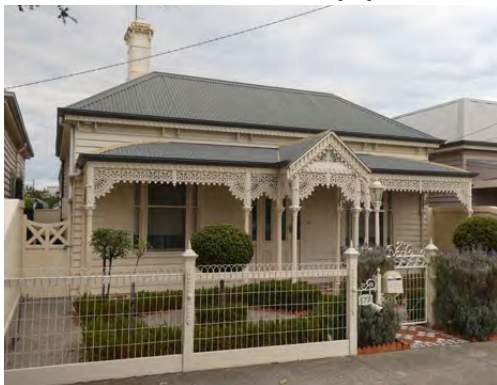
177 Swanston Street (D)

Description: a single storey detached dwelling in a Victorian architectural style, setback 2-5m from the street. Wall construction of weatherboard with a hipped roof form.

Integrity: the primary building is substantially unchanged from its early or significant character/form, with a large yet discrete addition to the rear.

include: complementary setback of the primary building from the street, scale/height, its roof form and presence of verandah/porch, its architectural style, its wall & roof cladding, chimney stacks, window and door layout & materials, aspects of its exterior detailing including iron verandah posts, lacework & fascia detail, eave brackets and panelling, rigid wire front fence.

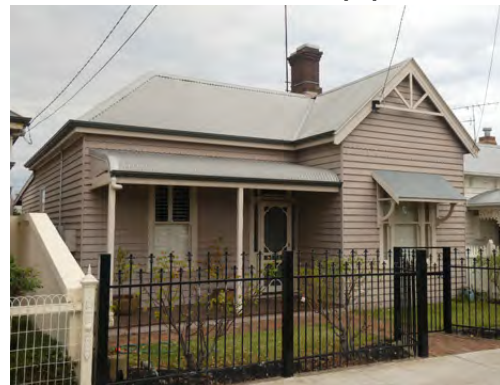
179 Swanston Street (D)

Description: a single storey detached dwelling in a Victorian architectural style, setback 2-5m from the street. Wall construction of weatherboard with a hip and gable roof form.

Integrity: the primary building is substantially unchanged from its early or significant character/form, with a discrete addition to the rear and latter but complementary front fence.

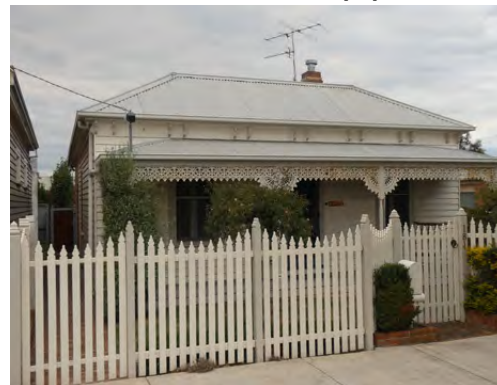
181 Swanston Street (D)

Description: a single storey detached dwelling in a Victorian architectural style, setback 2-5m from the street. Wall construction of weatherboard with a hipped roof form.

Integrity: the primary building is substantially unchanged from its early or significant character/form, with a discrete addition to the rear.

Assessed heritage value: overall the primary building and landscaping make a major contribution to the significant character of the area.

include: complementary setback of the primary building from the street, scale/height, its roof form and presence of verandah/porch, its architectural style, its wall & roof cladding, chimney stacks, window and door layout & materials, aspects of its exterior detailing including lacework, eave brackets, picket front fence.

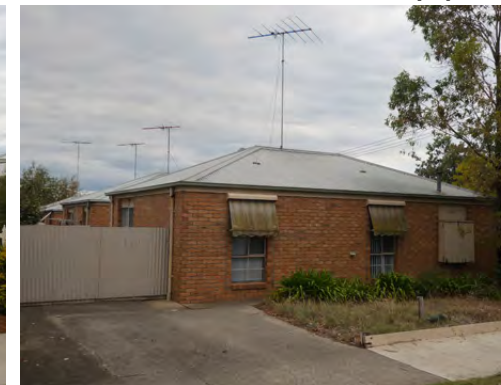
185 & 1/185 Swanston St (N)

Description: a single storey detached dwelling in a Postwar architectural style, setback 2-5m from the street. Wall construction of face brick with a hipped roof form.

Integrity: this block was subdivided into four and redeveloped c1980s, when a previous early residence was likely demolished.

Assessed heritage value: overall the primary building and landscaping make no substantive contribution to the significant character of the area, beyond maintaining a complementary scale, form and setback.

include: complementary setback of the primary building from the street, scale/height, its roof form, vertical format windows.

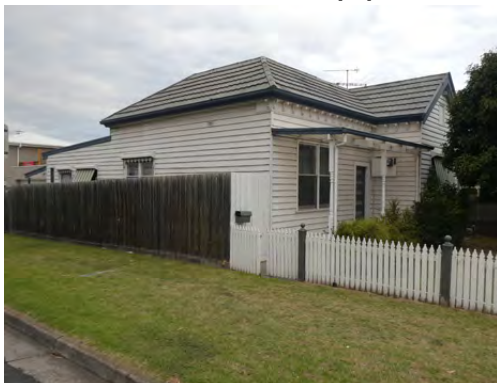
Description: a single storey detached dwelling in a late Victorian architectural style, setback 2-5m from the street. Wall construction of weatherboard with a hip and gable roof form of iron tile (?).

Integrity: the primary building has been subject to minor alterations that either do not diminish its significant character or can be easily reversed – verandah roof replaced, awnings added, chimneys removed.

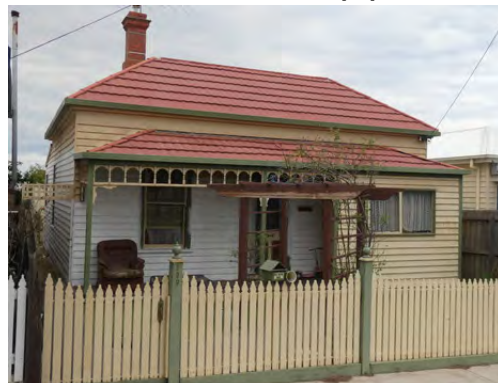
189 Swanston Street (D)

Description: a single storey detached dwelling in a late Victorian architectural style, setback 2-5m from the street. Wall construction of weatherboard with a hip and gable roof form of iron tile (?).

Integrity: the primary building has been subject to minor alterations that either do not diminish its significant character or can be easily reversed – verandah partly enclosed.

Assessed heritage value: overall the primary building and landscaping make a moderate contribution to the significant character of the area.

Significant character attributes include: complementary setback of the primary building from the street, scale/height, its roof form and presence of verandah/porch, its architectural style, its wall & roof cladding, chimney stacks, window and door layout & materials, aspects of its exterior detailing including verandah fretwork (possibly repro?), picket front fence.

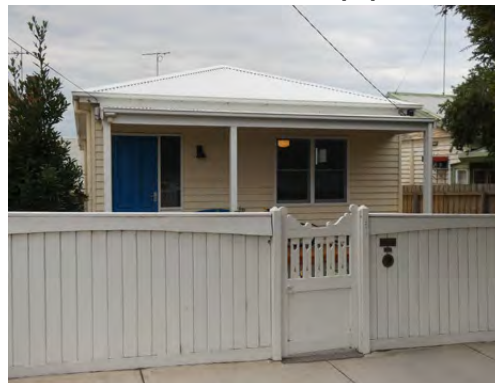
191 Swanston Street (N)

Description: a single storey detached dwelling in a Postwar architectural style drawing upon historical clues, setback 2-5m from the street. Wall construction of weatherboard with a shallow-pitched hipped roof form.

Integrity: streetview shows this house as a bare stud frame in 2018, when a previous early residence was either demolished or rebuilt to a new appearance.

Significant character attributes include: complementary setback of the primary building from the street, scale/height, its roof form, low timber front fence, street tree.

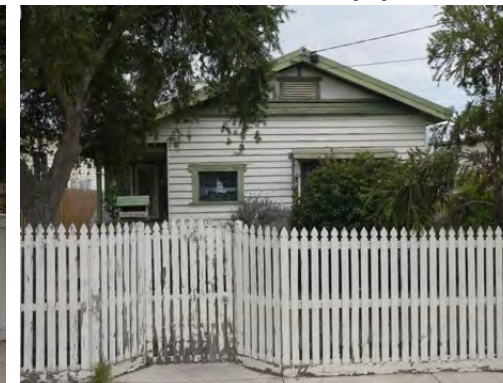
193 Swanston Street (D)

Description: a single storey detached dwelling in an Interwar architectural style, setback 5-10m from the street. Wall construction of weatherboard with a gable roof form.

Integrity: the primary building is substantially unchanged from its early or significant character/form, with a latter but complementary front fence.

Assessed heritage value: overall the primary building and landscaping make a major contribution to the significant character of the area.

Significant character attributes include: complementary setback of the primary building from the street, scale/height, its roof form with double-gabled façade and presence of verandah/porch, its architectural style, its wall & roof cladding, window and door layout & materials, stained glass, aspects of its exterior joinery including panelling & louvre vent on the gables, window hood, picket front fence, garden trees.

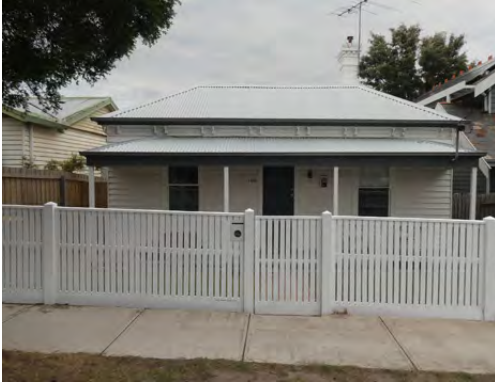
195 Swanston Street (D)

Description: a single storey detached dwelling in a Federation architectural style, setback 2-5m from the street. Wall construction of weatherboard with a hipped roof form.

Integrity: the primary building is substantially unchanged from its early or significant character/form, with a latter but complementary front fence.

include: complementary setback of the primary building from the street, scale/height, its roof form and presence of verandah/porch, its architectural style, its wall & roof cladding, chimney stacks, window and door layout & materials, aspects of its exterior detailing including eave brackets, picket front fence, street tree.

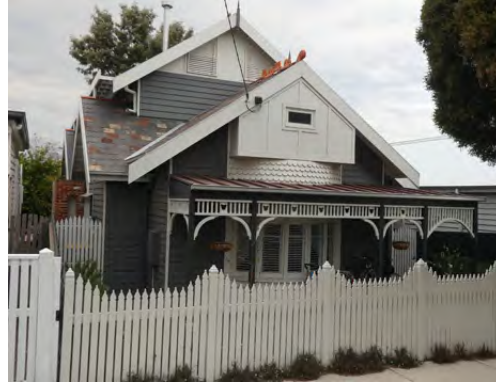
197 Swanston Street

Description: a two storey detached dwelling in a postwar architectural style with Federation cues, setback 2-5m from the street. Wall construction of weatherboard with a gabled roof form.

Integrity: the primary building has been subject to a major rebuild in 2015 that transformed it from a simple one-storey hipped roof with verandah structure.

include: complementary setback of the primary building from the street, scale/height, its roof form and presence of verandah/porch, its wall cladding, window and door materials, aspects of its exterior detailing including verandah fretwork, picket front fence.

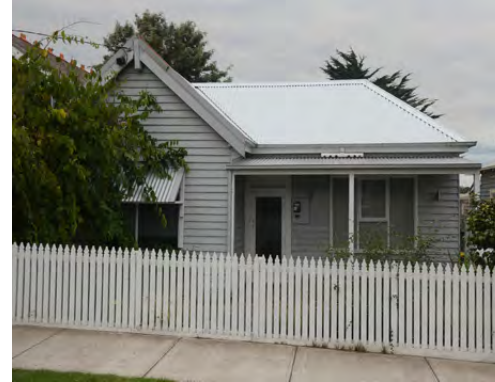
199 Swanston Street (D)

Description: a single storey detached dwelling in a Federation architectural style, setback 2-5m from the street. Wall construction of weatherboard with a hip and gable roof form.

Integrity: the primary building is substantially unchanged from its early or significant character/form, with a latter but complementary front fence.

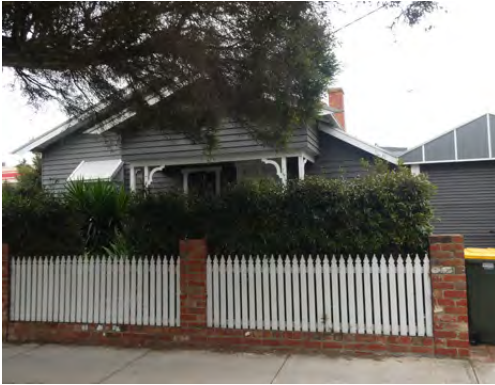
190 Swanston Street (D)

Description: a single storey detached dwelling in an Interwar architectural style, setback 2-5m from the street. Wall construction of weatherboard with a gable roof form.

Integrity: the primary building is substantially unchanged from its early or significant character/form, with a side garage addition and a possibly-latter but complementary front fence.

include: complementary setback of the primary building from the street, scale/height, its roof form with double-gabled façade and presence of verandah/porch, its architectural style, its wall & roof cladding, window and door layout & materials, aspects of its exterior joinery including paired verandah posts & brackets, window hood, gable brackets/projection, exposed rafters, picket front fence, street tree.

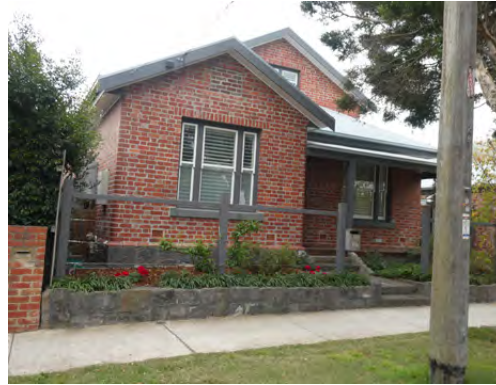
188 Swanston Street (N)

Description: a two storey detached dwelling in a Postwar architectural style drawing upon some Federation visual cues, setback 2-5m from the street. Wall construction of face brick masonry with a hip and gable roof form.

Integrity: the original residence has been demolished and replaced by new development that partly complement the character attributes of the area.

include: complementary setback of the primary building from the street, presence of verandah/porch, roof form, vertical format windows. low & transparent front fence, street tree.

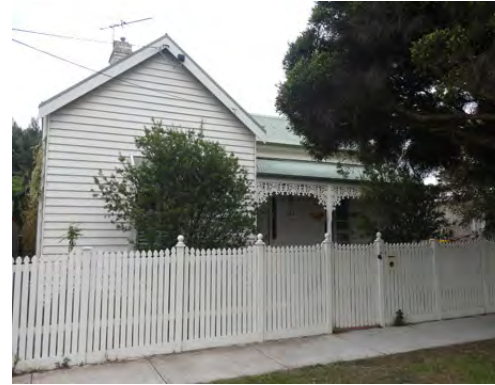
184 Swanston Street (D)

Description: a single storey detached dwelling in a Victorian architectural style, setback 2-5m from the street. Wall construction of weatherboard with a hip and gable roof form.

Integrity: the primary building is substantially unchanged from its early or significant character/form, with a latter but complementary front fence.

include: complementary setback of the primary building from the street, scale/height, its roof form and presence of verandah/porch, its architectural style, its wall & roof cladding, chimney stack, window and door layout & materials, aspects of its exterior detailing including iron lacework, window hood, picket front fence, garden tree.

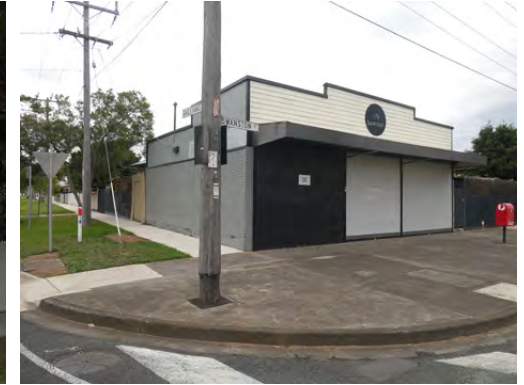
178 Swanston Street (N)

Description: a single storey corner shop with attached residence, likely it was originally in a Federation architectural style, situated with 0m setback. Wall construction is mix of painted brick & weatherboard, originally a hipped roof form of face brick, now a parapet roof form to shop.

Integrity: the primary building has been subject to major alterations that have effected its significant character – a small shop at the corner has been doubled in size to the north, and wrapped in a brick and parapeted form of a modern shopfront in the late C20th.

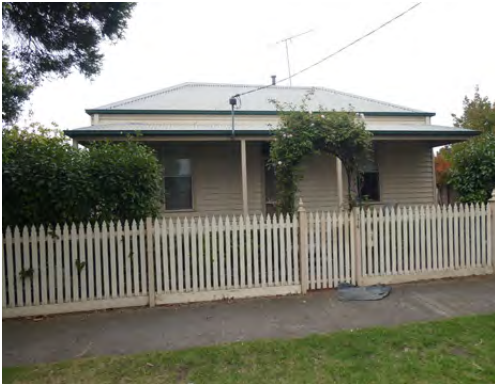
174 Swanston Street (D)

Description: a single storey detached dwelling in a Victorian architectural style, setback 2-5m from the street. Wall construction of weatherboard with a hipped roof form.

Integrity: the primary building is substantially unchanged from its early or significant character/form, with loss of chimney stacks, possible simplification of the verandah and latter but complementary front fence.

Significant character attributes include: complementary setback of the primary building from the street, scale/height, its roof form and presence of verandah/porch, its architectural style, its wall & roof cladding, window and door layout & materials, picket front fence, street tree.

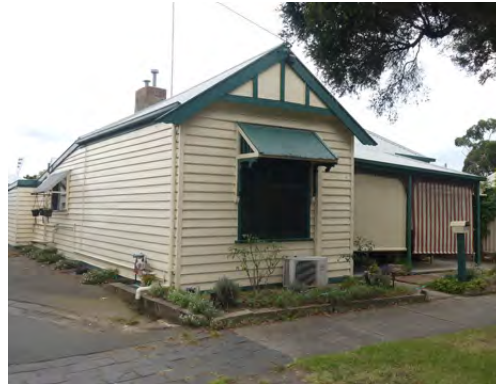
170 Swanston Street (D)

Description: a single storey detached dwelling in a Victorian architectural style, setback 2-5m from the street. Wall construction of weatherboard with a hipped roof form.

Integrity: the primary building is substantially unchanged from its early or significant character/form, side carport addition, possible change to verandah roof and removal of front fence.

Significant character attributes include: complementary setback of the primary building from the street, scale/height, its roof form and presence of verandah/porch, its architectural style, its wall & roof cladding, window and door layout & materials, aspects of its exterior detailing including panelled gable, window hood, street tree.

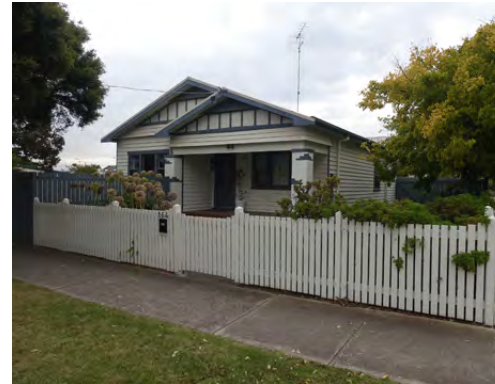
164 Swanston Street (D)

Description: a single storey detached dwelling in an Interwar architectural style, setback 2-5m from the street. Wall construction of weatherboard with a gable roof form.

Integrity: the primary building is substantially unchanged from its early or significant character/form, with a latter but complementary front fence.
