THE CITY OF
GREATER GEELONG

SOUTH GEELONG URBAN DESIGN FRAMEWORK

PROPOSED REVISION TO HO1641
CITY SOUTH HERITAGE AREA

FEBRUARY 2022

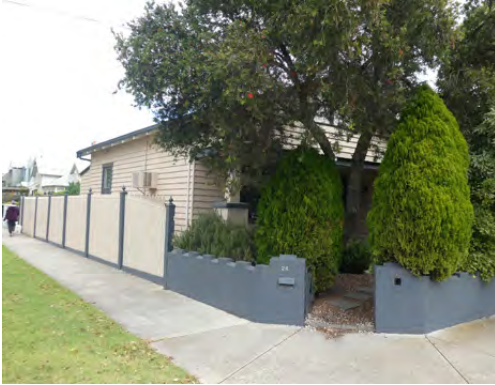
24 Foster Street (D)

Description: a single storey detached dwelling in an Interwar architectural style, setback 2-5m from the street. Wall construction of weatherboard with a gable roof form. This is one of a cluster of 4x Interwar Houses in an older area

Integrity: the primary building is substantially unchanged from its early or significant character/form, with a latter low brick front fence.

Significant character attributes include: complementary setback of the primary building from the street, scale/height, its roof form with double-gabled façade and presence of verandah/porch, its architectural style, its wall & roof cladding, window and door layout & materials, aspects of its exterior joinery including stucco(?) panelling on the gables, window hood on main gable, exposed rafters at eaves, brick/timber verandah posts, low front fence, garden & street trees.

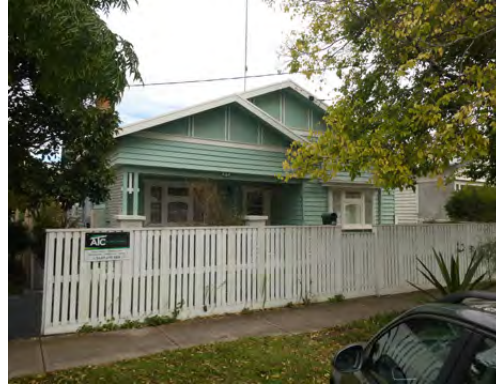
22 Foster Street (D)

Description: a single storey detached dwelling in an Interwar architectural style, setback 2-5m from the street. Wall construction of weatherboard with a gable roof form. This is one of a cluster of 4x Interwar Houses in an older area

Integrity: the primary building is substantially unchanged from its early or significant character/form, and a latter but complementary front fence.

Significant character attributes include: complementary setback of the primary building from the street, scale/height, its roof form with double-gabled façade and presence of verandah/porch, its architectural style, its wall & roof cladding, window and door layout & materials, chimney stack, aspects of its exterior joinery including stucco panelling on the gables, window hood on main gable, exposed rafters at eaves, brick/timber verandah posts, low/translucent front fence, street tree.

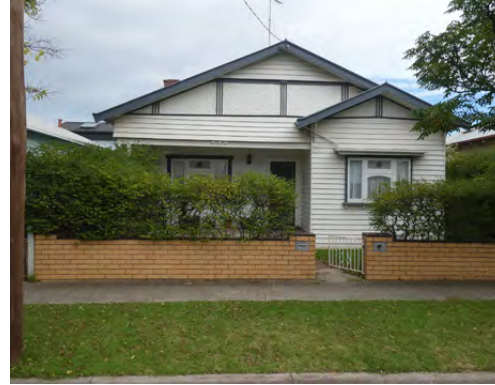
20 Foster Street (D)

Description: a single storey detached dwelling in an Interwar architectural style, setback 2-5m from the street. Wall construction of weatherboard with a gable roof form. This is one of a cluster of 4x Interwar Houses in an older area

Integrity: the primary building is substantially unchanged from its early or significant character/form, postwar low brick front fence.

Significant character attributes include: complementary setback of the primary building from the street, scale/height, its roof form with double-gabled façade and presence of verandah/porch, its architectural style, its wall & roof cladding, window and door layout & materials, chimney stack, aspects of its exterior joinery including stucco panelling on the gables, window hood on main gable, exposed rafters at eaves, brick/timber verandah posts, low front fence height.

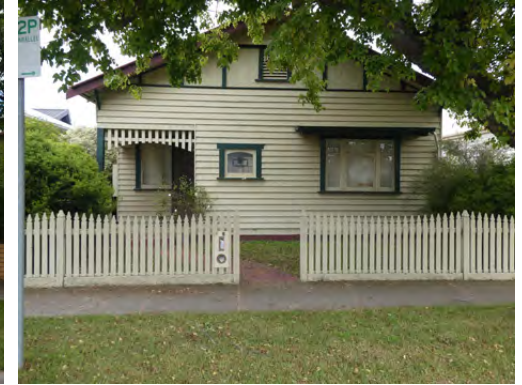
18 Foster Street (D)

Description: a single storey detached dwelling in an Interwar architectural style, setback 2-5m from the street. Wall construction of weatherboard with a gable roof form. This is one of a cluster of 4x Interwar Houses.

Integrity: the primary building is substantially unchanged from its early or significant character/form, latter but complementary front fence.

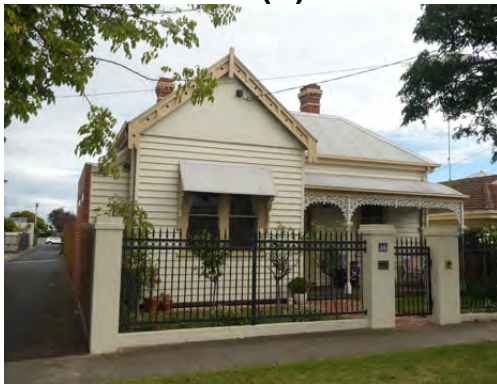
16 Foster Street (D)

Description: a single storey detached dwelling in a Victorian architectural style, setback 2-5m from the street. Wall construction of rendered masonry with a hip and gable roof form.

Integrity: the primary building is substantially unchanged from its early or significant character/form, with a discrete addition at rear, possible alteration of the stuccoed gable and latter but complementary front fence.

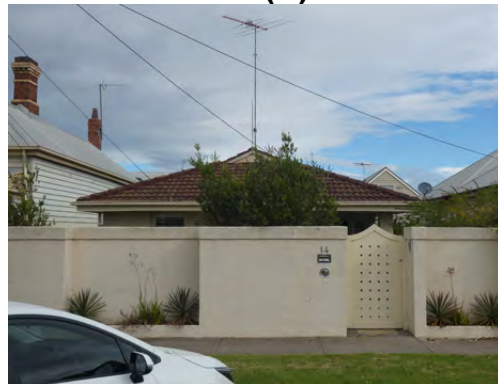
Description: a single storey detached dwelling in a Postwar architectural style, setback 2-5m from the street. Wall construction of rendered masonry with a hipped roof form.

Integrity: the original residence has been demolished and replaced by new development that broadly complements the character attributes of the area except for the high brick wall across the front boundary.

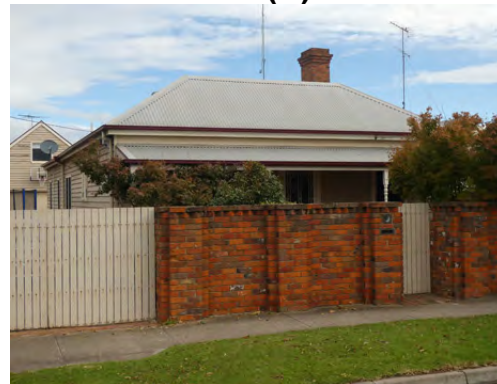
12 Foster Street (D)

Description: a single storey detached dwelling in a Victorian architectural style, setback 2-5m from the street. Wall construction of rendered masonry with a hip and gable roof form.

Integrity: the primary building is substantially unchanged from its early or significant character/form, with a large yet discrete addition at rear, and relatively unsympathetic high brick wall across the front boundary.

Assessed heritage value: overall the primary building and landscaping make a modest contribution to the significant character of the area, the front brick wall being the key limitation – detracting from the streetscape.

include: complementary setback of the primary building from the street, scale/height, its roof form and presence of verandah/porch, its architectural style, its wall & roof cladding, window and door layout & materials, chimney stacks, aspects of its exterior detailing including the verandah posts.

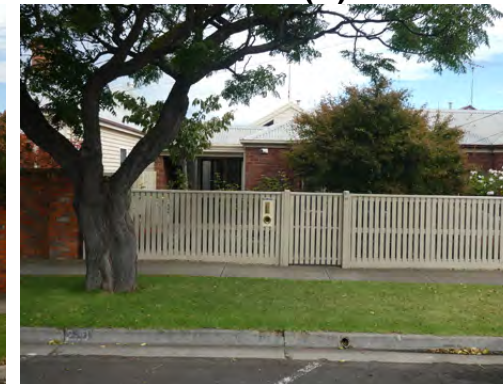
2/10 Foster Street (N)

Description: a single storey conjoined dwelling in a Postwar architectural style drawing upon some-Victorian visual cues, setback 2-5m from the street. Wall construction of face brick masonry with a hipped roof form.

Integrity: the original residence has been demolished and replaced by new development that broadly complements the character attributes of the area.

Assessed heritage value: overall the primary building and landscaping make no substantive contribution to the significant character of the area, beyond maintaining a complementary scale, form and setback.

include: complementary setback of the primary building from the street, scale/height, its roof form and presence of verandah/porch, low & partially transparent front fence, street tree.

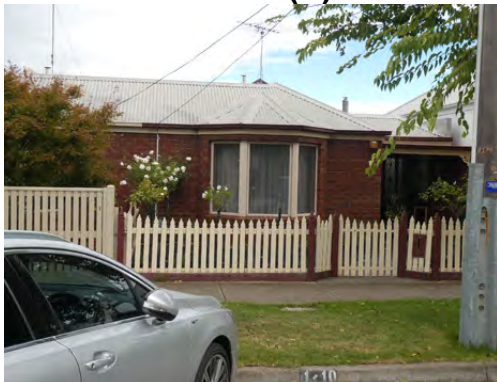
1/10 Foster Street (N)

Description: a single storey conjoined dwelling in a Postwar architectural style drawing upon some-Victorian visual cues, setback 2-5m from the street. Wall construction of face brick masonry with a hipped roof form.

Integrity: the original residence has been demolished and replaced by new development that broadly complements the character attributes of the area.

Assessed heritage value: overall the primary building and landscaping make no substantive contribution to the significant character of the area, beyond maintaining a complementary scale, form and setback.

include: complementary setback of the primary building from the street, scale/height, its roof form and presence of verandah/porch, low & partially transparent front fence, street tree.

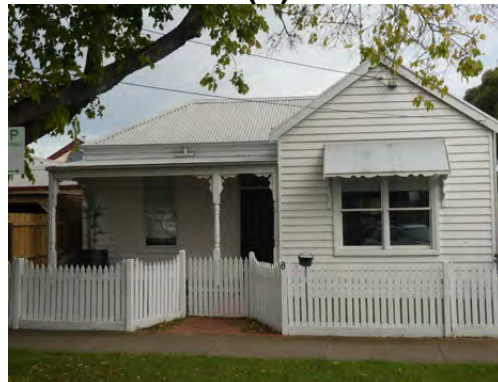
8 Foster Street (D)

Description: a single storey detached dwelling in a Federation architectural style, setback 2-5m from the street. Wall construction of weatherboard with a hip and gable roof form.

Integrity: the primary building is substantially unchanged from its early or significant character/form, with a large/unseen rear addition and latter but complementary front fence.

Assessed heritage value: overall the primary building and landscaping make a major contribution to the significant character of the area.

include: complementary setback of the primary building from the street, scale/height, its roof form and presence of verandah/porch, its architectural style, its wall & roof cladding, chimney stack, window and door layout & materials, aspects of its exterior joinery including fretwork & post along the verandah, window hood on main gable with sculpted fascia and brackets, front fence, garden tree, street tree.

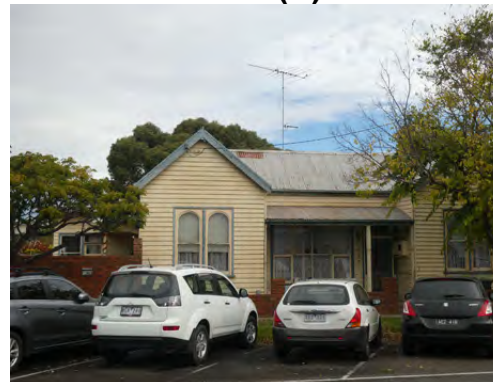
4-6 Foster Street (D)

Description: a single storey detached dwelling in a (predominantly) Victorian architectural style, nil setback from the street. Wall construction of weatherboard with a hip and gable roof form.

Integrity: the primary building is substantially unchanged from its early or significant character/form, with a discrete rear addition.

Assessed heritage value: overall the primary building and landscaping make a major contribution to the significant character of the area.

include: complementary setback of the primary building from the street, scale/height, its roof form and presence of porch with convex/barrel roof, its architectural style, its wall & roof cladding, chimney stack, window and door layout & materials, aspects of its exterior joinery including arched-sash windows and turned verandah post, street trees.

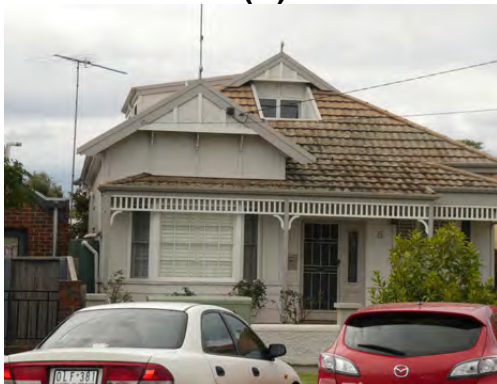
5 Foster Street (D)

Description: a single storey detached dwelling in a late Federation architectural style c1920, setback 2-5m from the street. Wall construction of fibre cement sheet weatherboard with a hip and gable roof form. This is one of a mirrored pair with minor detail differences.

Integrity: the primary building has been subject to minor alterations that either do not diminish its character or can be easily reversed, with a relatively discrete two storey addition aside from an attic balcony.

include: complementary setback of the primary building from the street, scale/height, its roof form with double-gabled façade and presence of verandah/porch, its architectural style, its wall & roof cladding, window and door layout & materials, aspects of its exterior joinery including stucco panelling on the gables, fretwork along the verandah, low brick front fence.

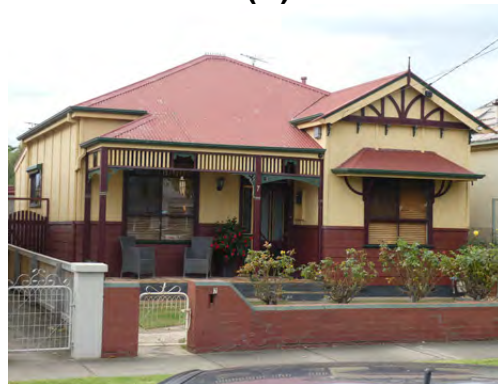
7 Foster Street (D)

Description: a single storey detached dwelling in a late Federation architectural style c1920, setback 2-5m from the street. Wall construction of fibre cement sheet weatherboard with a hip and gable roof form. This is one of a mirrored pair with minor detail differences.

Integrity: the primary building is substantially unchanged from its early or significant character/form, with a latter low brick front fence.

include: complementary setback of the primary building from the street, scale/height, its roof form with double-gabled façade and presence of verandah/porch, its architectural style, its wall & roof cladding, window and door layout & materials, window hood, aspects of its exterior joinery including fretwork on the gables, window hood and along the verandah, low brick front fence.

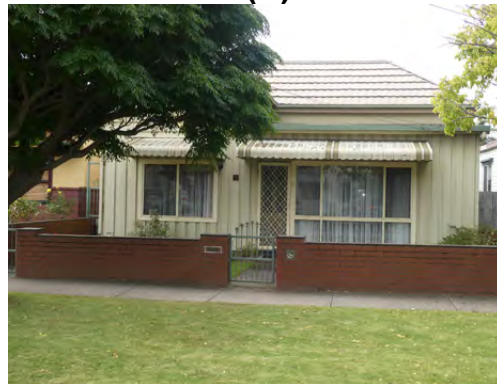
9 Foster Street (N)

Description: a single storey detached dwelling in a Federation (?) architectural style with postwar alterations, setback 2-5m from the street. Wall construction of vertical timber & weatherboards on façade, stucco or rendered masonry(?) elsewhere, with a hip and gable roof form.

Integrity: the primary building has been subject to major alterations that have effected its significant character but could be reversed, with front verandah being enclosed, façade reclad in vertical board. aluminium windows & awnings fitted, low brick wall added along front boundary.

include: complementary setback of the primary building from the street, scale/height, its roof form.

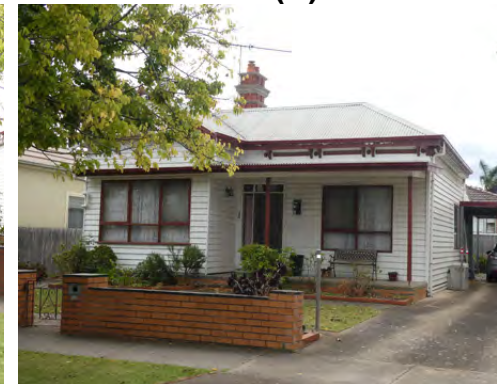
11 Foster Street (D)

Description: a single storey detached dwelling in a Federation (?) architectural style with postwar alterations, setback 2-5m from the street. Wall construction of vertical timber & weatherboards, with a hip and gable roof form.

Integrity: the primary building has been subject to minor alterations that either do not diminish its character or can be easily reversed, changes to the porch construction and enlarged front windows, low brick wall added along front boundary.

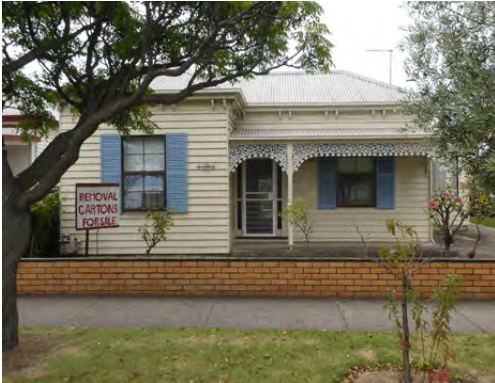
13 Foster Street (D)

Description: a single storey detached dwelling in a Victorian architectural style, setback 2-5m from the street. Wall construction of weatherboard with a hipped roof form.

Integrity: the primary building is substantially unchanged from its early or significant character/form, with a discrete addition to side and rear, newer concrete porch and latter low brick front fence.

Significant character attributes include: complementary setback of the primary building from the street, scale/height, its roof form and presence of verandah/porch, its architectural style, its wall & roof cladding, window and door layout & materials, aspects of its exterior detailing including the iron lacework on the verandah/porch, timber eaves brackets and panelling, low front fence, street tree.

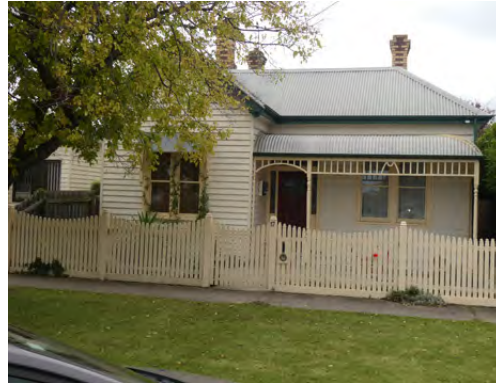
17 Foster Street (D)

Description: a single storey detached dwelling in a Victorian architectural style, setback 2-5m from the street. Wall construction of weatherboard with a hip and gable roof form.

Integrity: the primary building is substantially unchanged from its early or significant character/form, with a discrete addition to the rear.

Significant character attributes include: complementary setback of the primary building from the street, scale/height, its roof form and presence of verandah/porch, its architectural style, its wall & roof cladding, chimney stacks, window and door layout & materials, aspects of its exterior detailing including the timber fretwork on the verandah/porch, sculpted barge boards, front fence, street tree.

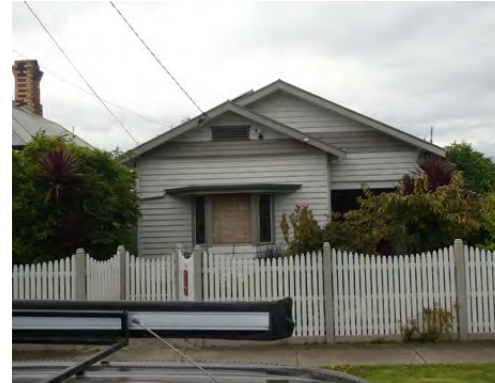
19 Foster Street (D)

Description: a single storey detached dwelling in an Interwar architectural style, setback 2-5m from the street. Wall construction of weatherboard with a gable roof form.

Integrity: the primary building is substantially unchanged from its early or significant character/form, with a discrete addition to the rear and a latter but complementary front fence.

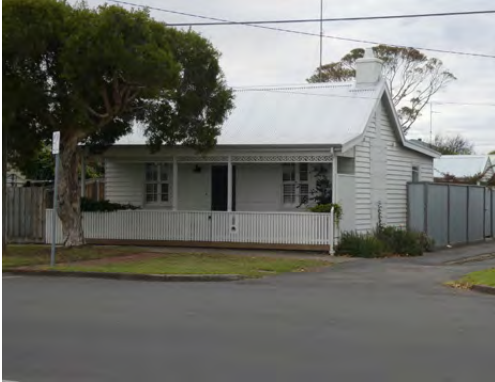
23 Foster Street (D)

Description: a single storey detached dwelling in a Victorian architectural style, nil setback from the street. Wall construction of weatherboard with a gable roof form.

Integrity: the primary building is substantially unchanged from its early or significant character/form, with a discrete addition to the rear, and latter but complementary front fence.

Significant character attributes include: complementary setback of the primary building from the street, scale/height, its roof form and presence of verandah/porch, its architectural style, its wall & roof cladding, window and door layout & materials, chimney stack, aspects of its exterior detailing including the iron lacework on the verandah/porch, front fence, street tree.

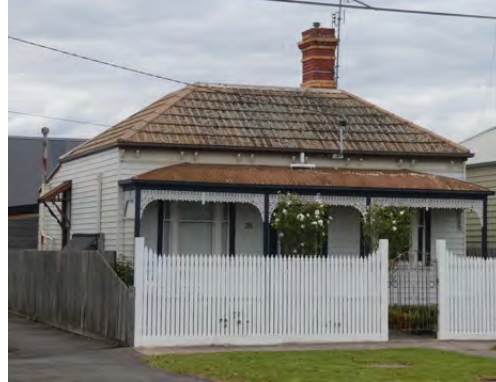
25 Foster Street (D)

Description: a single storey detached dwelling in a Victorian architectural style, setback 2-5m from the street. Wall construction of weatherboard with a hipped roof form.

Integrity: the primary building is substantially unchanged from its early or significant character/form, with a discrete addition to the rear, and latter but complementary front fence.

Significant character attributes include: complementary setback of the primary building from the street, scale/height, its roof form and presence of verandah/porch, its architectural style, its wall & roof cladding, window and door layout & materials, chimney stack, aspects of its exterior detailing including the iron lacework on the verandah/porch, timber eaves brackets, front fence.

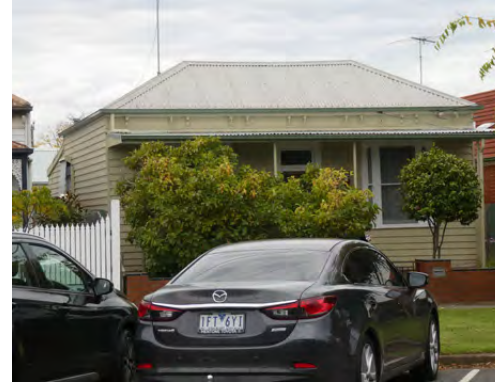
27 Foster Street (D)

Description: a single storey detached dwelling in a Victorian architectural style, setback 2-5m from the street. Wall construction of weatherboard with a hipped roof form.

Integrity: the primary building has been subject to minor alterations that either do not diminish its significant character or can be easily reversed., with a discrete addition to the rear, and post war reconstruction of the verandah to a simpler, flatter design, and postwar low brick wall along front boundary.

Significant character attributes include: complementary setback of the primary building from the street, scale/height, its roof form and presence of verandah/porch, its architectural style, its wall & roof cladding, window and door layout & materials, aspects of its exterior detailing including timber eaves brackets, low front boundary wall/fence.

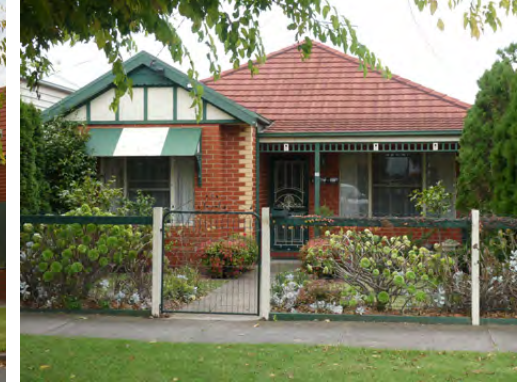
29 Foster Street (N)

Description: a single storey detached dwelling as a reproduction of a Federation architectural style, setback 2-5m from the street. Wall construction of face brick masonry with a hip and gable roof form.

Integrity: the original residence appears to have been demolished and replaced by new development that complements the character attributes of the area.

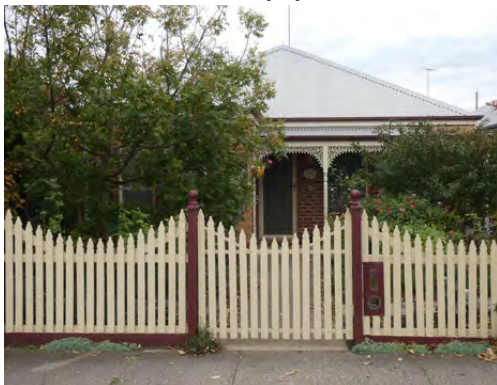
31 Foster Street (D)

Description: a single storey detached dwelling as a reproduction of a Federation architectural style, setback 2-5m from the street. Wall construction of face brick masonry with a hipped roof form.

Integrity: the original residence appears to have been demolished and replaced by new development that complements the character attributes of the area.

Significant character attributes include: complementary setback of the primary building from the street, scale/height, its roof form and presence of verandah/porch, its architectural style, its wall & roof cladding, window and door layout & materials, aspects of its exterior joinery including reproduction fretwork along the verandah, window hood on main gable with gable panelling, front fence, garden trees.

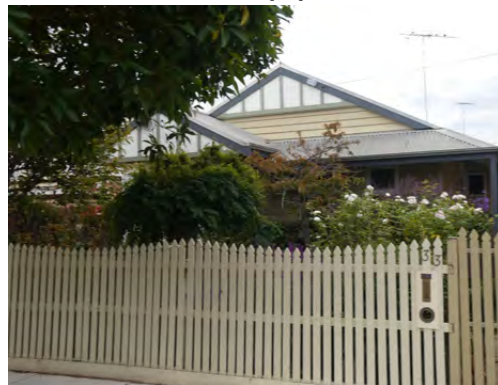
33 Foster Street (D)

Description: a single storey detached dwelling in a (reproduction?) Federation architectural style, setback 2-5m from the street. Wall construction of weatherboard masonry with a hip and gable roof form.

Integrity: uncertain due to screening; appears the original residence appears to have been demolished and replaced by new development that complements the character attributes of the area.

Significant character attributes include: complementary setback of the primary building from the street, scale/height, its roof form and presence of verandah/porch, its architectural style, its wall & roof cladding, window and door layout & materials, aspects of its exterior joinery including gable panelling, front fence, garden trees, street tree.

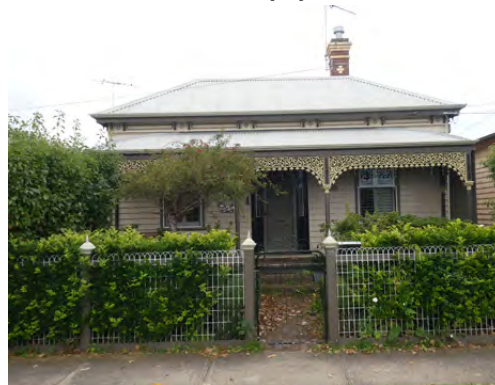
35 Foster Street (D)

Description: a single storey detached dwelling in a Victorian architectural style, setback 2-5m from the street. Wall construction of weatherboard with a hipped roof form.

Integrity: the primary building is substantially unchanged from its early or significant character/form, with a discrete two-storey addition at rear and latter but complementary front fence.

Significant character attributes include: complementary setback of the primary building from the street, scale/height, its roof form and presence of verandah/porch, its architectural style, its wall & roof cladding, window and door layout & materials, chimney stacks, aspects of its exterior detailing including the iron lacework on the verandah/porch, timber eaves brackets and panelling, front fence.

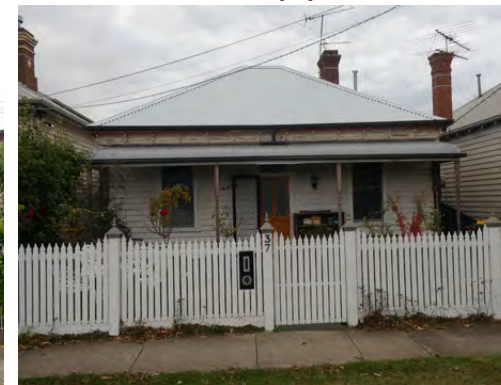
37 Foster Street (D)

Description: a single storey detached dwelling in a Victorian architectural style, setback 2-5m from the street. Wall construction of weatherboard with a hipped roof form.

Integrity: the primary building is substantially unchanged from its early or significant character/form, with a discrete addition at rear, possible changes to the verandah including removal of lace or fretwork.

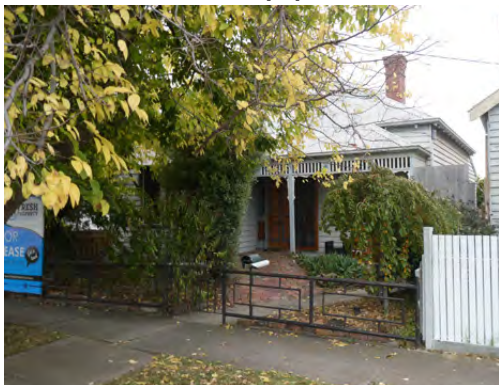
39 Foster Street (D)

Description: a single storey detached dwelling in a Federation architectural style, setback 2-5m from the street. Wall construction of weatherboard with a hip and gable roof form.

Integrity: the primary building is substantially unchanged from its early or significant character/form, with a large/unseen rear addition and latter but complementary front fence.

Assessed heritage value: overall the primary building and landscaping make a major contribution to the significant character of the area.

include: complementary setback of the primary building from the street, scale/height, its roof form and presence of verandah/porch, its architectural style, its wall & roof cladding, chimney stack, window and door layout & materials, aspects of its exterior joinery including fretwork & post along the verandah, window hood, exposed rafters, front fence, garden tree, street tree.

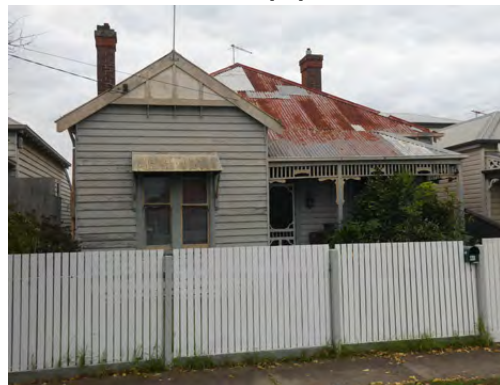
41 Foster Street (D)

Description: a single storey detached dwelling in a Federation architectural style, setback 2-5m from the street. Wall construction of weatherboard with a hip and gable roof form.

Integrity: the primary building is substantially unchanged from its early or significant character/form, with a discrete rear addition and latter but complementary front fence.

Assessed heritage value: overall the primary building and landscaping make a major contribution to the significant character of the area.

include: complementary setback of the primary building from the street, scale/height, its roof form and presence of verandah/porch, its architectural style, its wall & roof cladding, chimney stack, window and door layout & materials, aspects of its exterior joinery including fretwork & post along the verandah, window hood, gable panelling, exposed rafters, front fence.

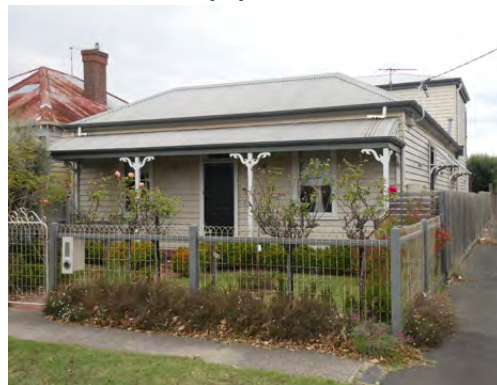
43 Foster St (D)

Description: a single storey detached dwelling in a Federation architectural style, setback 2-5m from the street. Wall construction of weatherboard with a hipped roof form.

Integrity: the primary building is substantially unchanged from its early or significant character/form, with a discrete two storey addition to the rear and latter but complementary front fence.

Assessed heritage value: overall the primary building and landscaping make a major contribution to the significant character of the area.

include: complementary setback of the primary building from the street, scale/height, its roof form and presence of verandah/porch, its architectural style, its wall & roof cladding, window and door layout & materials, aspects of its exterior joinery including fretwork along the verandah, window hoods and brackets, front fence.

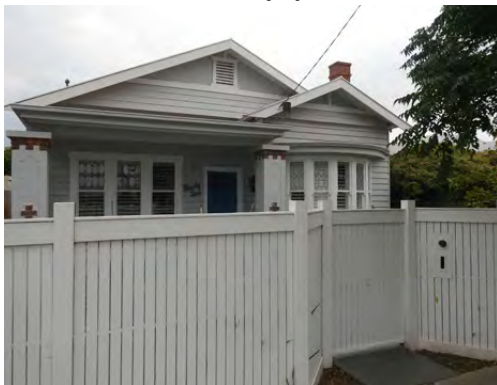
92 Foster Street (D)

Description: a single storey detached dwelling in an Interwar architectural style, setback 2-5m from the street. Wall construction of weatherboard with a gable roof form.

Integrity: the primary building is substantially unchanged from its early or significant character/form, aside from a modern solid timber front fence.

Assessed heritage value: overall the primary building and landscaping make a major contribution to the significant character of the area.

include: complementary setback of the primary building from the street, scale/height, its roof form with double-gabled façade and presence of verandah/porch, its architectural style, its wall & roof cladding, window and door layout & materials, leadlighting, hooded bay window, aspects of its exterior joinery including panelling on the and louvre vent on the gables, moulded masonry verandah columns, street tree.

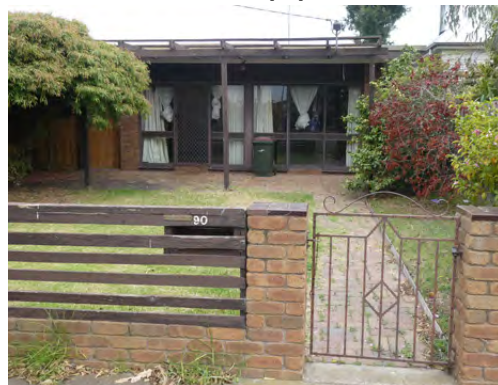
90 Foster Street (N)

Description: a single storey detached dwelling in a Postwar architectural style, setback 5-10m from the street. Wall construction of face brick with a skillion/flat roof form.

Integrity: this block was redeveloped c1980s, when a previous early residence was likely demolished.

include: complementary setback of the primary building from the street, scale/height, low semi-transparent front fence, garden tree, street tree.

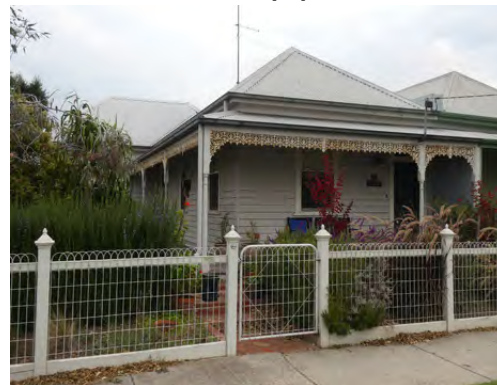
88 Foster Street (D)

Description: a single storey semi-detached dwelling in a Victorian architectural style, setback 2-5m from the street. Wall construction of weatherboard with a hipped roof form.

Integrity: the primary building is substantially unchanged from its early or significant character/form, with a very large yet discrete addition at rear and a rigid wire front fence.

include: complementary setback of the primary building from the street, scale/height, its roof form and presence of verandah/porch, its architectural style, its wall & roof cladding, window and door layout & materials, aspects of its exterior detailing including the iron posts & lacework on the verandah, low transparent front fence.

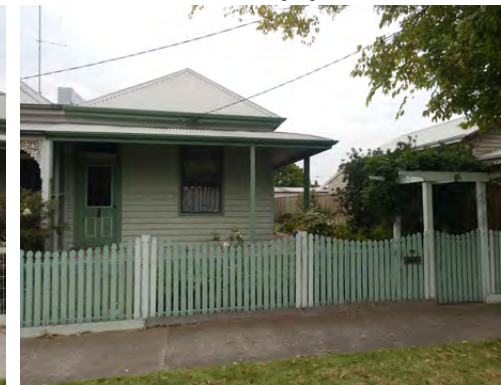
86 Foster Street (D)

Description: a single storey semi-detached dwelling in a Victorian architectural style, setback 2-5m from the street. Wall construction of weatherboard with a hipped roof form.

Integrity: the primary building is substantially unchanged from its early or significant character/form, with a discrete addition at rear and the verandah being rebuilt in a simpler form without iron posts or lacework.

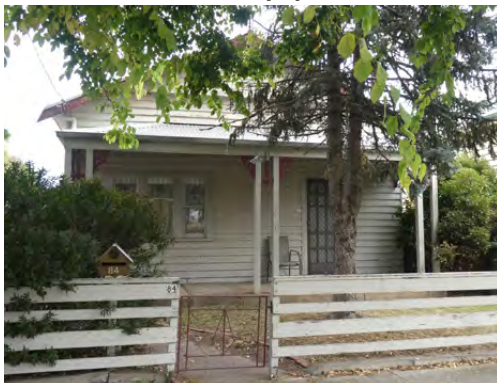
84 Foster Street (D)

Description: a single storey detached dwelling in Interwar architectural style with art nouveau cues, setback 2-5m from the street. Wall construction of weatherboard with a gable roof form.

Integrity: the primary building is substantially unchanged from its early or significant character/form; aside from a mid-late C20th timber rail fence.

include: complementary setback of the primary building from the street, scale/height, its roof form and presence of verandah/porch, its architectural style, its wall & roof cladding, window and door layout & materials, leadlighting, aspects of its exterior joinery including paired verandah posts and brackets, street tree.

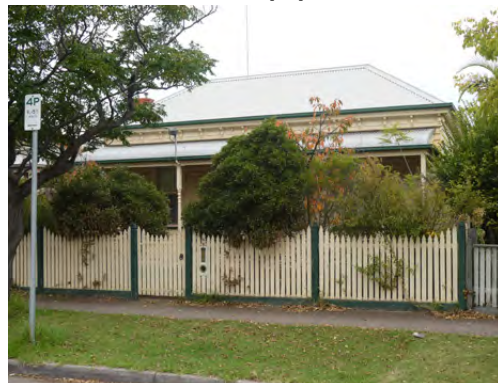
82 Foster Street (D)

Description: a single storey detached dwelling in a Victorian architectural style, setback 2-5m from the street. Wall construction of weatherboard with a hipped roof form.

Integrity: the primary building is substantially unchanged from its early or significant character/form, aside from the verandah appearing to have been simplified with any decorative lacework or fretwork removed.

include: complementary setback of the primary building from the street, scale/height, its roof form and presence of verandah/porch, its architectural style, its wall & roof cladding, window and door layout & materials, aspects of its exterior detailing including the eaves brackets and panelling, picket front fence, street tree.

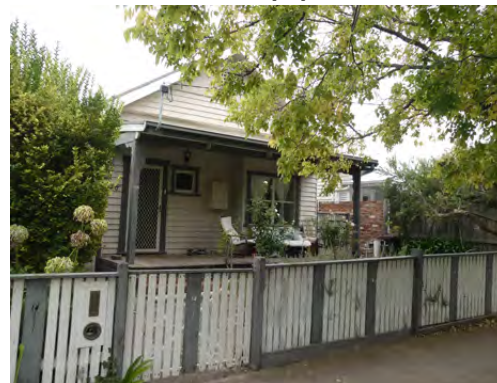
80 Foster Street (D)

Description: a single storey detached dwelling in an Interwar architectural style, setback 2-5m from the street. Wall construction of weatherboard with a gable roof form. Possibly the same original design as nearby 76 Foster.

Integrity: the primary building is substantially unchanged from its early or significant character/form, aside from latter/complementary front fence.

include: complementary setback of the primary building from the street, scale/height, its roof form and presence of verandah/porch, its architectural style, its wall & roof cladding, window and door layout & materials, leadlighting, squared bay window, aspects of its exterior joinery including post brackets, low semi-transparent front fence, street tree.

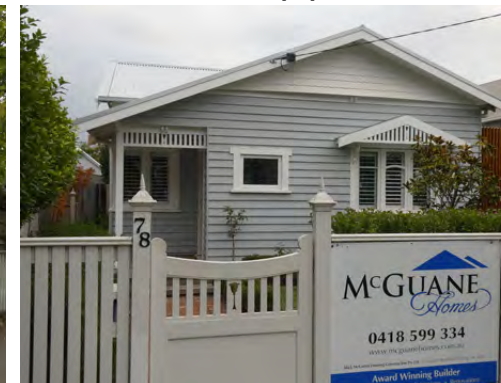
78 Foster Street (D)

Description: a single storey detached dwelling in an Interwar architectural style, setback 2-5m from the street. Wall construction of weatherboard with a gable roof form.

Integrity: the primary building is substantially unchanged from its early or significant character/form; with a discrete rear addition, a gabled window hood replacing the flat original, fretwork added to the porch and a latter/complementary front fence (c2018).

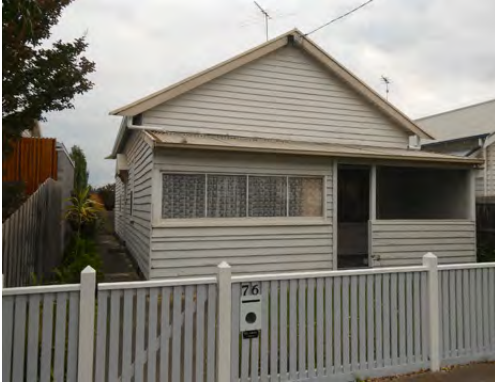
76 Foster Street (D)

Description: a single storey detached dwelling in an Interwar architectural style, setback 2-5m from the street. Wall construction of weatherboard with a gable roof form. Possibly the same original design as nearby 80 Foster.

Integrity: the primary building has been subject to moderate alterations that have effected its significant character but could be easily reversed – the front verandah has been partially enclosed, the front window back on the original façade has been enlarged.

Significant character attributes include: complementary setback of the primary building from the street, scale/height, its roof form and presence of verandah/porch, its wall & roof cladding, side window hood, low semi-transparent front fence.

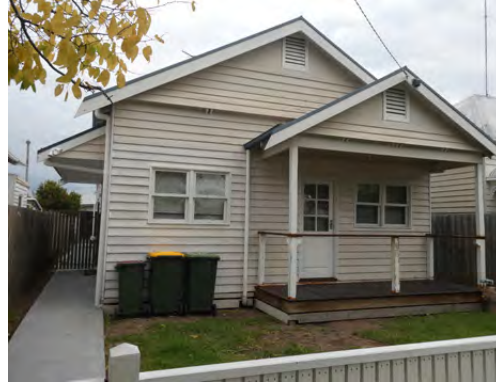
74 Foster Street (D)

Description: a single storey detached dwelling in an Interwar architectural style, setback 2-5m from the street. Wall construction of weatherboard with a gable roof form.

Integrity: the primary building is substantially unchanged from its early or significant character/form, with a discrete rear addition and cantilevered side awning roof, and a modern solid timber front fence.

Significant character attributes include: complementary setback of the primary building from the street, scale/height, its roof form with double-gabled façade and presence of verandah/porch, its architectural style, its wall & roof cladding, window and door layout & materials, aspects of its exterior joinery including panelling and louvre vents on the gables, low semi-transparent front fence.

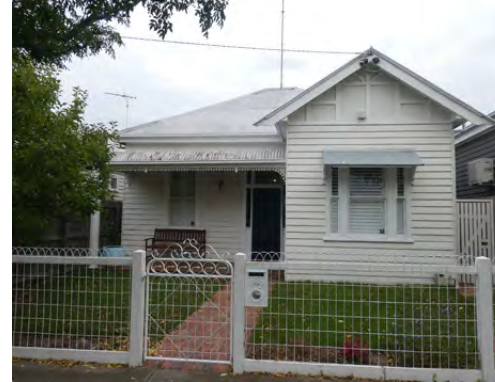
72A Foster Street (D)

Description: a single storey detached dwelling in a Victorian architectural style, setback 2-5m from the street. Wall construction of weatherboard with a hip and gable roof form.

Integrity: the primary building is substantially unchanged from its early or significant character/form, with a large/unseen rear addition and latter but complementary rigid wire front fence.

Significant character attributes include: complementary setback of the primary building from the street, scale/height, its roof form and presence of verandah/porch, its architectural style, its wall & roof cladding, window and door layout & materials, aspects of its exterior joinery including stucco gable panels and iron lacework along the verandah, window hood, , front fence, low transparent front fence, street tree.

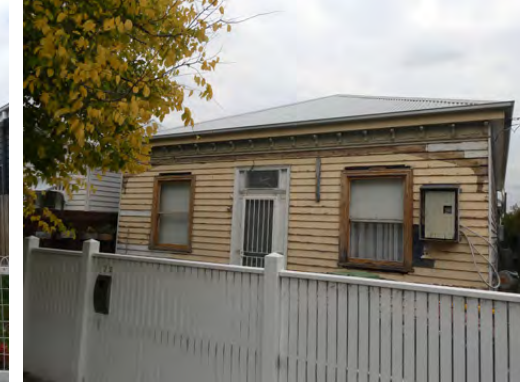
72 Foster Street (D)

Description: a single storey detached dwelling in a Victorian architectural style, setback 2-5m from the street. Wall construction of weatherboard with a hipped roof form.

Integrity: the primary building has been subject to minor alterations that either do not diminish its significant character or can be easily reversed – removal of the front verandah; it also has a discrete two-storey addition at rear and latter but complementary front fence.

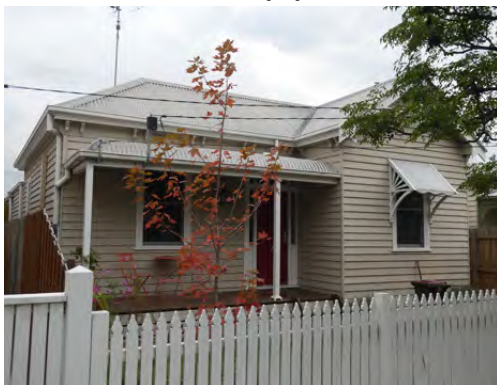
70 Foster Street (D)

Description: a single storey detached dwelling in a Federation architectural style with Art Nouveau cues, setback 2-5m from the street. Wall construction of weatherboard with a hip and gable roof form.

Integrity: the primary building is substantially unchanged from its early or significant character/form, with a discrete addition at rear and likely simplification of the front verandah with lacework/fretwork/brackets removed.

Significant character attributes include: complementary setback of the primary building from the street, scale/height, its roof form and presence of verandah/porch, its architectural style, its wall & roof cladding, window and door layout & materials, aspects of its exterior detailing including the window hood & brackets, eaves brackets and panelling, gable finial, picket front fence.

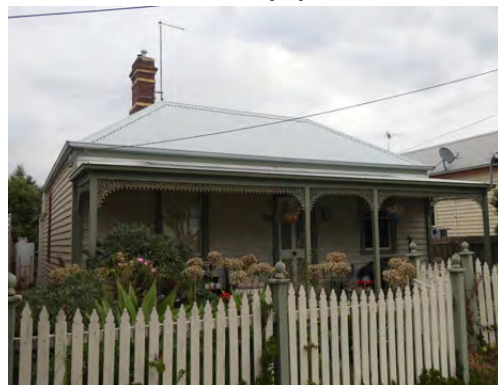
68 Foster Street (D)

Description: a single storey detached dwelling in a Victorian architectural style, setback 2-5m from the street. Wall construction of weatherboard with a hipped roof form.

Integrity: the primary building is substantially unchanged from its early or significant character/form, with a discrete addition at rear.

Significant character attributes include: complementary setback of the primary building from the street, scale/height, its roof form and presence of verandah/porch, its architectural style, its wall & roof cladding, window and door layout & materials, chimney stack, aspects of its exterior detailing including the iron lacework on the verandah, picket front fence.

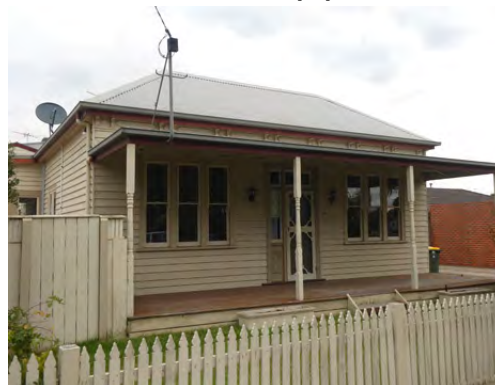
1/66 Foster Street (D)

Description: a single storey detached dwelling in a Victorian architectural style, setback 2-5m from the street. Wall construction of weatherboard with a hipped roof form.

Integrity: the primary building is substantially unchanged from its early or significant character/form, with likely simplification of the front verandah with lacework/fretwork/brackets removed; the property has been subdivided and two reasonably discrete two storey dwellings added at the rear (Lot 2 & 3 of no heritage interest).

Significant character attributes include: complementary setback of the primary building from the street, scale/height, its roof form and presence of verandah/porch, its architectural style, its wall & roof cladding, window and door layout & materials, aspects of its exterior detailing including eaves brackets & panelling, picket front fence.

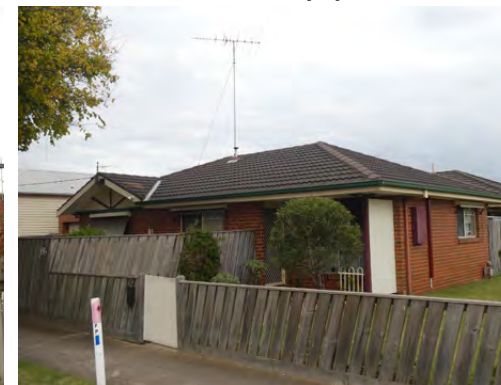
1/64 Foster Street (N)

Description: a single storey detached dwelling in a Postwar architectural style, setback 5-10m from the street. Wall construction of weatherboard with a hip and gable roof form.

Integrity: this block was redeveloped c1980s, when a previous early residence was likely demolished.

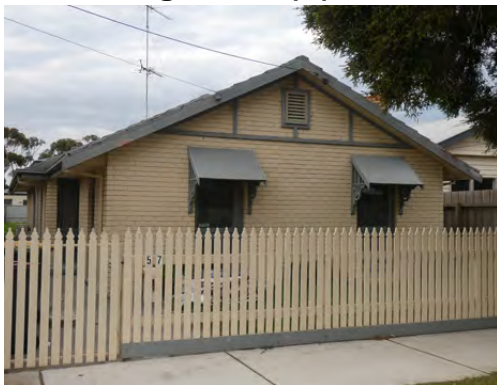
57 Balliang Street (N)

Description: a single storey detached dwelling in a Postwar architectural style with Interwar cues, setback 2-5m from the street. Wall construction of face brick with a gable roof form.

Integrity: this block was redeveloped c1990s, when a previous early residence was likely demolished.

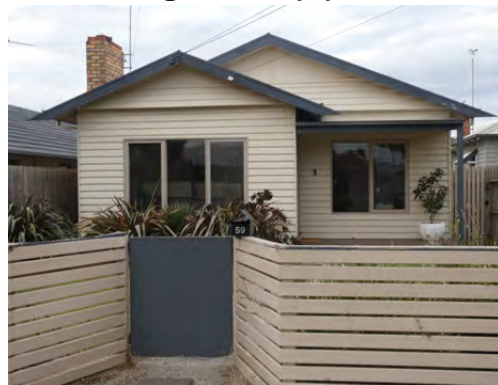
Description: a single storey detached dwelling in an Interwar architectural style, setback 2-5m from the street. Wall construction of weatherboard with a gable roof form.

Integrity: the primary building has been subject to moderate alterations that have effected its significant character but could be easily reversed –the front verandah has been replaced, larger modern-design front windows installed and a horizontal timber rail front fence added.

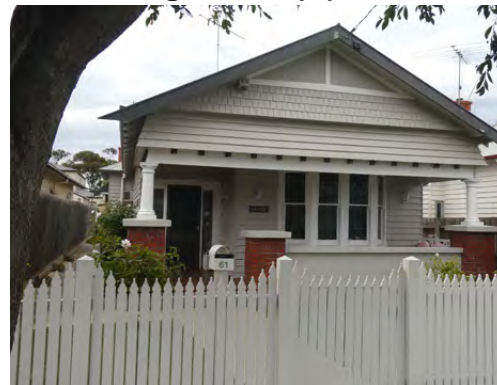
61 Balliang Street (D)

Description: a single storey detached dwelling in an Interwar architectural style, setback 2-5m from the street. Wall construction of weatherboard with a gable roof form.

Integrity: the primary building is substantially unchanged from its early or significant character/form.

Assessed heritage value: overall the primary building and landscaping make a major contribution to the significant character of the area.

include: complementary setback of the primary building from the street, scale/height, its roof form and presence of full width verandah, its architectural style, its wall & roof cladding, window and door layout & materials, bay window, leadlighting, aspects of its exterior joinery including shingle & stucco panelling on the gables, gable flaring with brackets, exposed rafters, masonry & concrete pillar verandah supports, picket front fence.

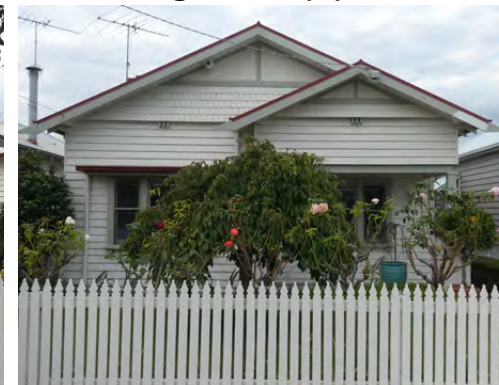
63 Balliang Street (D)

Description: a single storey detached dwelling in an Interwar architectural style, setback 2-5m from the street. Wall construction of weatherboard with a gable roof form.

Integrity: the primary building is substantially unchanged from its early or significant character/form.

Assessed heritage value: overall the primary building and landscaping make a major contribution to the significant character of the area.

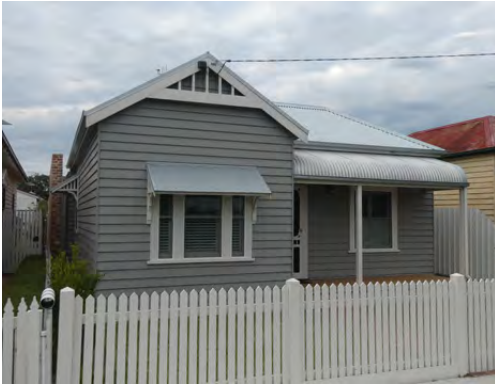
65 Balliang Street (D)

Description: a single storey detached dwelling in a Victorian architectural style, setback 2-5m from the street. Wall construction of weatherboard with a hip and gable roof form.

Integrity: the primary building is substantially unchanged from its early or significant character/form, with likely simplification of the front verandah with lacework/fretwork/brackets removed.

Significant character attributes include: complementary setback of the primary building from the street, scale/height, its roof form and presence of verandah/porch, its architectural style, its wall & roof cladding, window and door layout & materials, chimney stacks, aspects of its exterior detailing including the gable head bracket, window hoods, picket front fence.

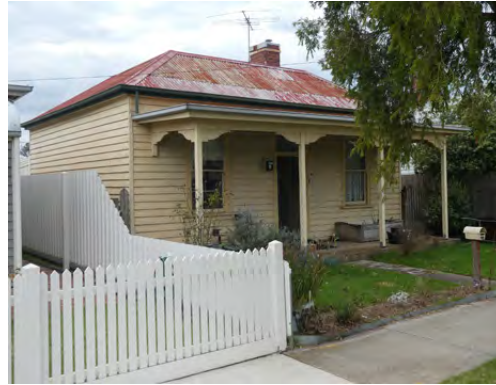
67 Balliang Street (D)

Description: a single storey detached dwelling in a Federation architectural style, setback 5-10m from the street. Wall construction of weatherboard with a hip and gable roof form.

Integrity: the primary building is substantially unchanged from its early or significant character/form, aside from the absence of a front fence.

Significant character attributes include: complementary setback of the primary building from the street, scale/height, its roof form and presence of verandah/porch, its architectural style, wall & roof cladding, chimney stack, window and door layout & materials, aspects of its exterior joinery including fretwork along verandah, street tree.

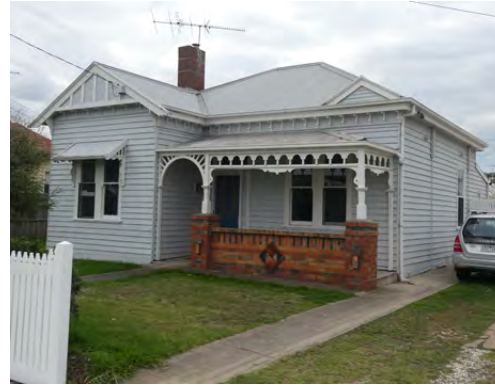
69 Balliang Street (D)

Description: a single storey detached dwelling in a Federation architectural style with Art Nouveau cues, setback 5-10m from the street. Wall construction of weatherboard with a hip and gable roof form.

Integrity: the primary building is substantially unchanged from its early or significant character/form, with a large/unseen rear addition and latter but complementary front fence.

Significant character attributes include: complementary setback of the primary building from the street, scale/height, its roof form and presence of verandah/porch, its architectural style, wall & roof cladding, chimney stacks, window and door layout & materials, aspects of its exterior joinery including fretwork along verandah, articulated red brick verandah wall, eave brackets, window hood, picket front fence, garden trees.

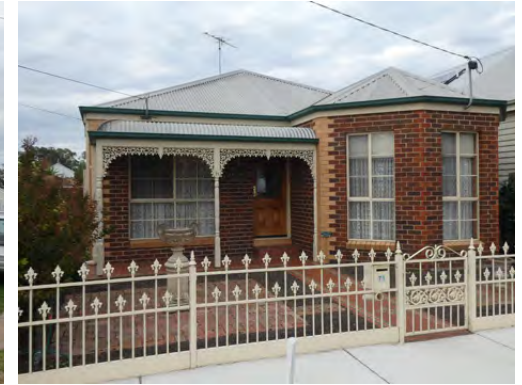
71 Balliang Street (N)

Description: a single storey detached dwelling in a Postwar architectural style with Victorian cues, setback 2-5m from the street. Wall construction of face brick with a gable roof form.

Integrity: this block was redeveloped c1990s, when a previous early residence was likely demolished.

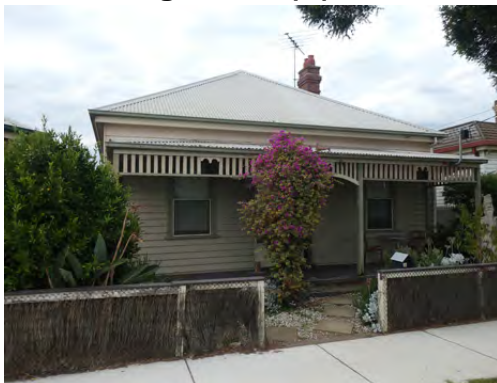
73 Balliang Street (D)

Description: a single storey detached dwelling in a Federation architectural style with Art Nouveau cues, setback 2-5m from the street. Wall construction of weatherboard with a hipped roof form.

Integrity: the primary building is substantially unchanged from its early or significant character/form, with a large/unseen rear addition and latter but complementary front fence.

include: complementary setback of the primary building from the street, scale/height, its roof form and presence of verandah/porch, its architectural style, wall & roof cladding, chimney stacks, window and door layout & materials, aspects of its exterior joinery including fretwork along verandah, articulated red brick verandah wall, eave brackets, window hood, picket front fence, garden trees, street tree.

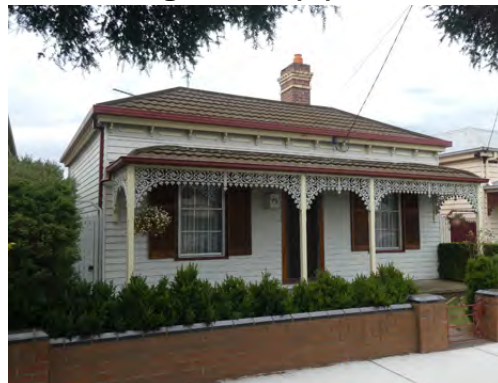
75 Balliang Street (D)

Description: a single storey detached dwelling in a Victorian architectural style, setback 2-5m from the street. Wall construction of weatherboard with a hipped roof form of iron tile (?).

Integrity: the primary building is substantially unchanged from its early or significant character/form, with a discrete addition at rear and low brick wall along the front boundary.

include: complementary setback of the primary building from the street, scale/height, its roof form and presence of verandah/porch, its architectural style, its wall & roof cladding, window and door layout & materials, chimney stack, aspects of its exterior detailing including the iron lacework on the verandah/porch, timber eaves brackets and panelling, street tree.

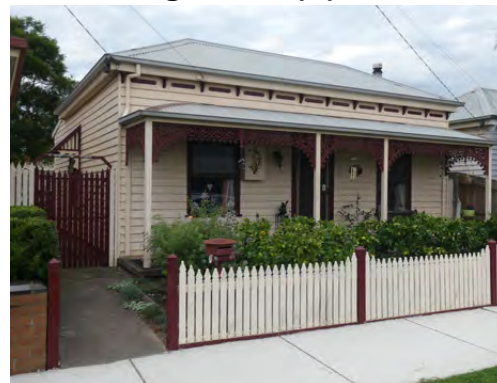
77 Balliang Street (D)

Description: a single storey detached dwelling in a Victorian architectural style, setback 2-5m from the street. Wall construction of weatherboard with a hipped roof form.

Integrity: the primary building is substantially unchanged from its early or significant character/form, with likely simplification of the front verandah with lacework/fretwork/brackets removed.

include: complementary setback of the primary building from the street, scale/height, its roof form and presence of verandah/porch, its architectural style, its wall & roof cladding, window and door layout & materials, aspects of its exterior detailing including the eaves brackets and panelling, side window hood, picket front fence.

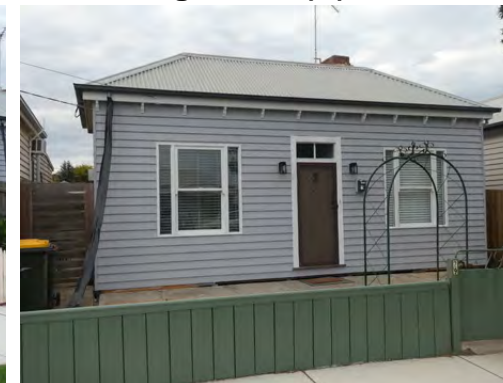
79 Balliang Street (D)

Description: a single storey detached dwelling in a Victorian architectural style, setback 2-5m from the street. Wall construction of weatherboard with a hipped roof form.

Integrity: the primary building is substantially unchanged from its early or significant character/form, with a large yet discrete addition at rear and low metal deck fence along the front boundary.
