THE CITY OF
GREATER GEELONG

SOUTH GEELONG URBAN DESIGN FRAMEWORK

PROPOSED REVISION TO HO1641
CITY SOUTH HERITAGE AREA

FEBRUARY 2022

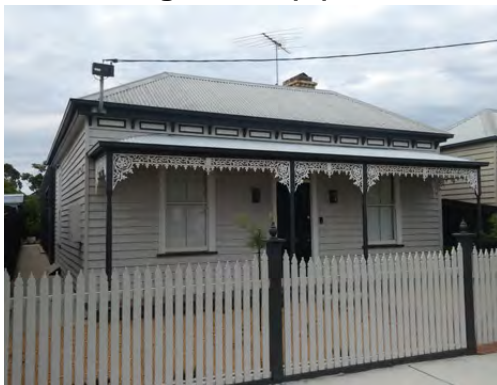
81 Balliang Street (D)

Description: a single storey detached dwelling in a Victorian architectural style, setback 2-5m from the street. Wall construction of weatherboard with a hipped roof form.

Integrity: the primary building is substantially unchanged from its early or significant character/form, with a large yet discrete addition at rear.

Significant character attributes include: complementary setback of the primary building from the street, scale/height, its roof form and presence of verandah/porch, its architectural style, its wall & roof cladding, window and door layout & materials, chimney stack, aspects of its exterior detailing including the turned posts (?) & iron lacework on the verandah, timber eaves brackets and panelling, picket front fence, street tree.

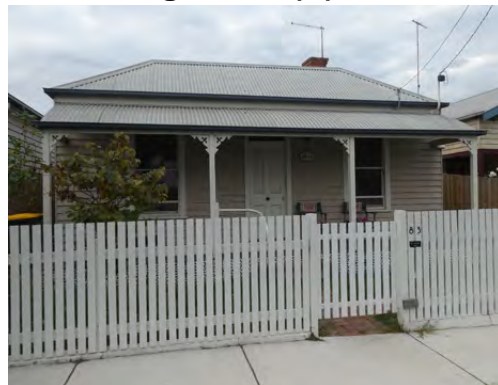
83 Balliang Street (D)

Description: a single storey detached dwelling in a Federation architectural style with Art Nouveau cues, setback 2-5m from the street. Wall construction of weatherboard with a hipped roof form.

Integrity: the primary building is substantially unchanged from its early or significant character/form, with a large/unseen rear addition and latter but complementary front fence.

Significant character attributes include: complementary setback of the primary building from the street, scale/height, its roof form and presence of verandah/porch, its architectural style, wall & roof cladding, chimney stack, window and door layout & materials, aspects of its exterior joinery including verandah brackets, picket front fence.

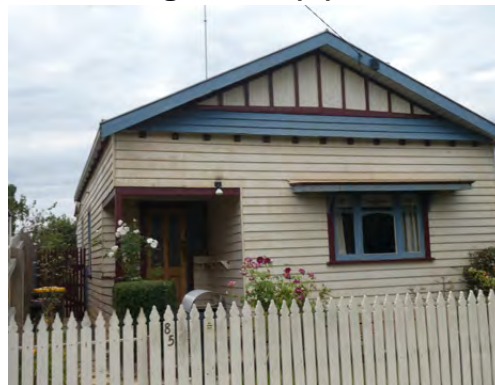
85 Balliang Street (D)

Description: a single storey detached dwelling in an Interwar architectural style, setback 2-5m from the street. Wall construction of weatherboard with a gable roof form.

Integrity: the primary building is substantially unchanged from its early or significant character/form; with a discrete rear addition.

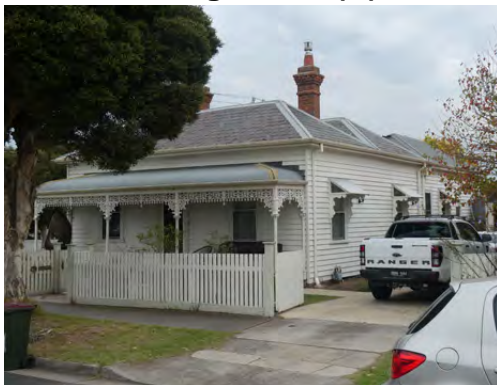
82-84 Balliang Street (D)

Description: a single storey detached dwelling in a Victorian architectural style, setback 0-2m from the street. Wall construction of weatherboard with a hipped roof form.

Integrity: the primary building is substantially unchanged from its early or significant character/form, with a large yet discrete addition at rear and latter but complementary front fence.

Significant character attributes include: complementary setback of the primary building from the street, scale/height, its roof form and presence of verandah/porch, its architectural style, its wall & roof cladding, window and door layout & materials, chimney stacks, aspects of its exterior detailing including the iron posts and lacework along the verandah, side window hoods, low semi-transparent front fence, street tree.

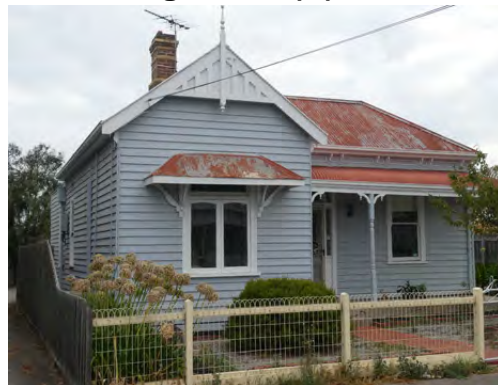
80 Balliang Street (D)

Description: a single storey detached dwelling in a Federation architectural style with Art Nouveau cues, setback 5-10m from the street. Wall construction of weatherboard with a hip and gable roof form.

Integrity: the primary building is substantially unchanged from its early or significant character/form, with a large/unseen rear addition and latter/complementary rigid wire front fence.

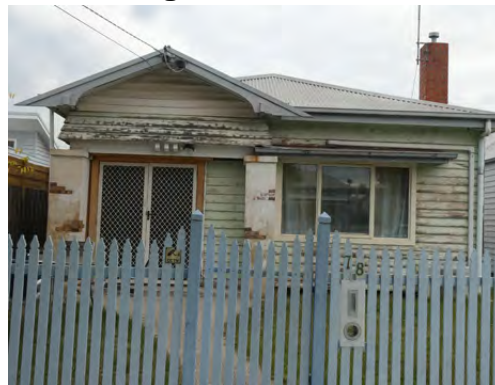
Description: a single storey detached dwelling in an Interwar architectural style, setback 2-5m from the street. Wall construction of weatherboard with a gable roof form.

Integrity: the primary building has been subject to minor alterations that have effected its significant character but could be easily reversed – replacement of front windows and doors with large aluminium-framed items.

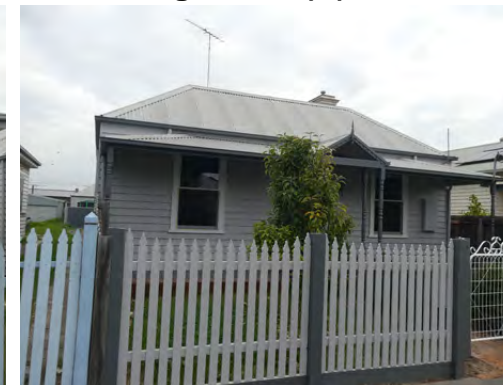
76 Balliang Street (D)

Description: a single storey detached dwelling in a basic architectural style – probably Federation or late Victorian, setback 2-5m from the street. Wall construction of weatherboard with a hipped roof form.

Integrity: the primary building has been subject to minor alterations that either do not diminish its significant character or can be easily reversed – the verandah has been rebuilt, drawing in both Victorian & Federation cues; also having a large/unseen rear addition.

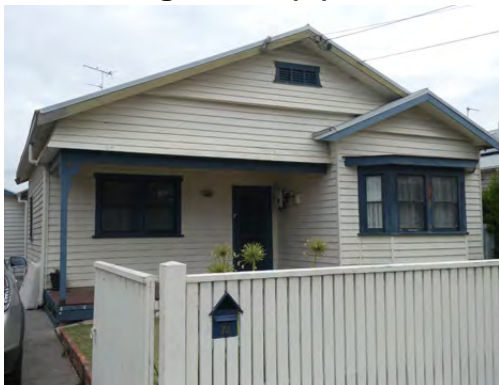
74 Balliang Street (D)

Description: a single storey detached dwelling in an Interwar architectural style, setback 5-10m from the street. Wall construction of weatherboard with a gable roof form.

Integrity: the primary building is substantially unchanged from its early or significant character/form, with a large yet discrete rear addition and modern yet complementary fence.

include: complementary setback of the primary building from the street, scale/height, its roof form with double-gabled façade and presence of verandah/porch, its architectural style, its wall & roof cladding, window and door layout & materials, hooded bay window, aspects of its exterior joinery including gable flaring with louvre vent, exposed rafters, timber verandah post with brackets, picket front fence.

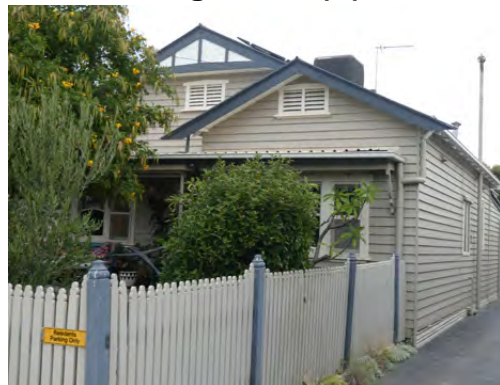
1/72 Balliang Street (D)

Description: a single storey detached dwelling in an Interwar architectural style, setback 5-10m from the street. Wall construction of weatherboard with a gable roof form.

Integrity: the primary building is substantially unchanged from its early or significant character/form, whilst the property has been subdivided and a second discrete dwelling added at the rear (Lot 2 of no heritage interest).

include: complementary setback of the primary building from the street, scale/height, its roof form with double-gabled façade and presence of verandah/porch, its architectural style, its wall & roof cladding, window and door layout & materials, window hood, aspects of its exterior joinery including projecting stucco gable panel and louvre vents, exposed rafters, picket front fence, garden trees, street tree.

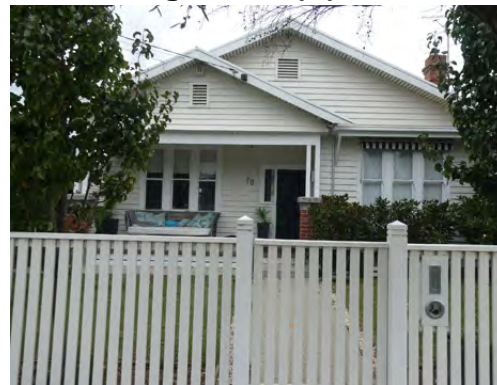
70 Balliang Street (D)

Description: a single storey detached dwelling in an Interwar architectural style, setback 5-10m from the street. Wall construction of weatherboard with a gable roof form.

Integrity: the primary building is substantially unchanged from its early or significant character/form, aside from a modern yet complementary fence.

include: complementary setback of the primary building from the street, scale/height, its roof form with double-gabled façade and presence of verandah/porch, its architectural style, its wall & roof cladding, window and door layout & materials, window hood, aspects of its exterior joinery including flared gables with brackets and louvre vents, pared verandah posts atop masonry piers, picket front fence, garden trees, street tree.

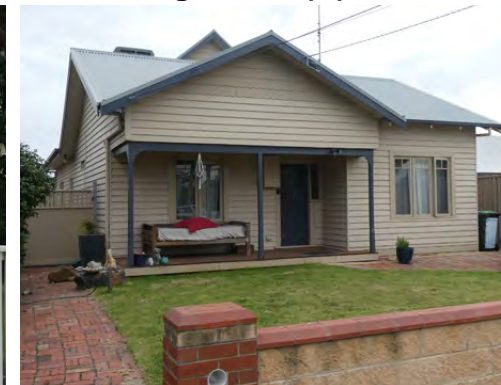
68 Balliang Street (D)

Description: a single storey detached dwelling in an Interwar architectural style, setback 5-10m from the street. Wall construction of weatherboard with a gable roof form.

Integrity: the primary building is substantially unchanged from its early or significant character/form, with a reasonably discrete rear addition and modern low brick/rough face block fence.

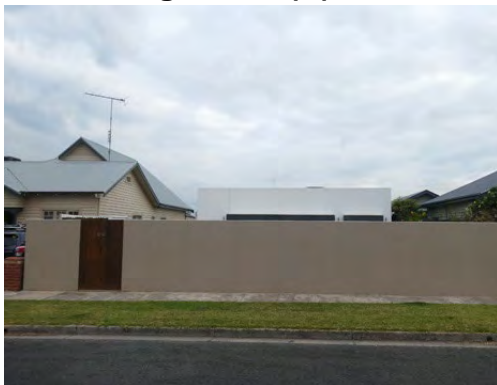
66 Balliang Street (N)

Description: a single storey detached dwelling in a modernist postwar architectural style, setback 10+m from the street. Wall construction of rendered brick with a skillion/flat roof form.

Integrity: this block was redeveloped c2000s, when a previous early residence was likely demolished, and a high masonry wall was erected along the street.

Assessed heritage value: overall the primary building and landscaping make no substantive contribution to the significant character of the area, the high wall adversely impacts the streetscape.

Significant character attributes include: scale/height of the dwelling.

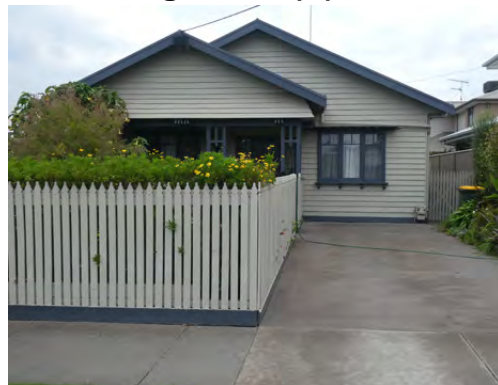
64 Balliang Street (D)

Description: a single storey detached dwelling in an Interwar architectural style, setback 5-10m from the street. Wall construction of weatherboard with a gable roof form.

Integrity: the primary building is substantially unchanged from its early or significant character/form, with a large yet discrete rear addition and an ungated concreted driveway.

Assessed heritage value: overall the primary building and landscaping make a major contribution to the significant character of the area.

Significant character attributes include: complementary setback of the primary building from the street, scale/height, its roof form with double-gabled façade and presence of verandah/porch, its architectural style, its wall & roof cladding, window and door layout & materials, window hood, aspects of its exterior joinery including gable flaring and brackets, paired timber verandah post with brackets, picket front fence.

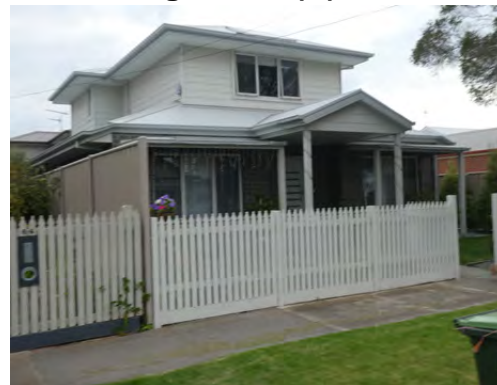
62 Balliang Street (N)

Description: a two storey detached dwelling in a Postwar architectural style, setback 0-2m from the street. Wall construction of weatherboard with a hip and gable roof form.

Integrity: this block was redeveloped c1990s, when a previous early residence was likely demolished.

Assessed heritage value: overall the primary building and landscaping make no substantive contribution to the significant character of the area, beyond maintaining complementary form and setback, the height of the development in close proximity to the front boundary adversely impacts the streetscape.

Significant character attributes include: complementary setback of the primary building from the street, roof forms, picket front fence.

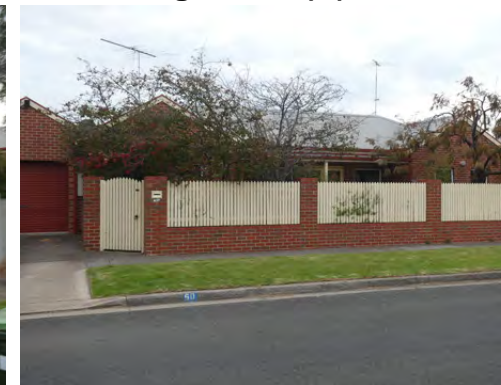
60 Balliang Street (N)

Description: a single storey detached dwelling in a Postwar architectural style with Victorian cues, setback 2-5m from the street. Wall construction of face brick with a gable roof form.

Integrity: this block was redeveloped c1990s, when a previous early residence was likely demolished.

Assessed heritage value: overall the primary building and landscaping make no substantive contribution to the significant character of the area, beyond maintaining a complementary scale, form and setback.

Significant character attributes include: complementary setback of the primary building from the street, scale/height, its roof form, vertical format windows, low semi-transparent front fence.

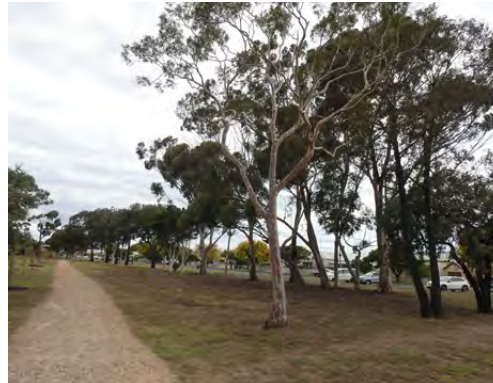
Foster Street Reserve (D)

Description: 5743m² public parkland; level grassed area with native tree spp (primarily melaleuca/paperbarks) around perimeter and a 17 x 10m tanbark playground area with numerous items of equipment.

Integrity: public open space substantially unchanged from the original subdivision,

include: landscaped public open space accommodating passive recreation and child playground activities; George Trickey memorial playground.

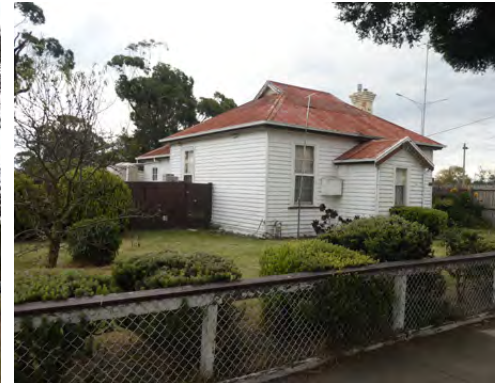
162 Swanston Street – Railway Gatekeepers Cottage (D)

Description: a single storey detached dwelling in a Federation architectural style, setback 5-10m from the street. Wall construction of weatherboard with a hip and gable roof form.

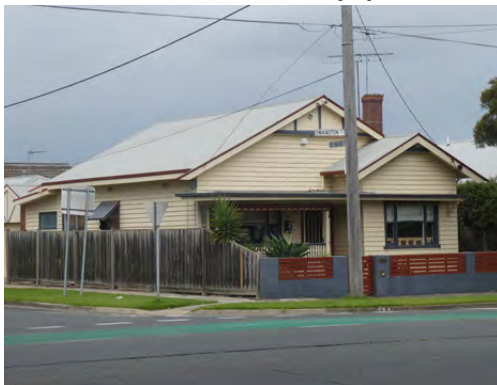
131 Swanston Street (D)

Description: a single storey detached dwelling in an Interwar architectural style, setback 2-5m from the street. Wall construction of weatherboard with a gable roof form. One of a cluster of 3x Interwar Houses.

Integrity: the primary building is substantially unchanged from its early or significant character/form, with a discrete rear addition and latter brick front fence.

include: complementary setback of the primary building from the street, scale/height, its roof form with double-gabled façade and presence of verandah/porch, its architectural style, its wall & roof cladding, window and door layout & materials, chimney stack, aspects of its exterior joinery including panelling on the gables, window hood, timber verandah posts & ballustrade, low front fence, street tree.

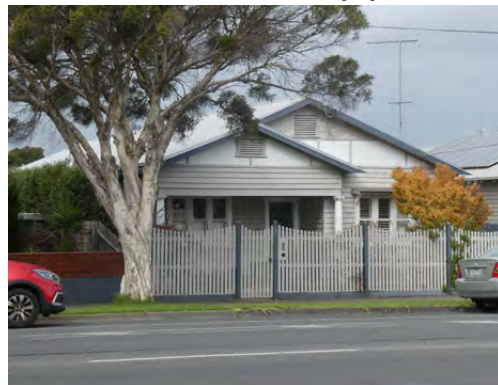
133 Swanston Street (D)

Description: a single storey detached dwelling in an Interwar architectural style, setback 2-5m from the street. Wall construction of weatherboard with a gable roof form. One of a cluster of 3x Interwar Houses, a mirrored pair with 135 Swanston.

Integrity: the primary building is substantially unchanged from its early or significant character/form, with a discrete rear addition.

include: complementary setback of the primary building from the street, scale/height, its roof form with double-gabled façade and presence of verandah/porch, its architectural style, its wall & roof cladding, window and door layout & materials, aspects of its exterior joinery including panelling & louvred vents on the gables, window hood, masonry & timber verandah posts, picket front fence.

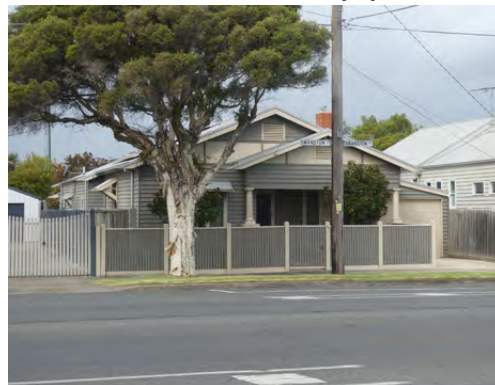
135 Swanston Street (D)

Description: a single storey detached dwelling in an Interwar architectural style, setback 2-5m from the street. Wall construction of weatherboard with a gable roof form. One of a cluster of 3x Interwar Houses, a mirrored pair with 133 Swanston.

Integrity: the primary building is substantially unchanged from its early or significant character/form, with a discrete rear addition.

include: complementary setback of the primary building from the street, scale/height, its roof form with double-gabled façade and presence of verandah/porch, its architectural style, its wall & roof cladding, window and door layout & materials, chimney stack, aspects of its exterior joinery including panelling & louvred vents on the gables, window hood, masonry & timber verandah posts, front fence, street tree.

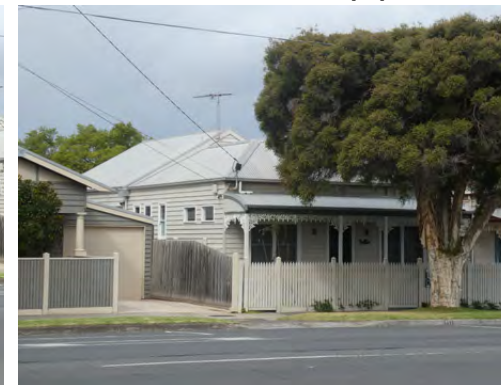
137 Swanston Street (D)

Description: a single storey detached dwelling in a Victorian architectural style, setback 0-2m from the street. Wall construction of weatherboard with a hipped roof form. Possibly 1 of a row of 3 or 4 matching designs.

Integrity: the primary building is substantially unchanged from its early or significant character/form, with a large and reasonably discrete addition at rear, enlarged front windows (?).

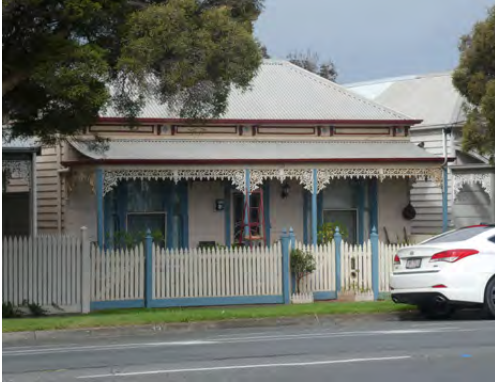
139 Swanston Street (D)

Description: a single storey detached dwelling in a Victorian architectural style, setback 0-2m from the street. Wall construction of weatherboard with a hipped roof form. Appears to be 1 of a row of 3-4 matching/similar designs.

Integrity: the primary building is substantially unchanged from its early or significant character/form, with a discrete addition at rear, possibly larger windows.

include: complementary setback of the primary building from the street, scale/height, its roof form and presence of verandah/porch, its architectural style, its wall & roof cladding, large weatherboards (possibly to resemble ashlar stone?) window and door layout & materials, chimney stack, aspects of its exterior detailing including the iron lacework, eaves brackets & panelling, picket front fence.

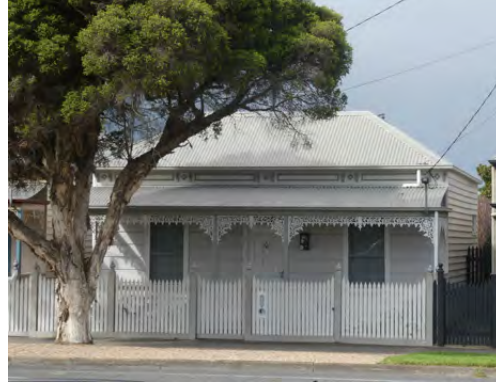
141 Swanston Street (D)

Description: a single storey detached dwelling in a Victorian architectural style, setback 0-2m from the street. Wall construction of weatherboard with a hipped roof form. Appears to be 1 of a row of 3-4 matching/similar designs.

Integrity: the primary building is substantially unchanged from its early or significant character/form, with a discrete addition at rear.

include: complementary setback of the primary building from the street, scale/height, its roof form and presence of verandah/porch, its architectural style, its wall & roof cladding, large weatherboards (possibly to resemble ashlar stone?) window and door layout & materials, aspects of its exterior detailing including the iron lacework, eaves brackets & panelling, picket front fence.

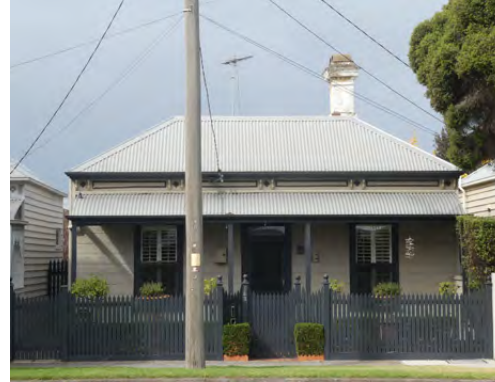
143 Swanston Street (D)

Description: a single storey detached dwelling in a Victorian architectural style, setback 0-2m from the street. Wall construction of weatherboard with a hipped roof form. Appears to be 1 of a row of 3-4 matching/similar designs.

Integrity: the primary building is substantially unchanged from its early or significant character/form, with a discrete addition at rear, simplified verandah with removed lacework.

include: complementary setback of the primary building from the street, scale/height, its roof form and presence of verandah/porch, its architectural style, its wall & roof cladding, large weatherboards (possibly to resemble ashlar stone?) window and door layout & materials, chimney stack, aspects of its exterior detailing including eaves brackets & panelling, picket front fence.

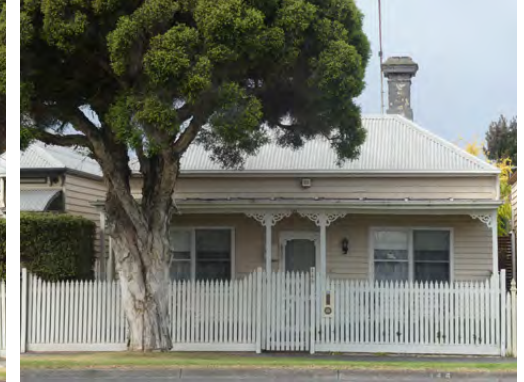
145 Swanston Street (D)

Description: a single storey detached dwelling in a Victorian architectural style with art nouveau cues, setback 0-2m from the street. Wall construction of weatherboard with a hipped roof form.

Integrity: the primary building is substantially unchanged from its early or significant character/form, with a discrete addition at rear, larger windows and flat verandah roof could be early change but likely original;.

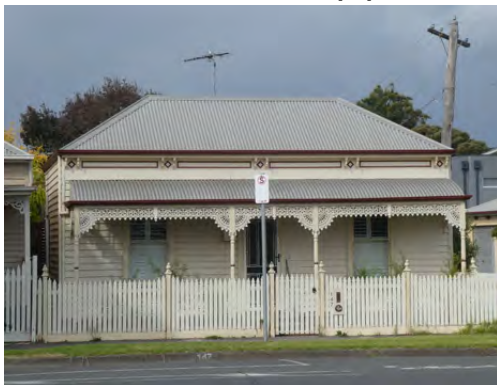
147 Swanston Street (D)

Description: a single storey detached dwelling in a Victorian architectural style, setback 0-2m from the street. Wall construction of weatherboard with a hipped roof form.

Integrity: the primary building is substantially unchanged from its early or significant character/form, with a large yet discrete addition at rear.

include: complementary setback of the primary building from the street, scale/height, its roof form and presence of verandah/porch, its architectural style, its wall & roof cladding, window and door layout & materials, aspects of its exterior detailing including turned verandah posts and iron lacework, eaves brackets & panelling, picket front fence.

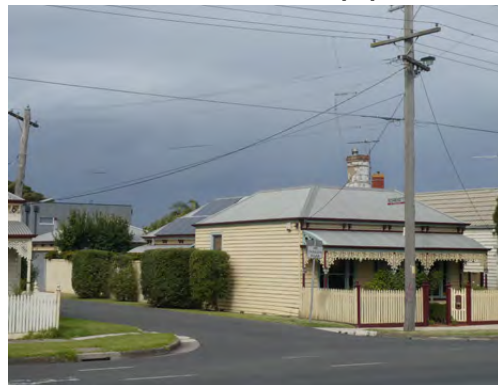
149 Swanston Street (D)

Description: a single storey detached dwelling in a Victorian architectural style, setback 0-2m from the street. Wall construction of weatherboard with a hipped roof form.

Integrity: the primary building is substantially unchanged from its early or significant character/form, with a large yet discrete addition at rear.

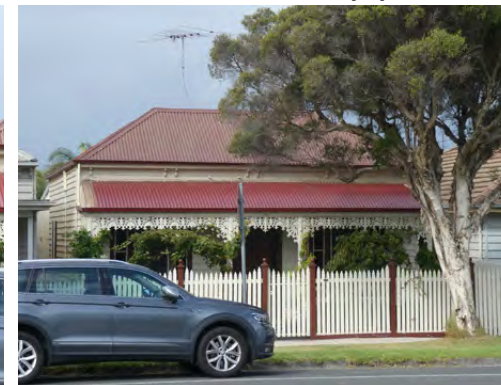
153 Swanston Street (D)

Description: a single storey detached dwelling in a Victorian architectural style, setback 0-2m from the street. Wall construction of weatherboard with a hipped roof form.

Integrity: the primary building is substantially unchanged from its early or significant character/form, with a large yet discrete addition at rear.

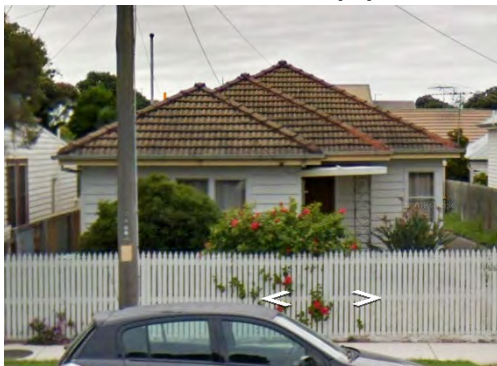
155 Swanston Street (D)

Description: a single storey detached dwelling in a Postwar (c1940s-50s) architectural style, setback 2-5m from the street. Wall construction of weatherboard with a hip roof form.

Integrity: the primary building is substantially unchanged from its early or significant character/form, with a discrete rear addition.

include: complementary setback of the primary building from the street, scale/height, its triple-hip roof form, presence of verandah/porch, its architectural style, its wall & roof cladding, window and door layout & materials, aspects of its exterior detailing including flat porch roof with ornamental iron rail support, front fence.

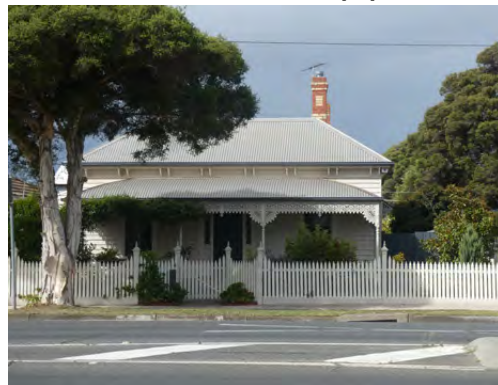
157 Swanston Street (D)

Description: a single storey detached dwelling in a Victorian architectural style, setback 2-5m from the street. Wall construction of weatherboard with a hipped roof form.

Integrity: the primary building is substantially unchanged from its early or significant character/form, with a large yet discrete addition at rear.

include: complementary setback of the primary building from the street, scale/height, its roof form and presence of verandah/porch, its architectural style, its wall & roof cladding, multiple ornate chimney stacks, window and door layout & materials, aspects of its exterior detailing including verandah posts and iron lacework, eaves brackets & panelling, picket front fence, street tree.

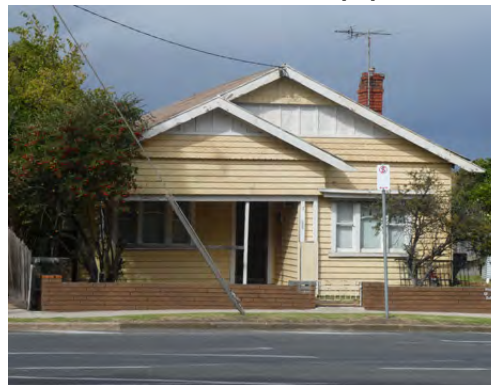
159 Swanston Street (D)

Description: a single storey detached dwelling in an Interwar architectural style, setback 2-5m from the street. Wall construction of weatherboard with a gable roof form.

Integrity: the primary building is substantially unchanged from its early or significant character/form, with a discrete rear addition and a latter but reasonably complementary brick front fence.

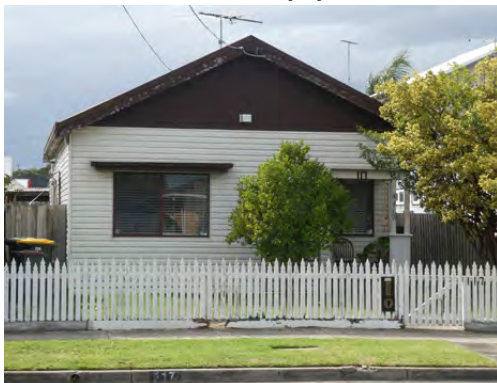
Description: a single storey detached dwelling in an Interwar architectural style, setback 2-5m from the street. Wall construction of weatherboard with a gable roof form..

Integrity: the primary building has been subject to minor alterations that either do not diminish its significant character or can be easily reversed, including replacement of timber windows with aluminium sliding units and a discrete rear addition.

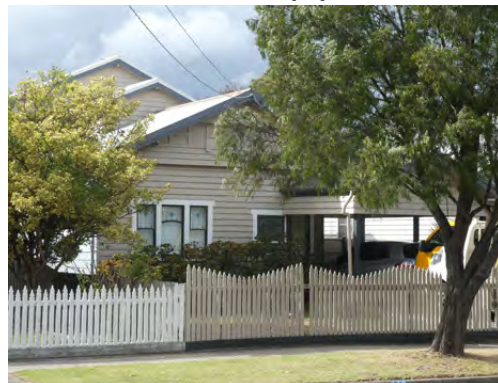
119 Verner Street (D)

Description: a two storey detached dwelling in an Interwar architectural style, setback 2-5m from the street. Wall construction of weatherboard with a gable roof form.

Integrity: the primary building has been subject to major alterations that substantially change its scale & layout but complement its significant character, with a two storey rear addition and attached front carport.

Significant character attributes include: complementary setback of the primary building from the street, scale/height, its multi-gabled roof form and presence of verandah/porch, its architectural style, its wall & roof cladding, window and door layout & materials, aspects of its exterior joinery including panelling on the gables, stained glass windows, front fence, street tree.

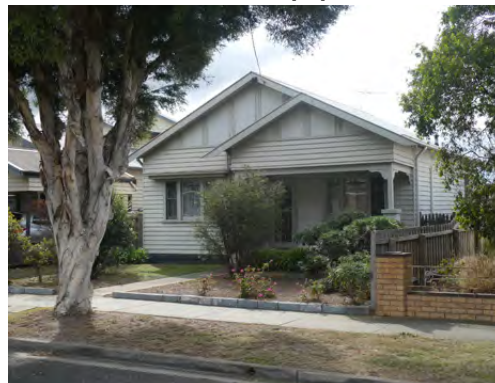
121 Verner Street (D)

Description: a single storey detached dwelling in an Interwar architectural style, setback 2-5m from the street. Wall construction of weatherboard with a gable roof form.

Integrity: the primary building is substantially unchanged from its early or significant character/form; the absence of a front fence & chimney stacks the only notable change.

Assessed heritage value: overall the primary building and landscaping make a major contribution to the significant character of the area.

Significant character attributes include: complementary setback of the primary building from the street, scale/height, its roof form with double-gabled façade and presence of verandah/porch, its architectural style, its wall & roof cladding, window and door layout & materials, leadlighting, aspects of its exterior joinery including panelling on the gables, window hood, exposed rafters, masonry & timber verandah posts, street tree.

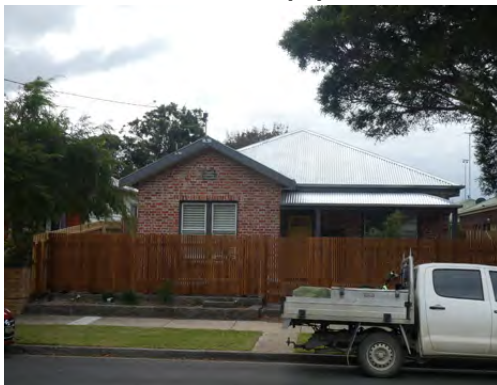
125 Verner Street (N)

Description: a single storey detached dwelling in a 2019 reproduction façade of Federation style, setback 2-5m from the street. Wall construction of face brick masonry with a hip and gable roof form.

Integrity: the original residence has been demolished and replaced by new development that complements the character attributes of the area.

Assessed heritage value: overall the primary building and landscaping make no substantive contribution to the significant character of the area, beyond maintaining a complementary scale, form and setback.

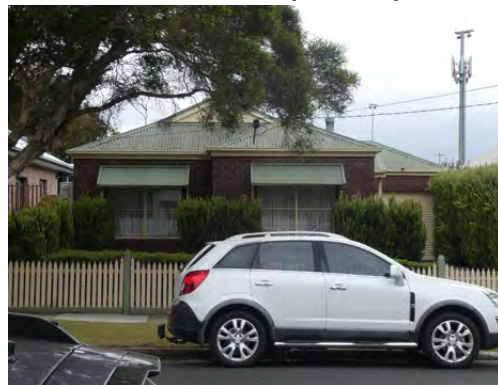
127 Verner Street (Non-C)

Description: a single storey detached dwelling in a Postwar architectural style drawing upon some Federation visual cues, setback 2-5m from the street. Wall construction of face brick masonry with a hip and gable roof form.

Integrity: the original residence has been demolished and replaced by new development that broadly complements the character attributes of the area.

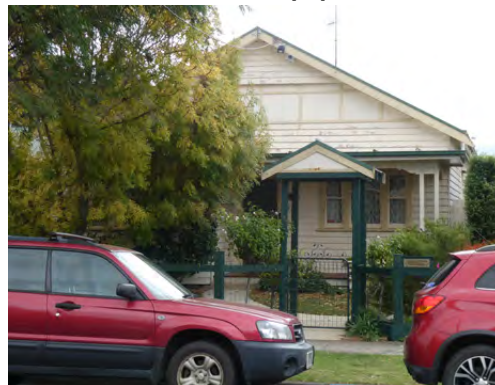
129 Verner Street (D)

Description: a single storey detached dwelling in an Interwar architectural style, setback 2-5m from the street. Wall construction of weatherboard with a gable roof form.

Integrity: the primary building is substantially unchanged from its early or significant character/form, with a discrete rear addition and a latter but reasonably complementary front fence.

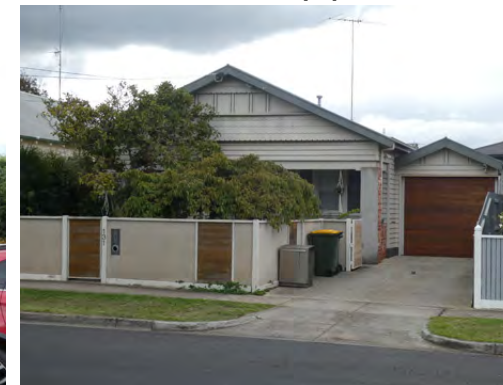
131 Verner Street (D)

Description: a single storey detached dwelling in an Interwar architectural style, setback 2-5m from the street. Wall construction of weatherboard with a gable roof form.

Integrity: the primary building has been subject to minor alterations that either do not diminish its significant character or can be easily reversed, including garage addition at side, new column supports to front porch, a discrete rear addition and a solid panelled front fence.

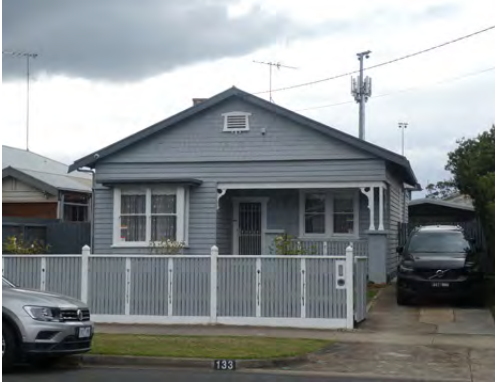
133 Verner Street (D)

Description: a single storey detached dwelling in an Interwar architectural style, setback 2-5m from the street. Wall construction of weatherboard with a gable roof form.

Integrity: the primary building is substantially unchanged from its early or significant character/form, with a latter but complementary front fence.

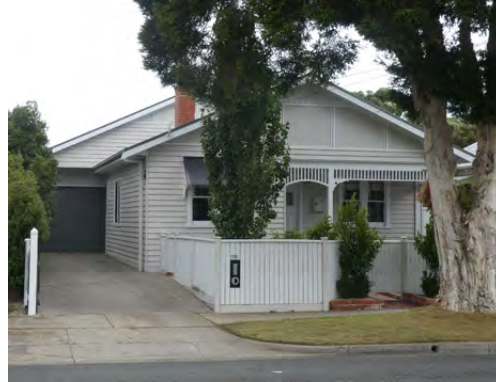
135 Verner Street (D)

Description: predominantly a single storey detached dwelling in an Interwar architectural style setback 2-5m from the street. Wall construction of weatherboard with a gable roof form.

Integrity: the primary building has been subject to major alterations that substantially change its scale but complement its significant character, with a two storey rear addition and what appears to be Federation-inspired verandah fretwork and window hood, plus a latter/complementary front fence.

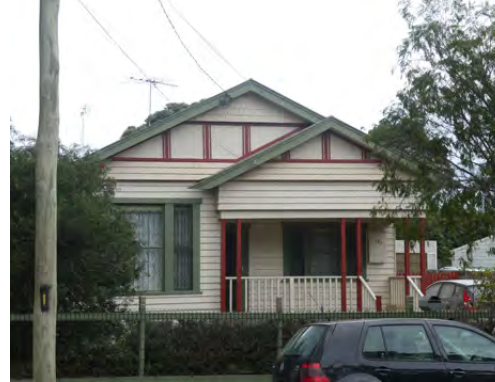
137 Verner Street (D)

Description: a single storey detached dwelling in an Interwar architectural style, setback 2-5m from the street. Wall construction of weatherboard with a gable roof form.

Integrity: the primary building is substantially unchanged from its early or significant character/form; albeit the front porch has been rebuilt in concrete with a new balustrade and it has a latter but complementary front fence.

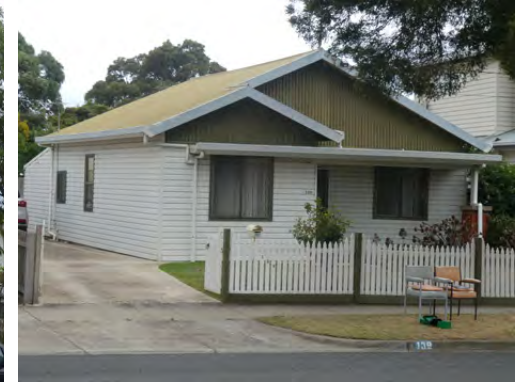
Description: a single storey detached dwelling in an Interwar architectural style, setback 2-5m from the street. Wall construction of weatherboard with a gable roof form..

Integrity: the primary building has been subject to minor alterations that either do not diminish its significant character or can be easily reversed, including replacement of timber windows with aluminium sliding units and changes to guttering/fascias and downpipes.

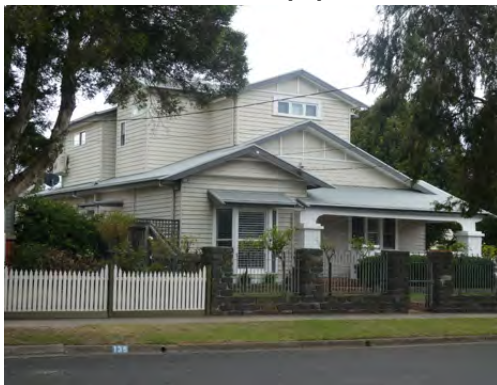
141 Verner Street (D)

Description: a two storey detached dwelling in an Interwar architectural style setback 2-5m from the street. Wall construction of weatherboard with a hip and gable roof form.

Integrity: the primary building has been subject to major alterations that substantially change its scale & layout but broadly complement its significant character, with a two storey addition and a latter but complementary front fence.

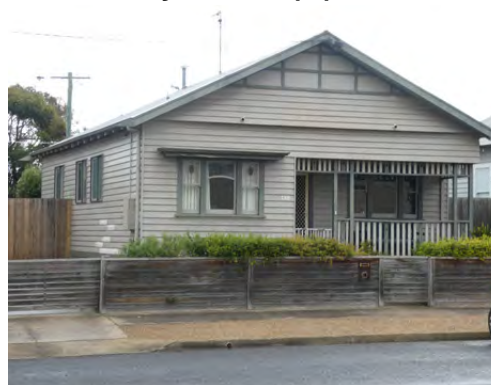
138 Fitzroy Street (D)

Description: a single storey detached dwelling in an Interwar architectural style, setback 2-5m from the street. Wall construction of weatherboard with a gable roof form.

Integrity: the primary building is substantially unchanged from its early or significant character/form, with a latter but complementary front fence.

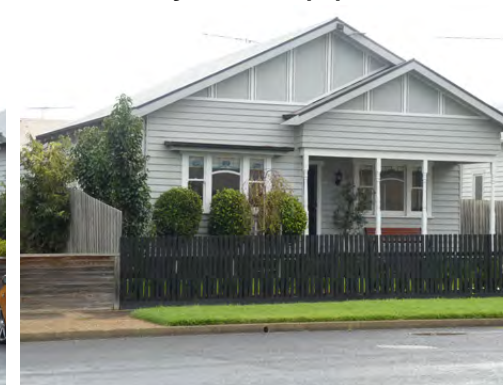
136 Fitzroy Street (D)

Description: a single storey detached dwelling in an Interwar architectural style, setback 2-5m from the street. Wall construction of weatherboard with a gable roof form.

Integrity: the primary building is substantially unchanged from its early or significant character/form; with a discrete rear addition and a latter but complementary front fence.

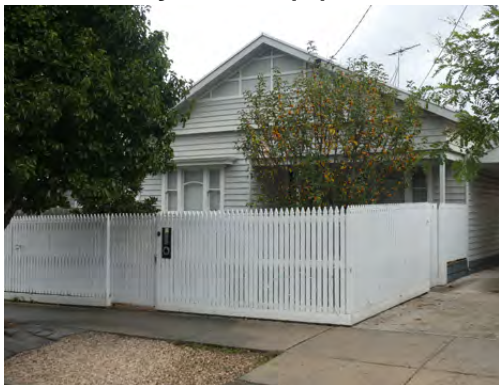
134 Fitzroy Street (D)

Description: a single storey detached dwelling in an Interwar architectural style, setback 2-5m from the street. Wall construction of weatherboard with a gable roof form.

Integrity: the primary building is substantially unchanged from its early or significant character/form, with a discrete rear addition and a latter but complementary front fence.

Significant character attributes include: complementary setback of the primary building from the street, scale/height, its roof form and presence of verandah/porch, its architectural style, its wall & roof cladding, window and door layout & materials, aspects of its exterior joinery including panelling on the gable, window hood, timber verandah posts, exposed rafters, low front fence, street tree.

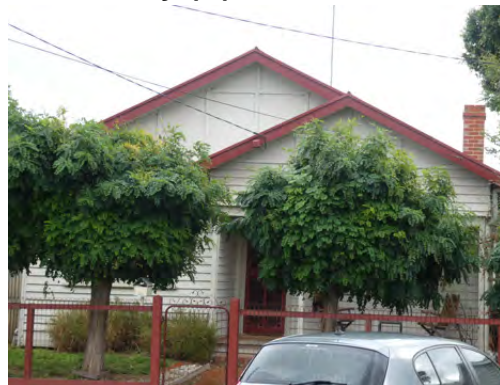
132 Fitzroy (D)

Description: a single storey detached dwelling in an Interwar architectural style, setback 2-5m from the street. Wall construction of weatherboard with a gable roof form.

Integrity: the primary building is substantially unchanged from its early or significant character/form; with a discrete rear addition and a latter but complementary front fence.

Significant character attributes include: complementary setback of the primary building from the street, scale/height, its roof form with double-gabled façade and presence of verandah/porch, its architectural style, its wall & roof cladding, window and door layout & materials, leadlighting, aspects of its exterior joinery including panelling on the gables, window hood, exposed rafters, timber verandah posts, low & partially transparent front fence, garden trees.

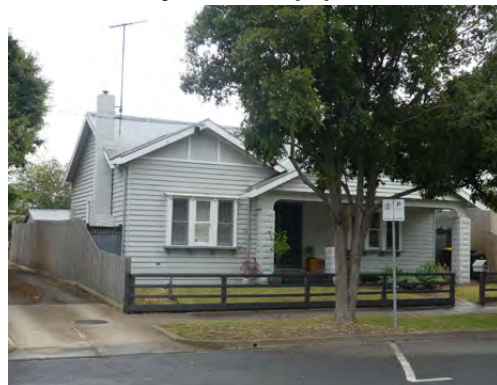
130 Fitzroy Street (D)

Description: a single storey detached dwelling in an Interwar architectural style, setback 2-5m from the street. Wall construction of weatherboard with a gable roof form.

Integrity: the primary building is substantially unchanged from its early or significant character/form; with a discrete rear addition and a latter but complementary front fence.

Assessed heritage value: overall the primary building and landscaping make a major contribution to the significant character of the area.

Significant character attributes include: complementary setback of the primary building from the street, scale/height, its roof form with double-gabled façade and presence of verandah/porch, its architectural style, its wall & roof cladding, window and door layout & materials, leadlighting, aspects of its exterior joinery including panelling on the gables, window hood and bench sill, masonry verandah posts, low & partially transparent front fence, street tree.

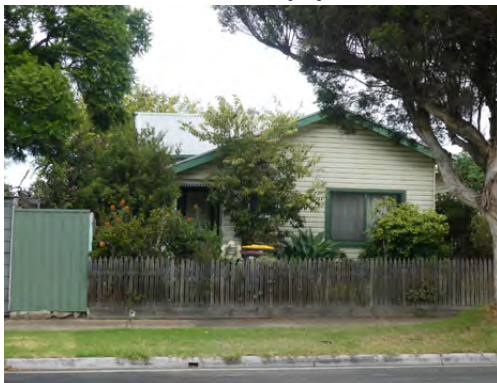
Description: a single storey detached dwelling in an Interwar architectural style, setback 2-5m from the street. Wall construction of weatherboard with a gable roof form..

Integrity: the primary building has been subject to minor alterations that either do not diminish its significant character or can be easily reversed, including replacement of timber windows with aluminium sliding units, and possible addition or iron/lace (?) work to porch.

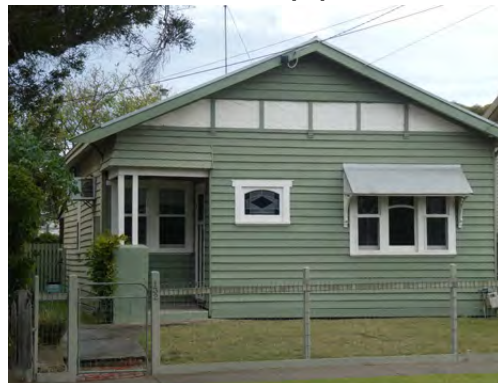
132 Verner Street (D)

Description: a single storey detached dwelling in an Interwar architectural style, setback 2-5m from the street. Wall construction of weatherboard with a gable roof form.

Integrity: the primary building is substantially unchanged from its early or significant character/form; with a discrete rear addition and a latter but complementary front fence.

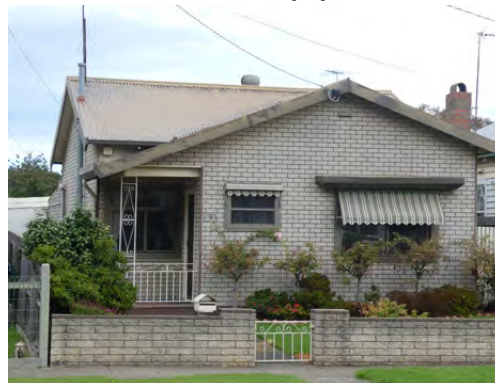
Description: a single storey detached dwelling in an Interwar architectural style, setback 2-5m from the street. Wall construction of imitation brick FC sheeting with a gable roof form..

Integrity: the primary building has been subject to minor alterations that substantially change its appearance but can be easily reversed, including replacement of weatherboards with brick panelling, replacement of timber verandah posts with iron railing, replacement of windows & window hood, installation of blinds, erection of low brick front fence.

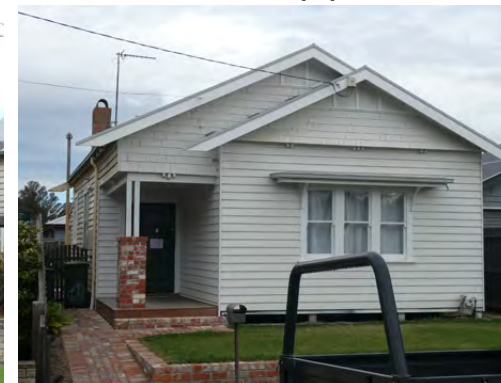
128 Verner Street (D)

Description: a single storey detached dwelling in an Interwar architectural style, setback 2-5m from the street. Wall construction of weatherboard with a gable roof form.

Integrity: the primary building is substantially unchanged from its early or significant character/form; with a discrete rear addition and removal of the front fence.

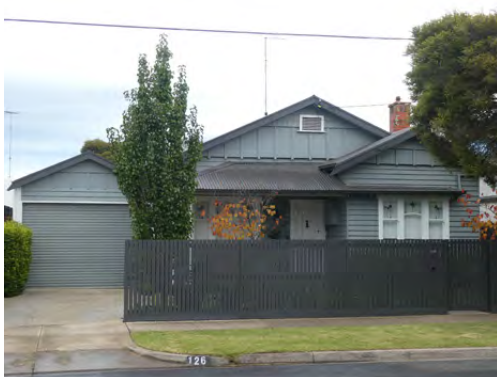
126 Verner Street (D)

Description: a single storey detached dwelling in an Interwar architectural style, setback 2-5m from the street. Wall construction of weatherboard with a gable roof form.

Integrity: the primary building is substantially unchanged from its early or significant character/form; with a discrete rear addition, attached garage, plus a latter/complementary front fence.

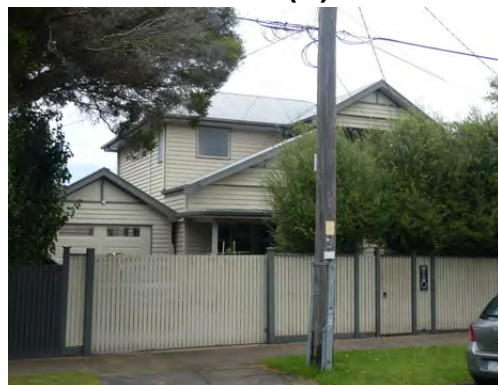
124 Verner Street (D)

Description: a two storey detached dwelling in an Interwar architectural style setback 2-5m from the street. Wall construction of weatherboard with a hip and gable roof form.

Integrity: the primary building has been subject to major alterations that substantially change its scale & layout but broadly complement its significant character, with a two storey addition, an attached garage and a latter but complementary front fence.

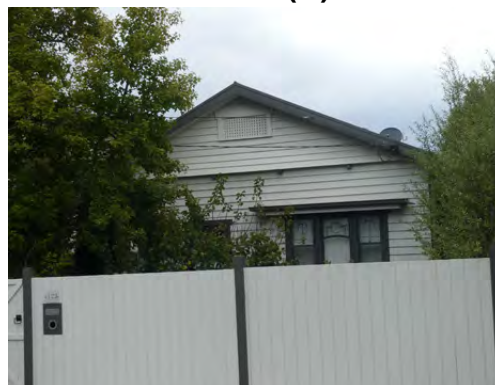
122 Verner Street (D)

Description: a single storey detached dwelling in an Interwar architectural style, setback 2-5m from the street. Wall construction of weatherboard with a gable roof form.

Integrity: the primary building is substantially unchanged from its early or significant character/form; with a discrete rear addition and a relatively high & non-transparent front fence.

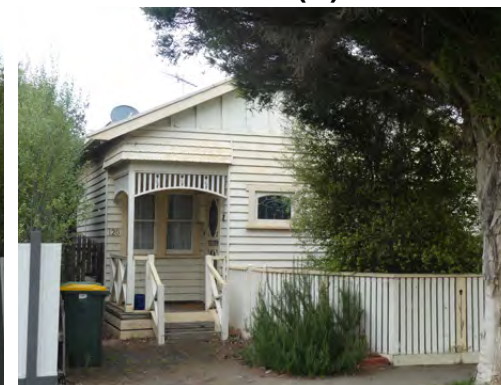
120 Verner Street (D)

Description: a single storey detached dwelling in an Interwar architectural style, setback 2-5m from the street. Wall construction of weatherboard with a gable roof form.

Integrity: the primary building is substantially unchanged from its early or significant character/form; with a discrete rear addition and a latter but complementary porch balustrade & front fence.

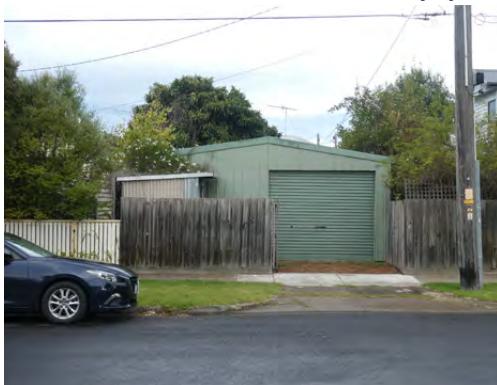
Description: single storey metal deck garage setback 2-5m from the street. [Note a reasonably intact one storey detached dwelling in a Federation architectural style & weatherboard construction fronts Carr St on the opposite side of the lot, but the Carr St streetscape has little merit and the concern with this property is its contribution to Verner St].

Integrity: the original outbuildings have been demolished and replaced by new utilitarian buildings closer to the street than nearby historical dwellings.

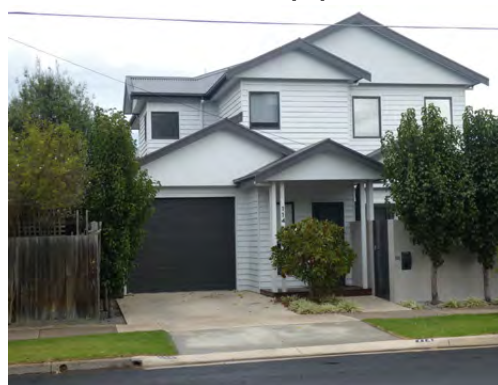
114 Verner Street (N)

Description: a two storey detached dwelling in a Postwar architectural style setback 2-5m from the street. Wall construction of weatherboard with a gable roof form.

Integrity: the original residence has been demolished and replaced by new development that struggles to complement the character attributes of the area.

Assessed heritage value: overall the primary building and landscaping make no substantive contribution to the significant character of the area.

Significant character attributes include: complementary setback of the primary building from the street, multi-gabled roof form, wall and roof cladding, presence of verandah/porch, low & partially transparent front fence, garden trees.

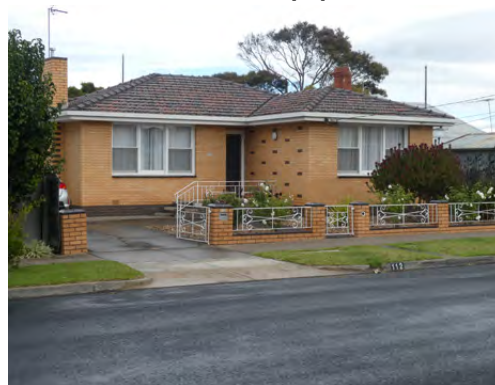
112 Verner Street (N)

Description: a single storey detached dwelling in a Postwar architectural style setback 2-5m from the street. Wall construction of face brick with a hipped roof form.

Integrity: the original residence has been demolished and replaced c1960 by new development that broadly complements the character attributes of the area.

Assessed heritage value: overall the primary building and landscaping make no substantive contribution to the significant character of the area.

Significant character attributes include: complementary setback of the primary building from the street, scale/height, roof form, low & partially transparent front fence, garden trees.

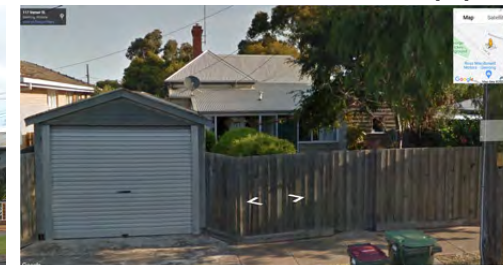
53 Carr Street – north half (N)

Description: single storey metal deck garage setback 2-5m from the street. [Note a reasonably intact one storey detached dwelling in a Federation architectural style & weatherboard construction fronts Carr St on the opposite side of the lot, but the Carr St streetscape has little merit and the concern with this property is its contribution to Verner St].

Integrity: the original outbuildings have been demolished and replaced by new utilitarian buildings closer to the street than nearby historical dwellings.

Assessed heritage value: overall the primary building and landscaping make no substantive contribution to the significant character of the area.

Significant character attributes include: complementary scale.

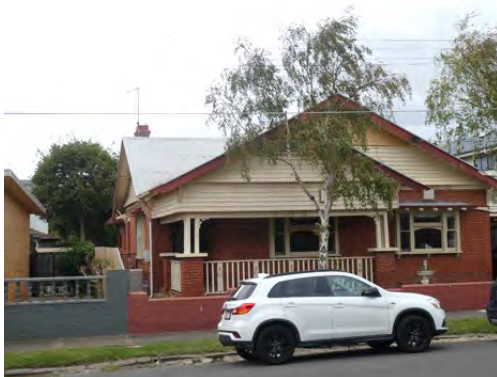
6 School Street (D)

Description: a single storey detached dwelling in a Interwar architectural style, setback 2-5m from the street. Wall construction of face brick masonry with a gable roof form.

Integrity: the primary building is substantially unchanged from its early or significant character/form.

Assessed heritage value: overall the primary building and landscaping make a major contribution to the significant character of the area.

include: complementary setback of the primary building from the street, scale/height, its roof form and presence of verandah/porch, its architectural style, its wall & roof cladding, window and door layout & materials including projecting windows, chimney stack, aspects of its exterior joinery including panelling/shingling of the gables, timber brackets and balustrading on the verandah/porch, eave brackets, front fence, garden trees.

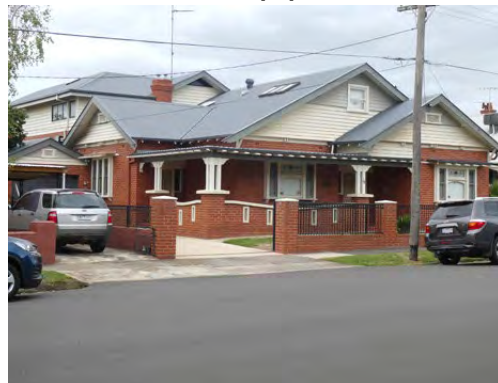
4 School Street (D)

Description: a two storey detached dwelling in a Interwar architectural style, setback 2-5m from the street. Wall construction of face brick masonry with a gable roof form.

Integrity: the front half of the primary building is substantially unchanged from its early or significant character/form, major changes include a complementary two storey addition at the rear, an attached garage and a brick and steel front fence.

Assessed heritage value: overall the primary building and landscaping make a moderate contribution to the significant character of the area.

include: complementary setback of the primary building from the street, scale/height, its roof form and presence of verandah/porch, its architectural style, its wall & roof cladding, window and door layout & materials including projecting windows, chimney stack, aspects of its exterior joinery including panelling/shingling of the gables, timber fretwork on the verandah/porch, eave brackets.
