THE CITY OF
GREATER GEELONG

SOUTH GEELONG URBAN DESIGN FRAMEWORK

PROPOSED REVISION TO HO1641
CITY SOUTH HERITAGE AREA

FEBRUARY 2022

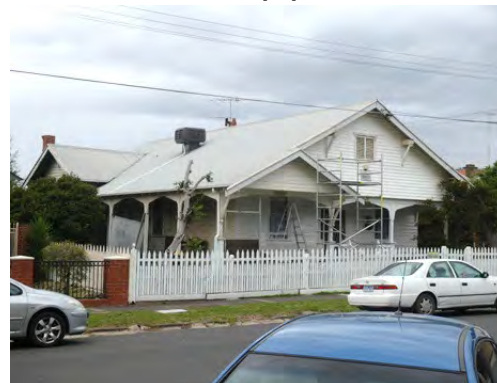
2 School Street (D)

Description: a single storey detached dwelling in a Interwar architectural style, setback 2-5m from the street. Wall construction of weatherboard with a gable roof form.

Integrity: the primary building is (?) substantially unchanged from its early or significant character/form.

Assessed heritage value: overall the primary building and landscaping make a major contribution to the significant character of the area.

include: complementary setback of the primary building from the street, scale/height, its roof form and presence of an unusual and distinctive verandah/porch, its architectural style, its wall & roof cladding, window and door layout & materials, chimney stacks, aspects of its exterior joinery including panelling of the gables, timber fretwork on the verandah/porch, front fence, garden trees /shrubs.

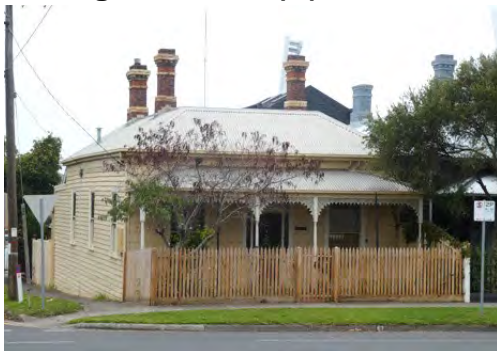
62 Kilgour Street (D)

Description: a single storey detached dwelling in a Victorian architectural style, setback 2-5m from the street. Wall construction of weatherboard with a hipped roof form.

Integrity: the primary building is substantially unchanged from its early or significant character/form, with latter but complementary fencing on both frontages.

Assessed heritage value: overall the primary building and landscaping make a major contribution to the significant character of the area.

include: complementary setback of the primary building from the street, scale/height, its roof form and presence of verandah/porch, its architectural style, its wall & roof cladding, window and door layout & materials, chimney stacks, aspects of its exterior detailing including iron posts and lacework on the verandah/porch, eave brackets, front fence, garden trees, street tree.

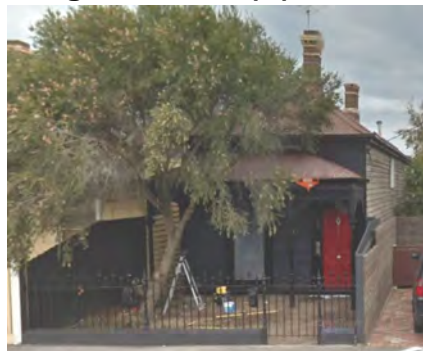
60 Kilgour Street (D)

Description: front half of the building comprises a narrow single storey townhouse in a Victorian architectural style, setback 2-5m from the street; wall construction of weatherboard with a hipped roof form. The rear part comprises a gabled two storey weatherboard structure.

Integrity: the primary building is substantially unchanged from its early or significant character/form, albeit having a two storey addition downhill to the rear and a latter/complementary front fence.

Assessed heritage value: overall the primary building and landscaping make a moderate contribution to the significant character of the area.

include: complementary setback of the primary building from the street, scale/height, its roof form and presence of verandah/porch, its architectural style, its wall & roof cladding, window and door layout & materials, chimney stacks, aspects of its exterior detailing including iron posts and lacework on the verandah/porch, front fence, garden trees.

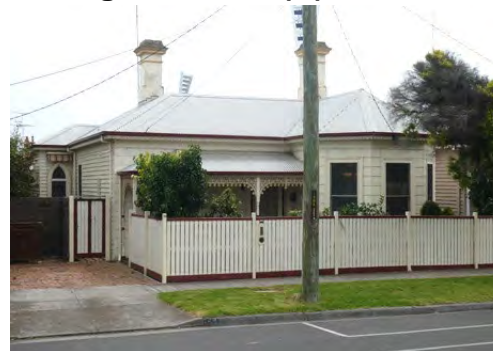
58 Kilgour Street (D)

Description: a single storey detached dwelling in a Victorian architectural style, setback 2-5m from the street. Wall construction of weatherboard with a hipped roof form, the front wall having timber boarding imitating ashlar stonework.

Integrity: the primary building is substantially unchanged from its early or significant character/form, with a latter but complementary front fence.

Assessed heritage value: overall the primary building and landscaping make a major contribution to the significant character of the area.

include: complementary setback of the primary building from the street, scale/height, its roof form and presence of verandah/porch, its architectural style, its wall & roof cladding, window and door layout & materials, chimney stacks, aspects of its exterior joinery detailing including moulded posts and lacework on the verandah/porch, ornate fascia board, imitation ashlar facade, front fence, garden trees, street tree.

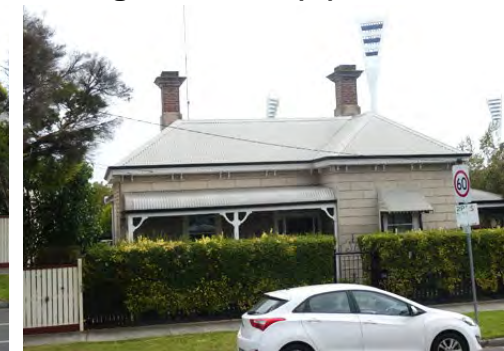
56 Kilgour Street (D)

Description: a single storey detached dwelling in a Victorian architectural style, setback 2-5m from the street. Wall construction of weatherboard with a hipped roof form, the front wall having timber boarding imitating ashlar stonework.

Integrity: the primary building is substantially unchanged from its early or significant character/form, with a latter but complementary front fence/hedge.

Assessed heritage value: overall the primary building and landscaping make a major contribution to the significant character of the area.

include: complementary setback of the primary building from the street, scale/height, its roof form and presence of verandah/porch, its architectural style, its wall & roof cladding, window and door layout & materials, chimney stacks, aspects of its exterior joinery including timber fretwork on the verandah/porch, eave brackets and ornate fascia board, imitation ashlar facade window hoods, front fence and hedge.

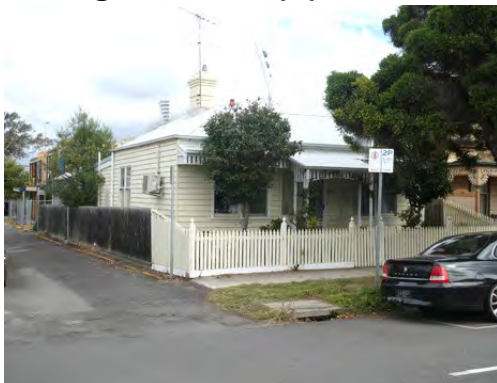
54 Kilgour Street (D)

Description: a single storey unit within a villa or townhouse cluster in a Federation architectural style, setback 2-5m from the street. Wall construction of weatherboard with a hipped roof form.

Integrity: the primary building has been subject to minor alterations that either do not diminish its significant character or can be easily reversed – wider windows installed (?).

Assessed heritage value: overall the primary building and landscaping make a major contribution to the significant character of the area.

Significant character attributes include: complementary setback of the primary building from the street, scale/height, its roof form and presence of verandah/porch, its architectural style, its wall & roof cladding, window and door layout & materials, chimney stacks, aspects of its exterior joinery including timber fretwork on the verandah/porch, timber front fence, garden trees & street tree.

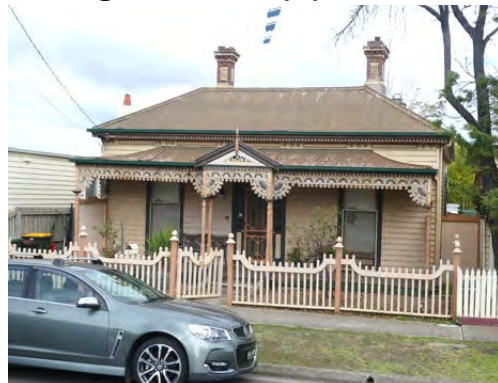
52 Kilgour Street (D)

Description: a single storey detached dwelling in a Victorian architectural style, setback 2-5m from the street. Wall construction of weatherboard with a hipped roof form.

Integrity: the primary building is substantially unchanged from its early or significant character/form.

Significant character attributes include: complementary setback of the primary building from the street, scale/height, its roof form and presence of verandah/porch, its architectural style, its wall & roof cladding, window and door layout & materials, chimney stacks, aspects of its exterior joinery including timber fretwork on the verandah/porch, eaves brackets and associated panelling, timber front fence.

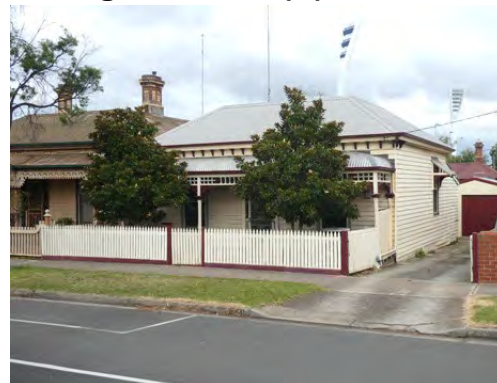
50 Kilgour Street (D)

Description: a single storey detached dwelling in a Victorian architectural style, setback 2-5m from the street. Wall construction of weatherboard with a hipped roof form.

Integrity: the primary building has been subject to minor alterations that either do not diminish its significant character or can be easily reversed – chimneys removed.

Significant character attributes include: complementary setback of the primary building from the street, scale/height, its roof form and presence of verandah/porch, its architectural style, its wall & roof cladding, window and door layout & materials, aspects of its exterior joinery including timber fretwork on the verandah/porch, timber brackets on the window hoods, eaves brackets, front fence, garden trees.

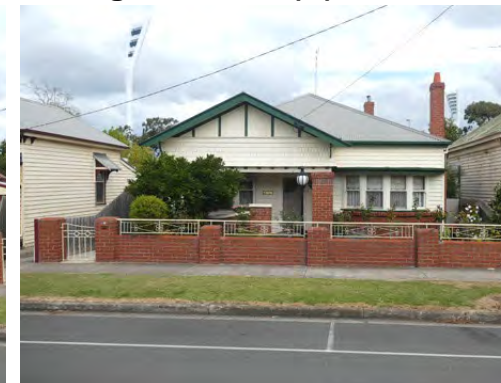
48 Kilgour Street (D)

Description: a single storey detached dwelling in an Interwar architectural style, setback 2-5m from the street. Wall construction of weatherboard on a red brick base with a hip and gable roof form.

Integrity: the primary building is substantially unchanged from its early or significant character/form.

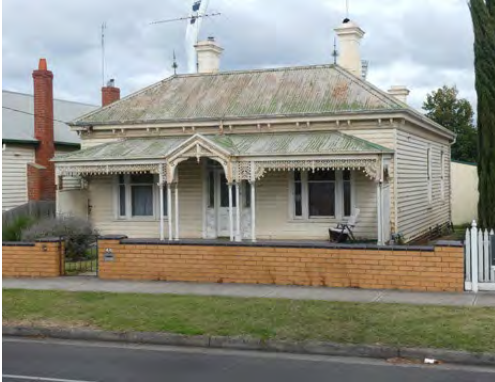
46 Kilgour Street (D)

Description: a single storey detached dwelling in a Victorian architectural style, setback 5-10m from the street. Wall construction of weatherboard with a hipped roof form.

Integrity: the primary building is substantially unchanged from its early or significant character/form, with a latter low, but otherwise uncomplimentary, brick fence.

Significant character attributes include: complementary setback of the primary building from the street, scale/height, its roof form and presence of verandah/porch, its architectural style, its wall & roof cladding, window and door layout & materials, chimney stacks, aspects of its exterior detailing including iron posts and lacework on the verandah/porch, eaves brackets.

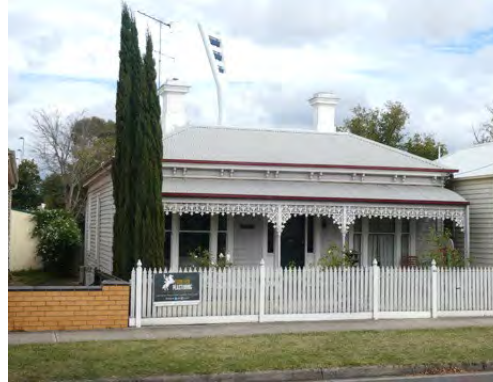
44 Kilgour Street (D)

Description: a single storey detached dwelling in a Victorian architectural style, setback 5-10m from the street. Wall construction of weatherboard with a hipped roof form.

Integrity: the primary building is substantially unchanged from its early or significant character/form, with a latter but complementary front fence.

Significant character attributes include: complementary setback of the primary building from the street, scale/height, its roof form and presence of verandah/porch, its architectural style, its wall & roof cladding, window and door layout & materials, chimney stacks, aspects of its exterior detailing including iron posts and lacework on the verandah/porch, eaves brackets and associated panelling, front fence, garden trees.

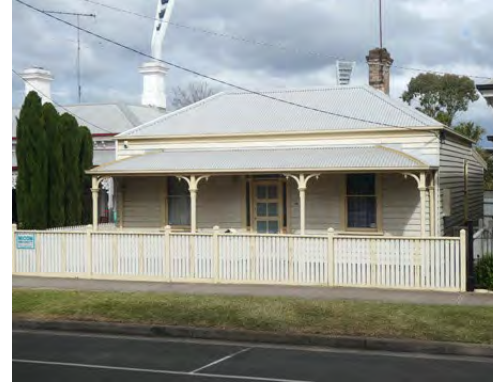
42 Kilgour Street (D)

Description: a single storey detached dwelling in a Victorian architectural style, setback 2-5m from the street. Wall construction of weatherboard with a hipped roof form.

Integrity: the primary building has been subject to minor alterations that either do not diminish its significant character or can be easily reversed – a chimney appears to have been removed and possibly the verandah form has been simplified, with a latter but complementary front fence.

Significant character attributes include: complementary setback of the primary building from the street, scale/height, its roof form and presence of verandah/porch, its architectural style, its wall & roof cladding, window and door layout & materials, chimney stack, aspects of its exterior joinery including, timber fretwork on the verandah/porch, front fence.

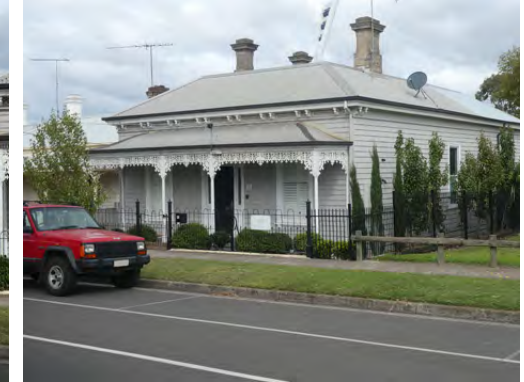
40 Kilgour Street (D)

Description: a single storey detached dwelling in a Victorian architectural style, setback 2-5m from the street. Wall construction of weatherboard with a hipped roof form.

Integrity: the primary building is substantially unchanged from its early or significant character/form, with a modified or latter but complementary fence.
